**Closure Report**  
**Denton 5 SWD**  
**Lea County, New Mexico**  
**Unit N Sec 02 T15S R37E**  
**33.041141°, -103.173094°**

**Incident Number: NPAC0614540738**  
**Produced Water Release**  
**Point of Release: Tank overflow due to pump failure**  
**Release Date: 05/23/2006**  
**Volume Released: 125 barrels of Produced Water**  
**Volume Recovered: 80 barrels of Produced Water**

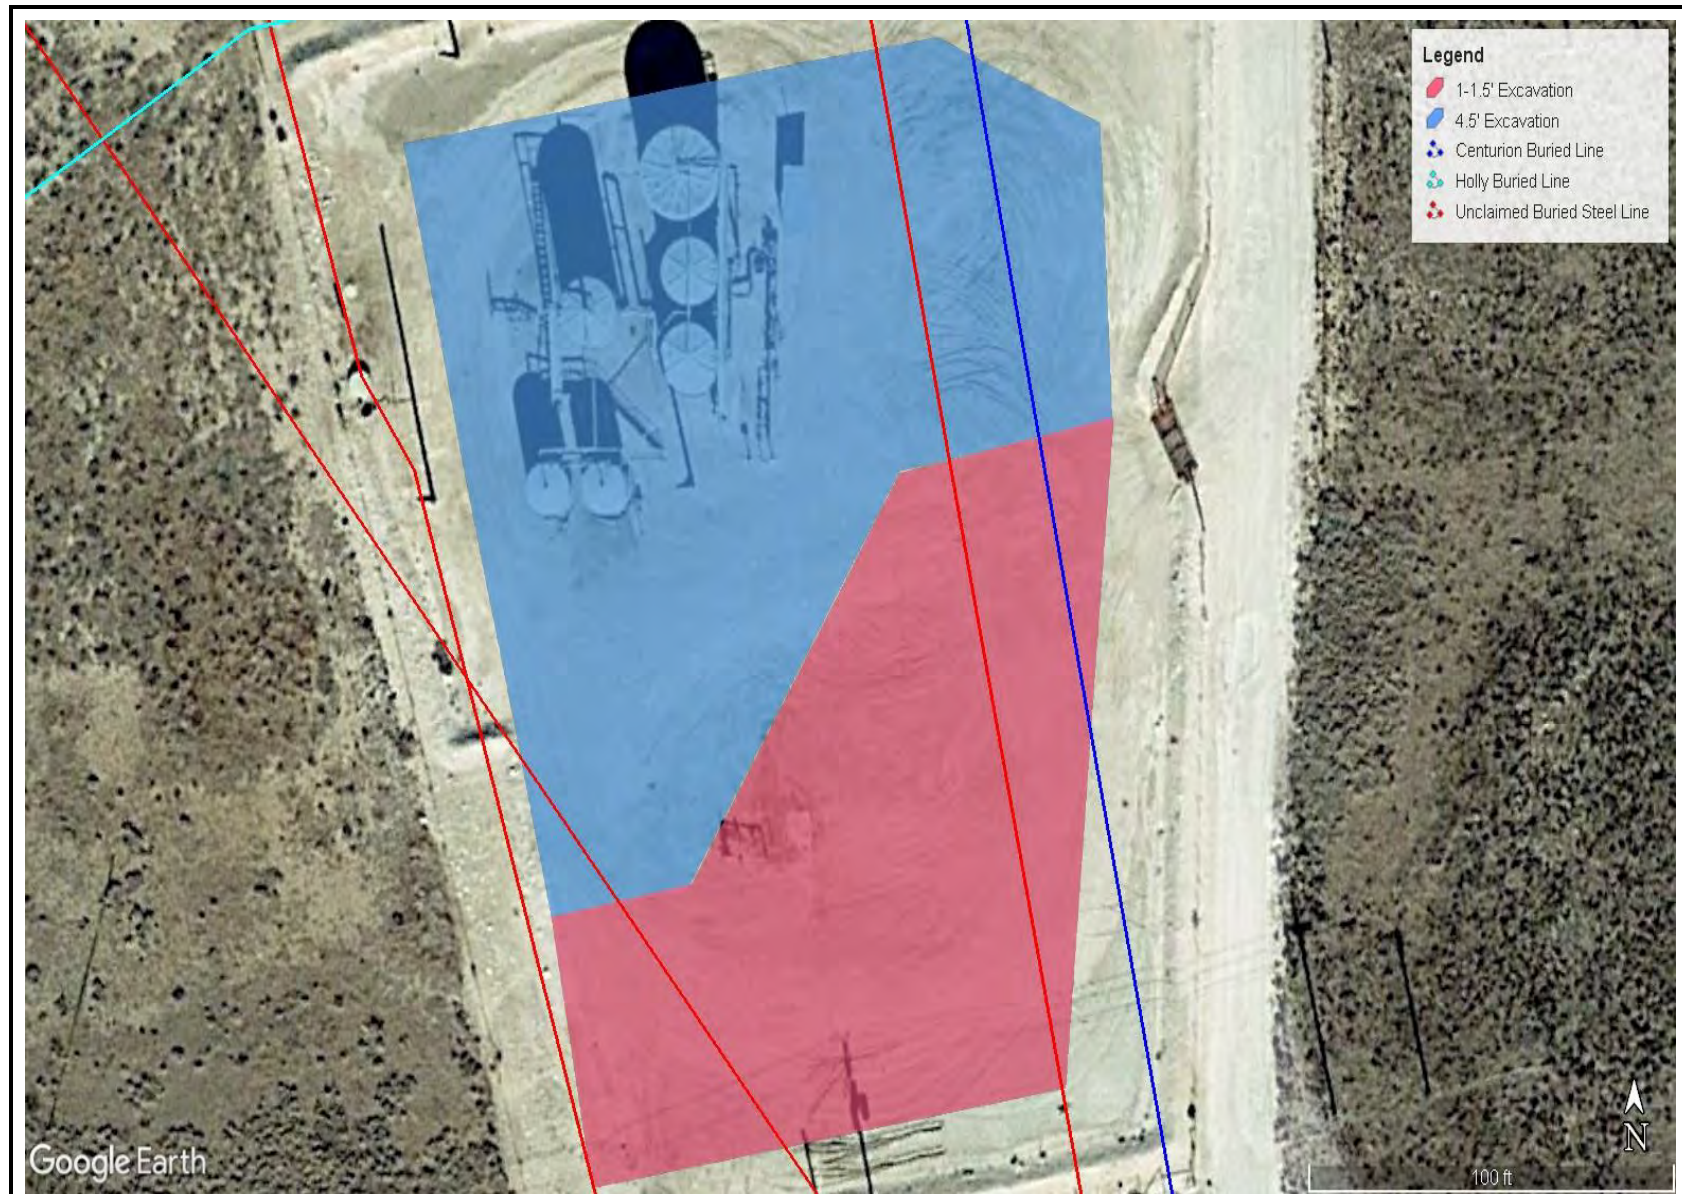
FIGURE 4

EXCAVATION OVERVIEW MAP  
FASKEN OIL AND RANCH  
DENTON 5 SWD  
LEA COUNTY, NEW MEXICO  
33.041141°, -103.173094°

Once the remediation activities were completed, the excavated areas were backfilled with clean material to surface grade. Based on further investigation, once all the facility equipment and tanks were removed, additional material was hauled to disposal from under the tanks. The firewall material was tested and found to be impacted. Approximately 5,060 cubic yards of material were excavated and transported offsite for proper disposal.

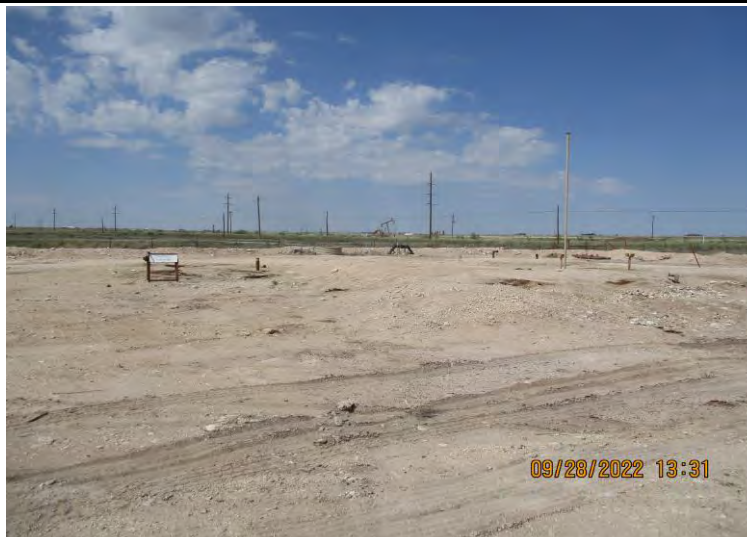
**PHOTOGRAPHIC LOG****Fasken Oil and Ranch****Photograph No. 1**

View of the pad, area of backhoe samples (1-6).

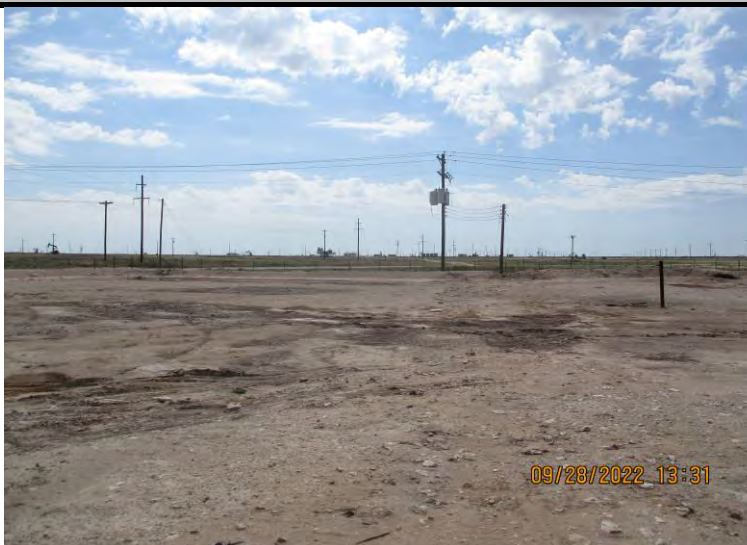
**Photograph No. 2**

View of the pad, area of backhoe samples (1-6).

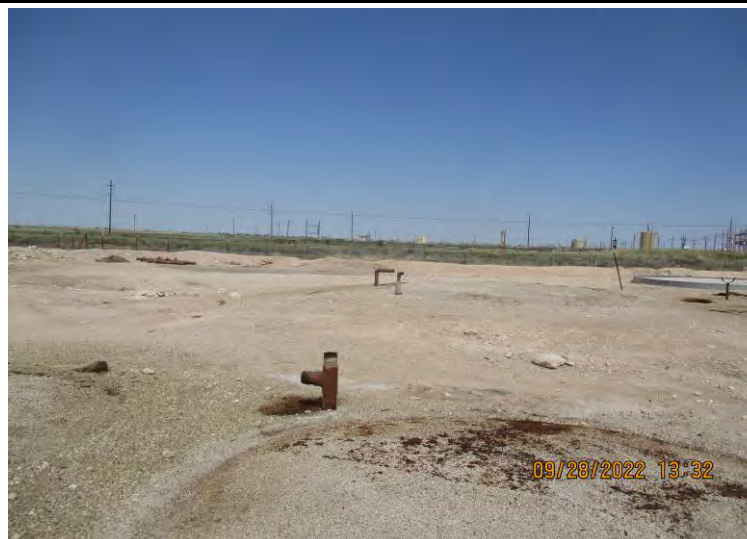
**Photograph No. 3**

View of the pad, area of backhoe samples (1-6).

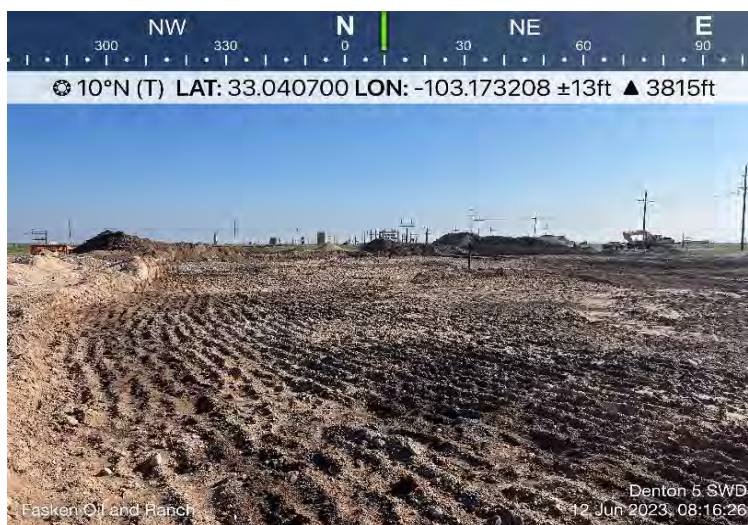
View of the excavation, area of confirmation samples (1-26) & (44-46).

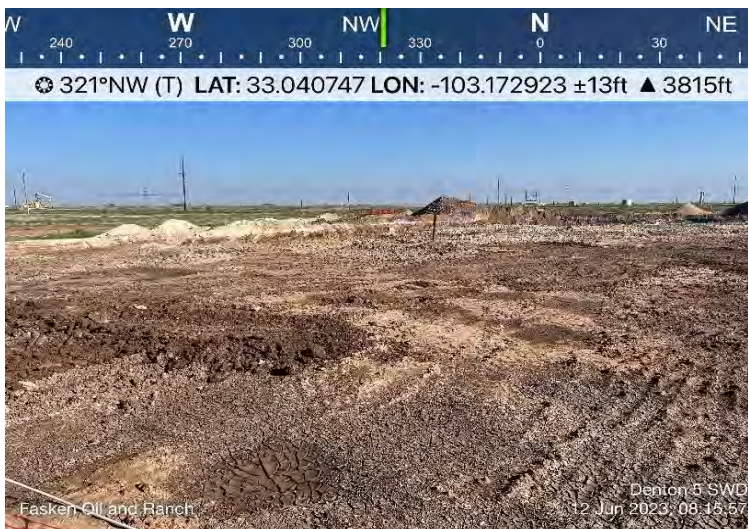
### Photograph No. 5

View of the excavation, area of confirmation samples (1-22) & (44-46).

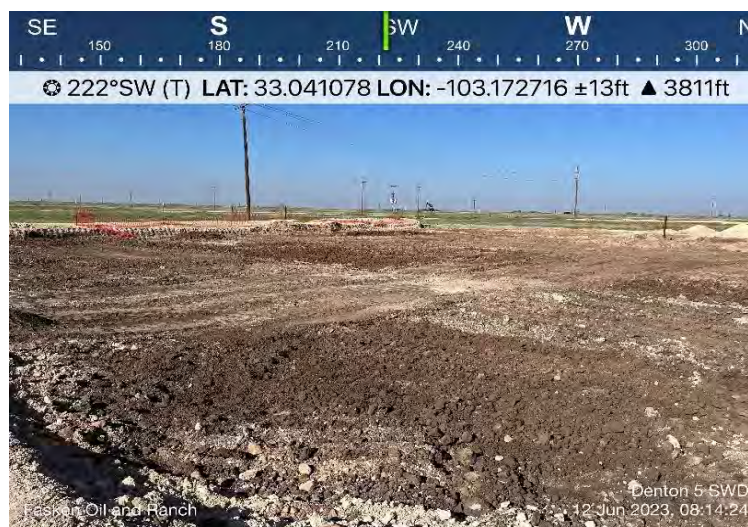
### Photograph No. 6

View of the excavation, area of confirmation samples (1-26) & (44-46).

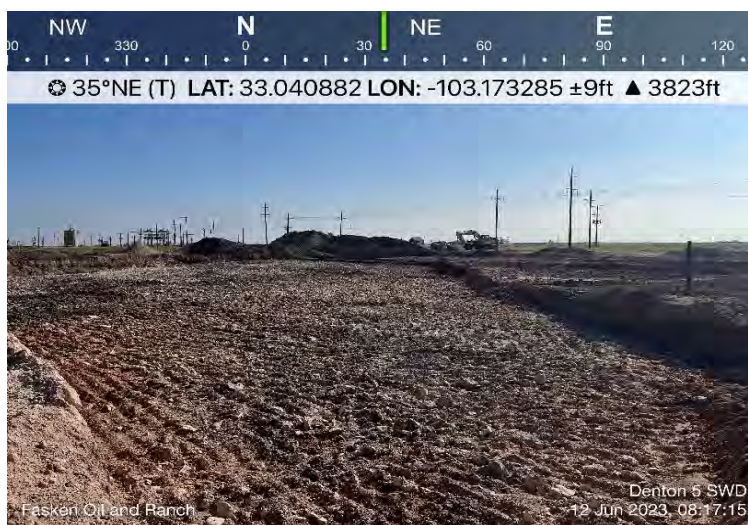
View of the excavation, area of confirmation samples (27-43), (47-63) & (82-94).

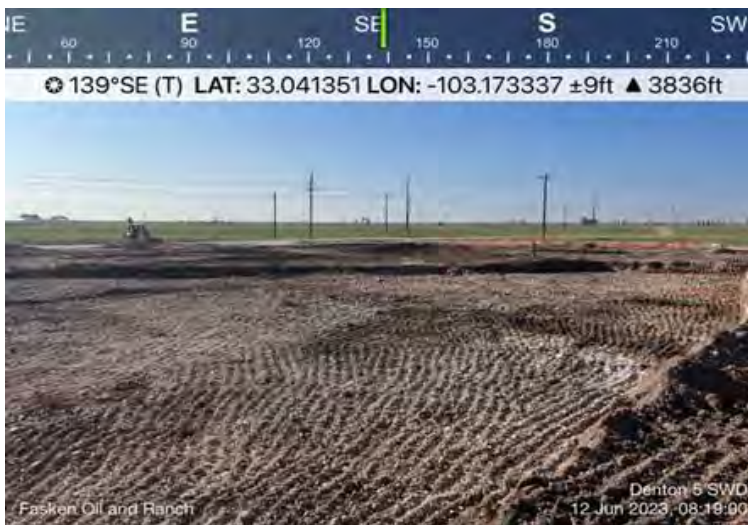
### Photograph No. 8

View of the excavation, area of confirmation samples (27-40), (53-60) & (82-84).

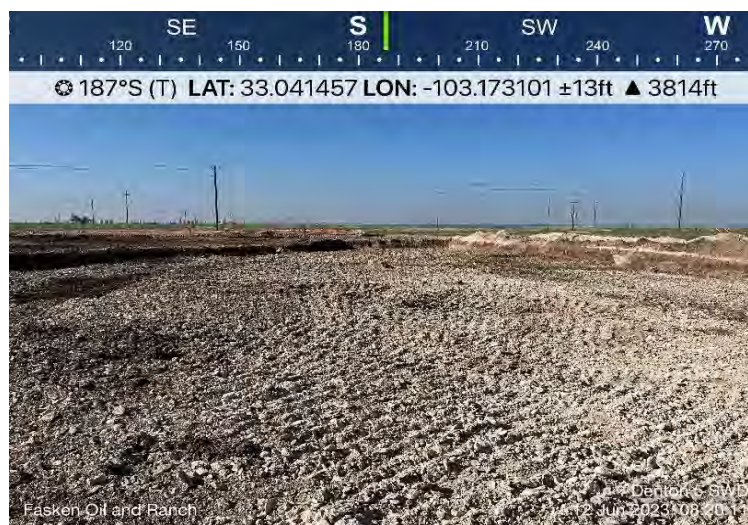
### Photograph No. 9

View of the excavation, area of confirmation samples (27-43), (47-63) & (82-94).

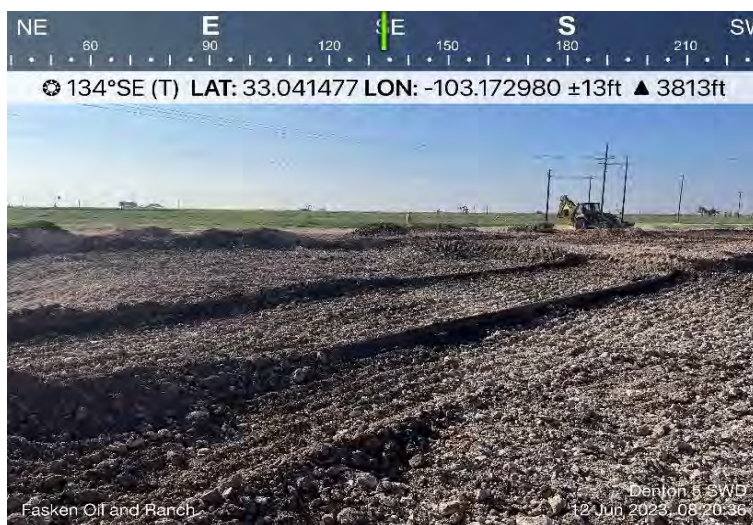
View of the excavation, area of confirmation samples (64-81).

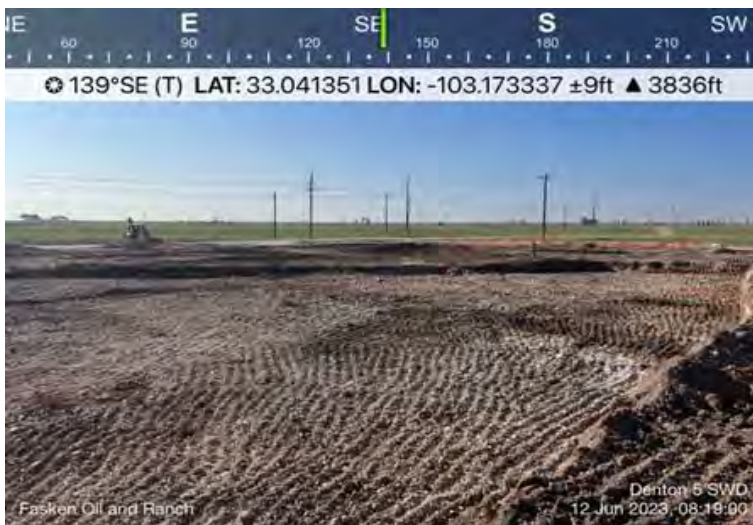
### Photograph No. 11

View of the excavation, area of confirmation samples (27-40), (53-60) & (82-84).

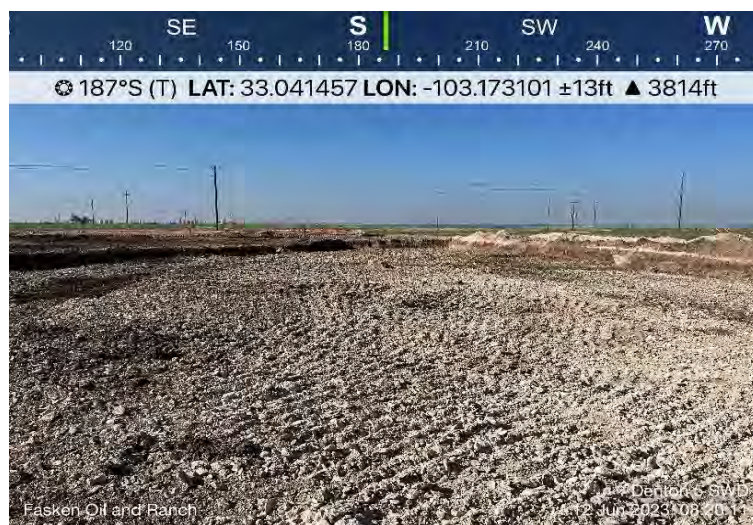
### Photograph No. 12

View of the excavation, area of confirmation samples (27-43), (47-63) & (82-94).

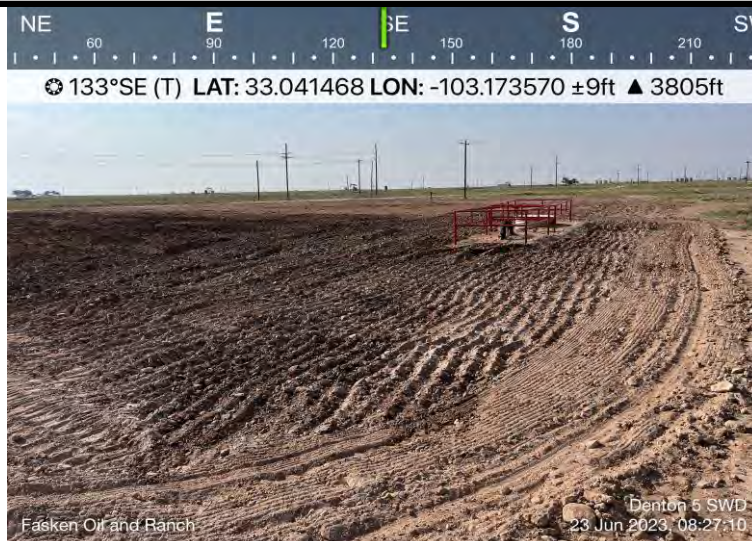
View Southeast, of the the reclamation area reseeded.

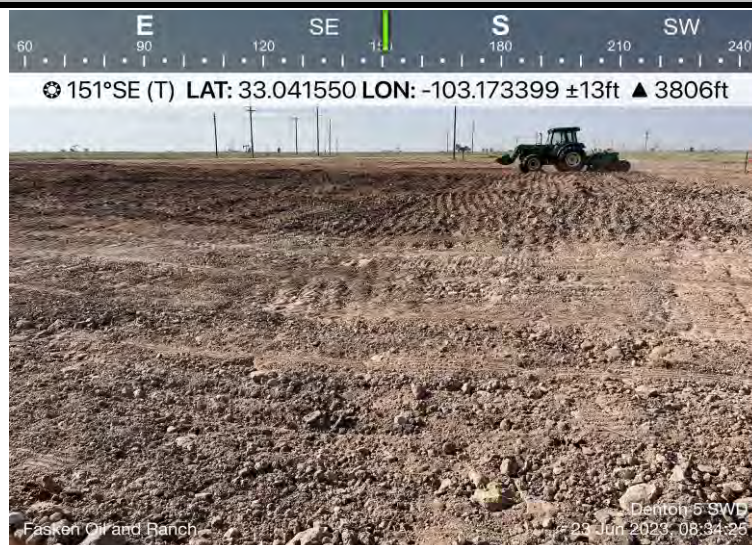
### Photograph No. 14

View Southeast, of the tractor reseeding the reclamation area.

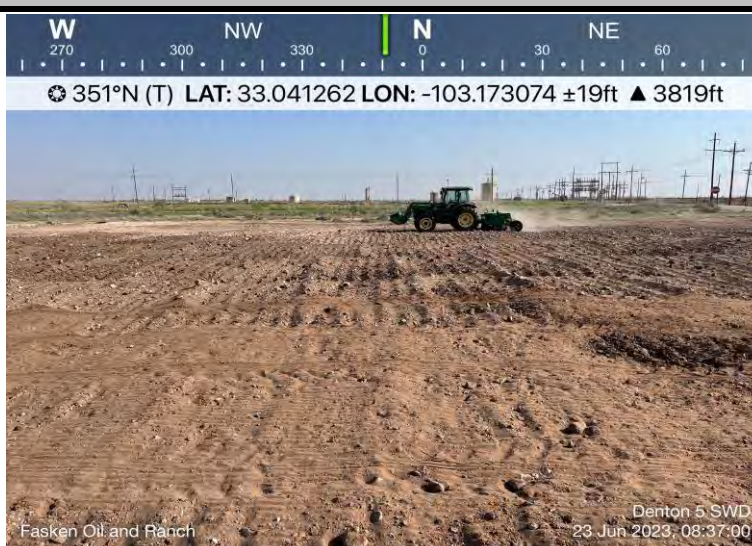
### Photograph No. 15

View North, of the tractor reseeding the reclamation area.

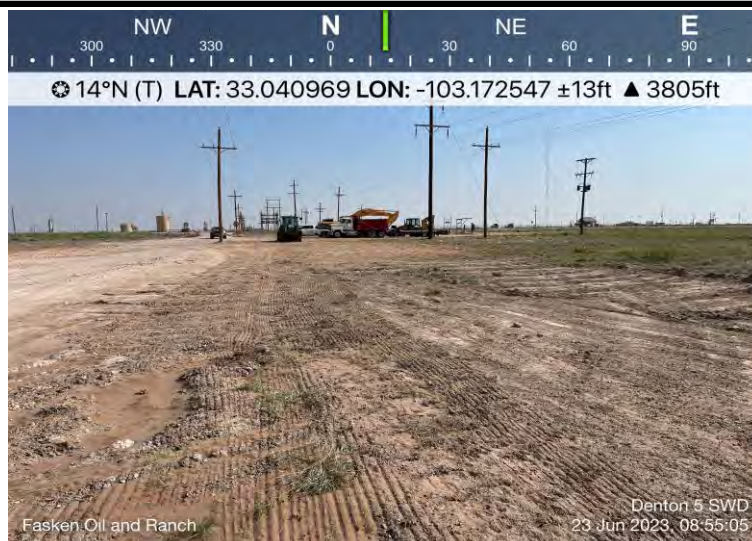
View North of a disturbed area after being reseeded.

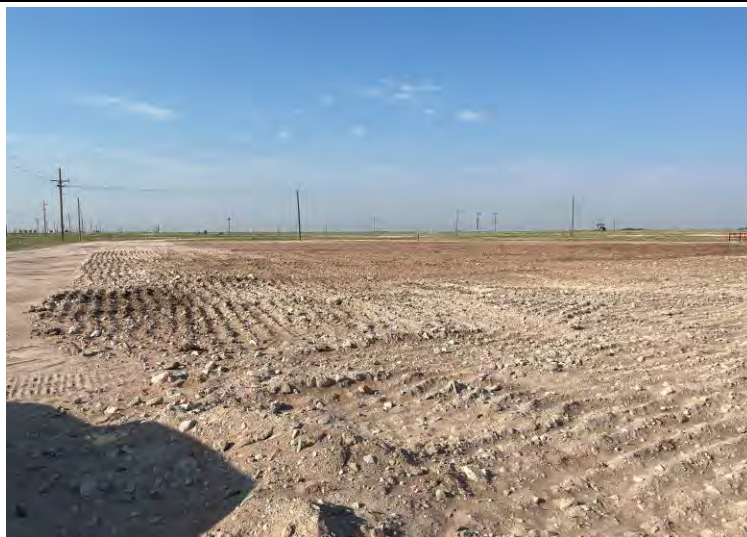
### Photograph No. 17

View South of the lease road and the reseeded reclamation area.

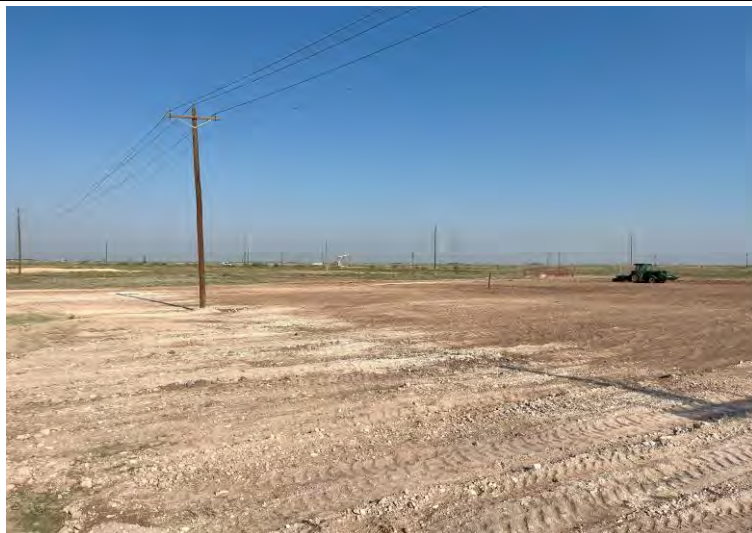
### Photograph No. 18

View Northwest, of the reseeded reclamation area.

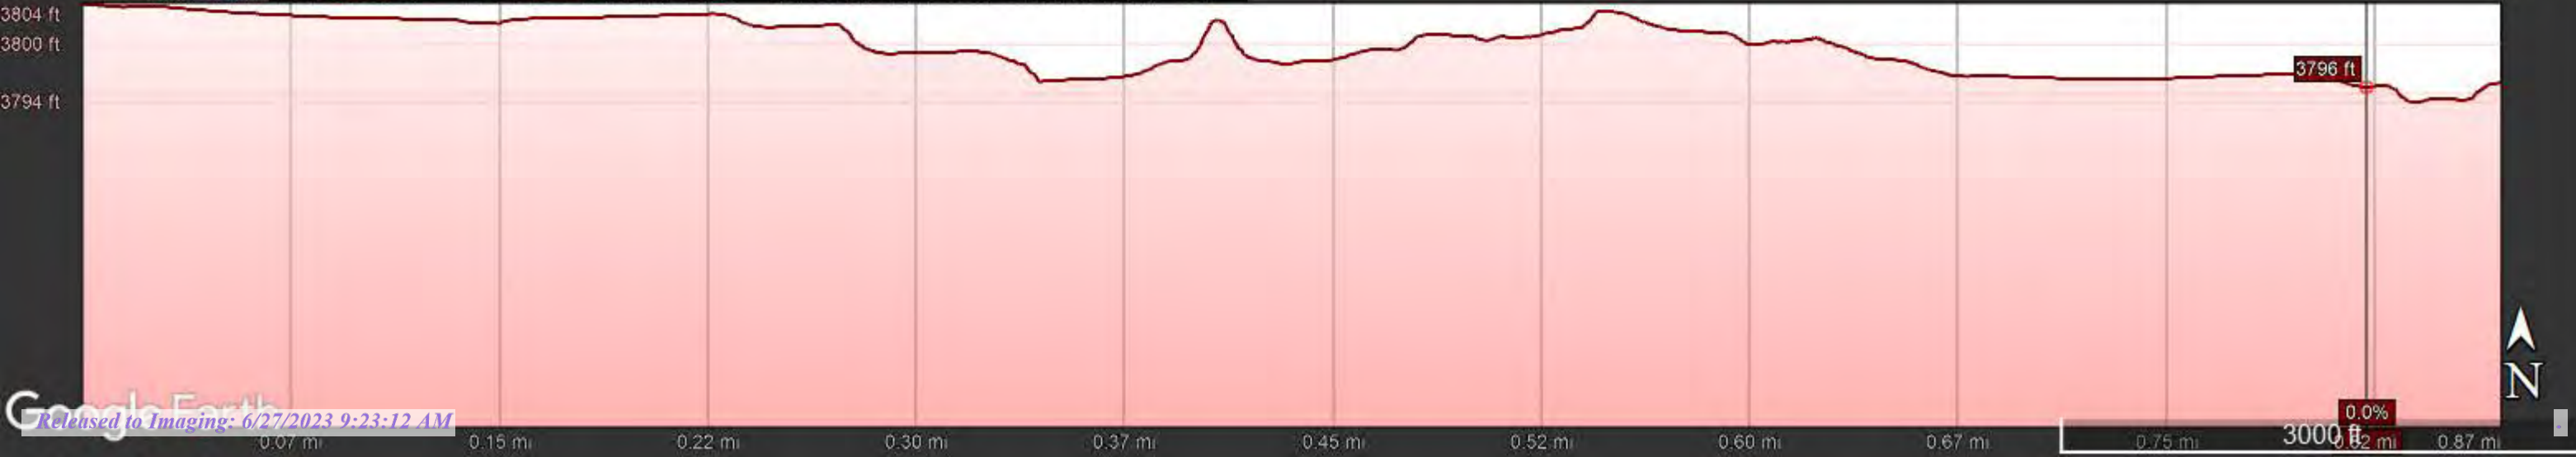
Graph: Min, Avg, Max Elevation: 3794, 3800, 3804 ft  
Range Totals: Distance: 0.87 mi Elev Gain/Loss: 18.7 ft, -26.7 ft Max Slope: 11.4%, -9.6% Avg Slope: 0.8%, -1.0%

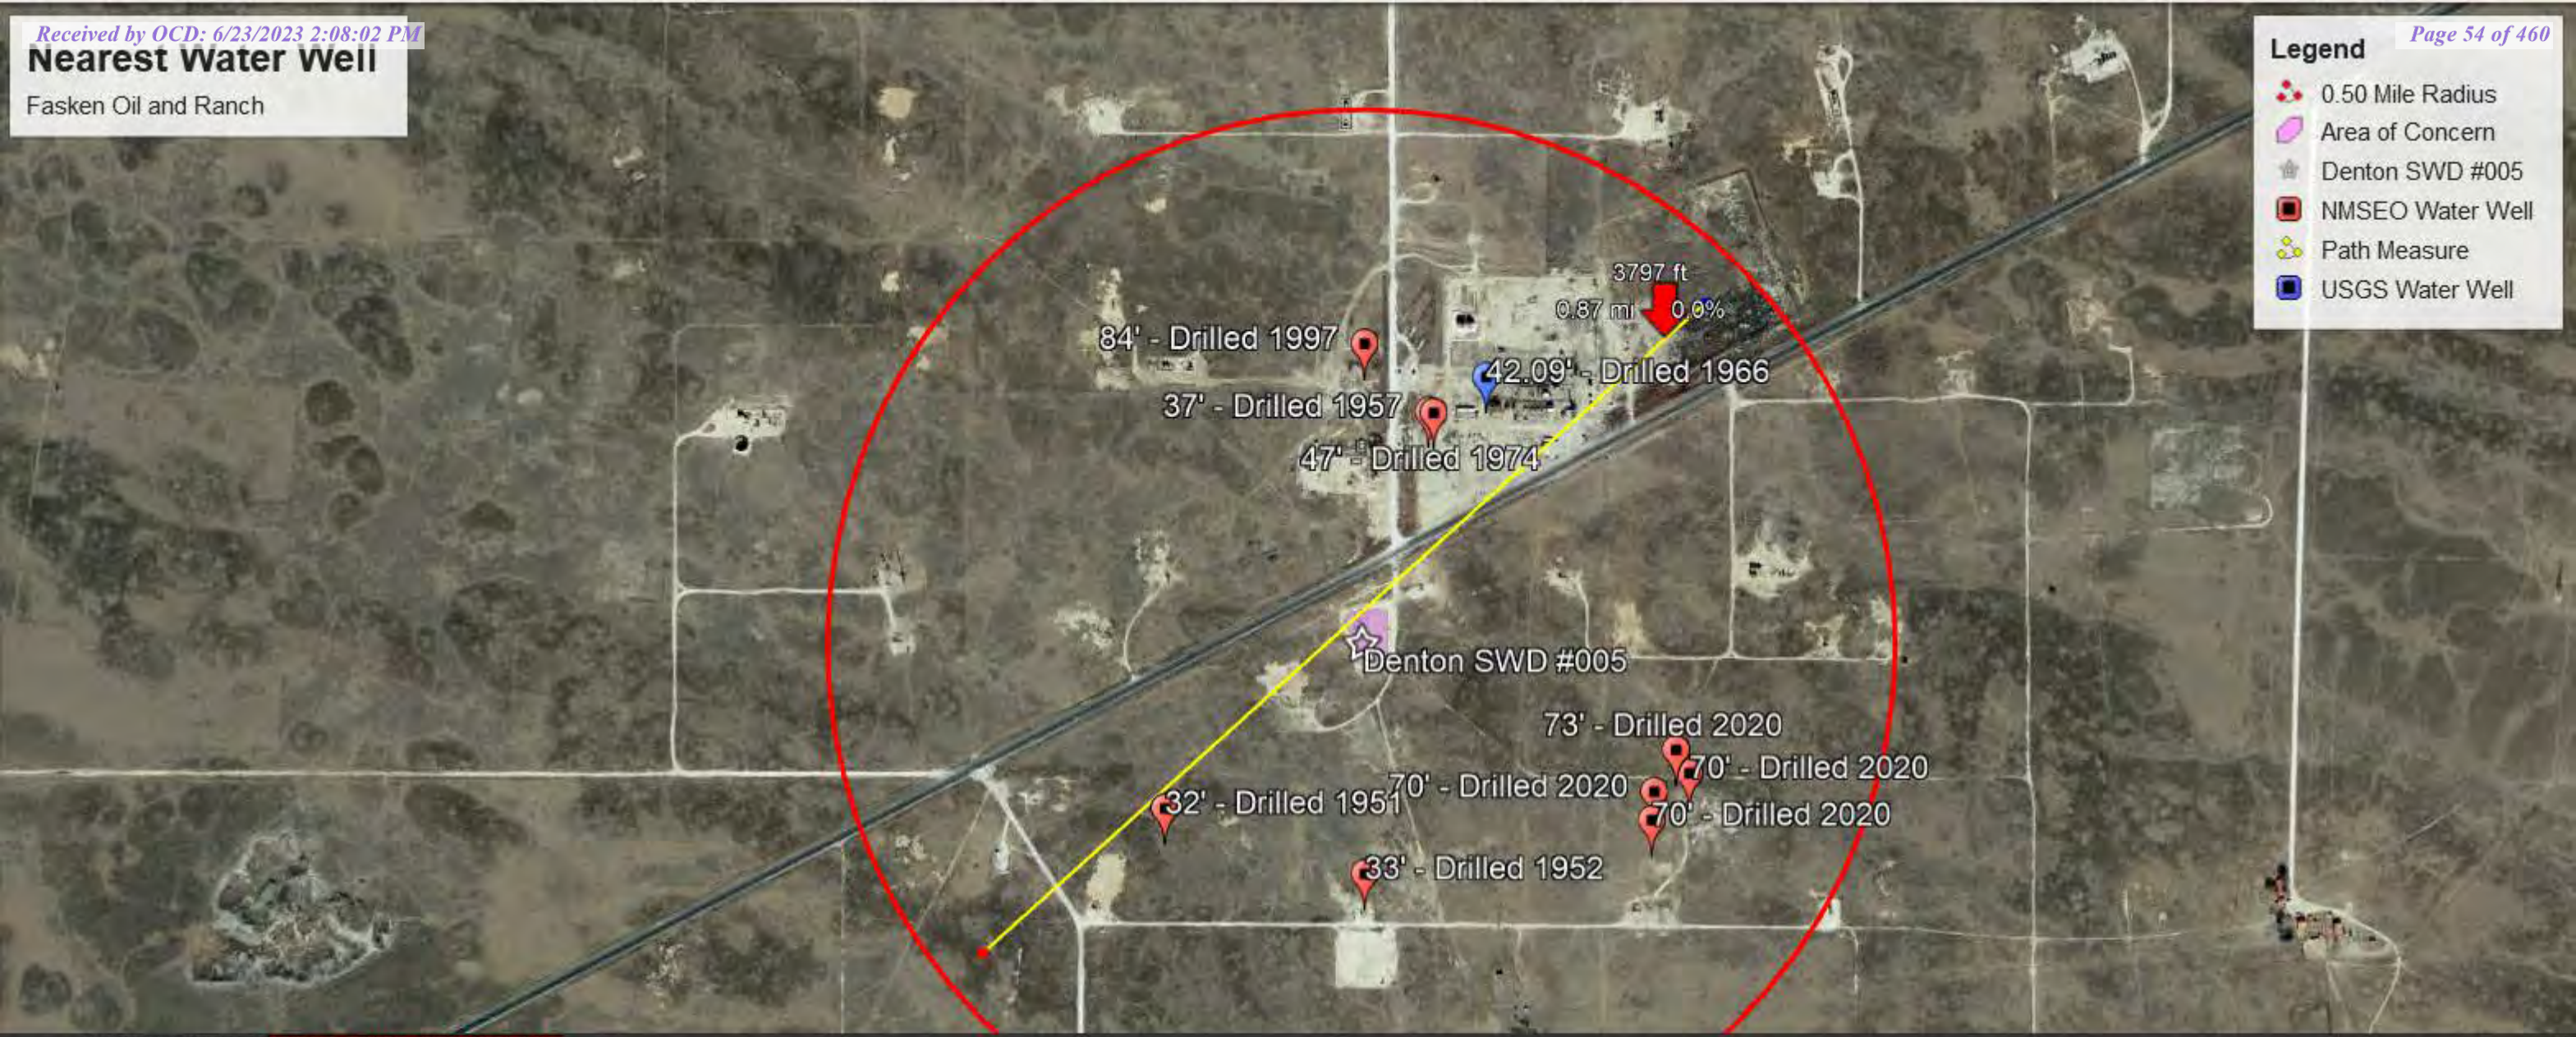
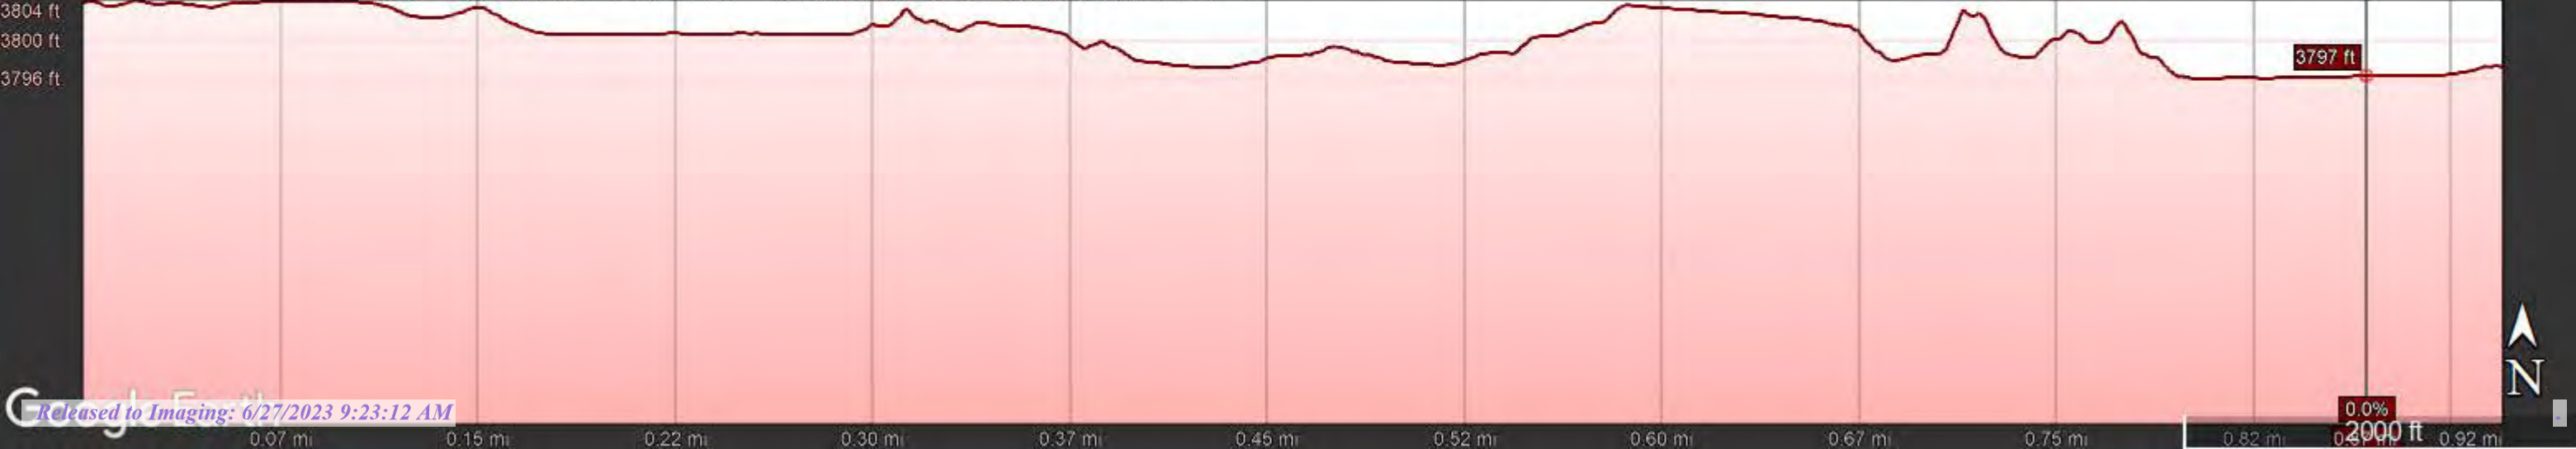
Graph: Min, Avg, Max Elevation: 3796, 3800, 3804 ft  
Range Totals: Distance: 0.92 mi Elev Gain/Loss: 26.3 ft, -32.4 ft Max Slope: 11.7%, -9.6% Avg Slope: 1.0%, -1.2%
