**Closure Report
Denton 5 SWD
Lea County, New Mexico
Unit N Sec 02 T15S R37E
33.041141°, -103.173094°**

Incident Number: NPAC0614540738

**Fasken Oil and Ranch, Ltd
6101 Holiday Hill Road
Midland, Texas 79707**

**Carmona Resources, LLC
310 West Wall Street
Suite 500
Midland, Texas 79701**

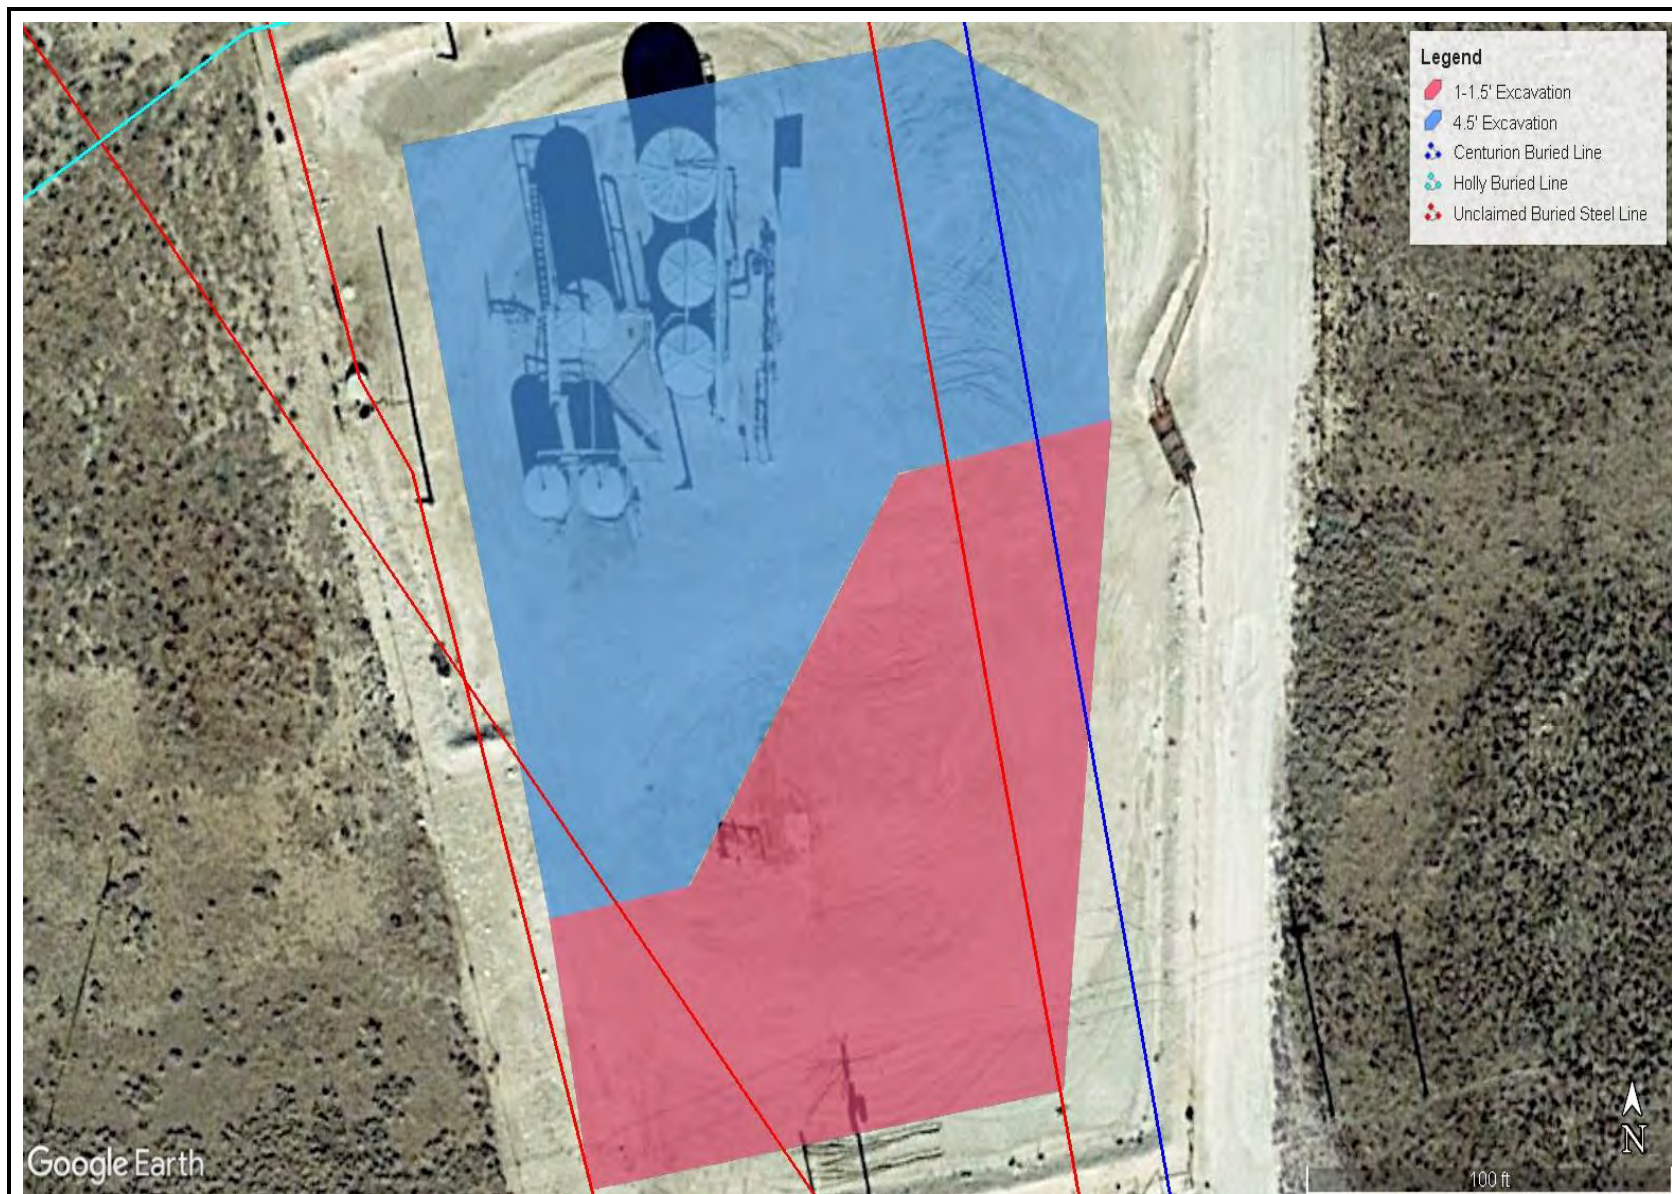
FIGURE 4

Once the remediation activities were completed, the excavated areas were backfilled with clean material to surface grade. Based on further investigation, once all the facility equipment and tanks were removed, additional material was hauled to disposal from under the tanks. The firewall material was tested and found to be impacted. Approximately 5,060 cubic yards of material were excavated and transported offsite for proper disposal.

EXCAVATION OVERVIEW MAP
FASKEN OIL AND RANCH
DENTON 5 SWD
LEA COUNTY, NEW MEXICO
33.041141°, -103.173094°

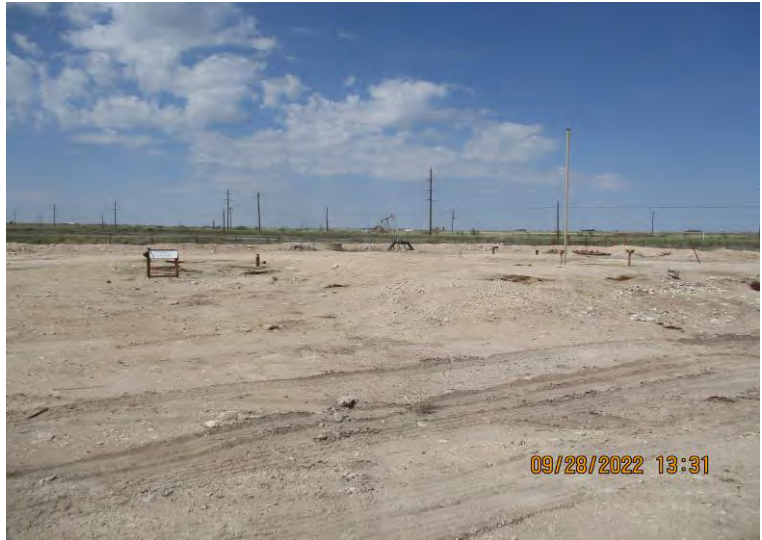
Photograph No. 2

View of the pad, area of backhoe samples (1-6).

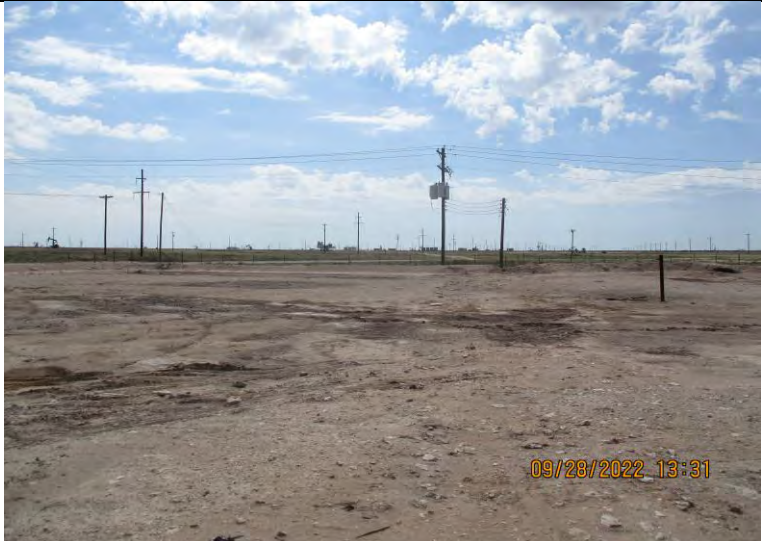
Photograph No. 3

View of the pad, area of backhoe samples (1-6).

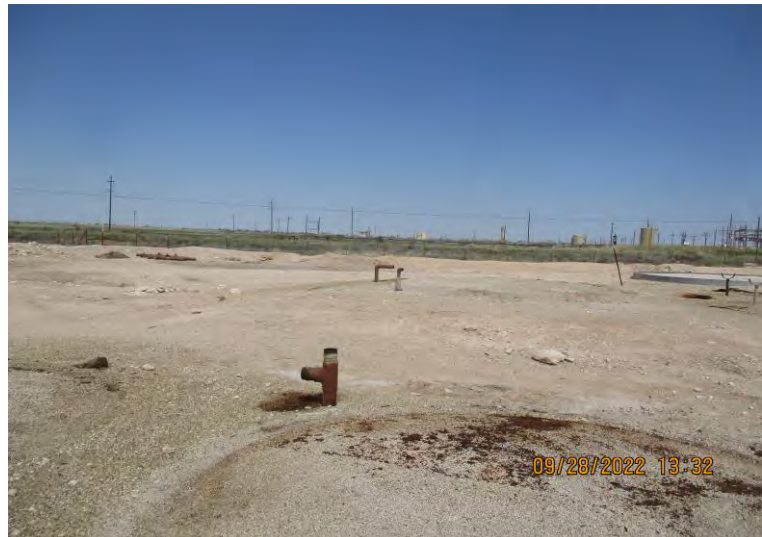
View of the pad, area of backhoe samples (1-6).

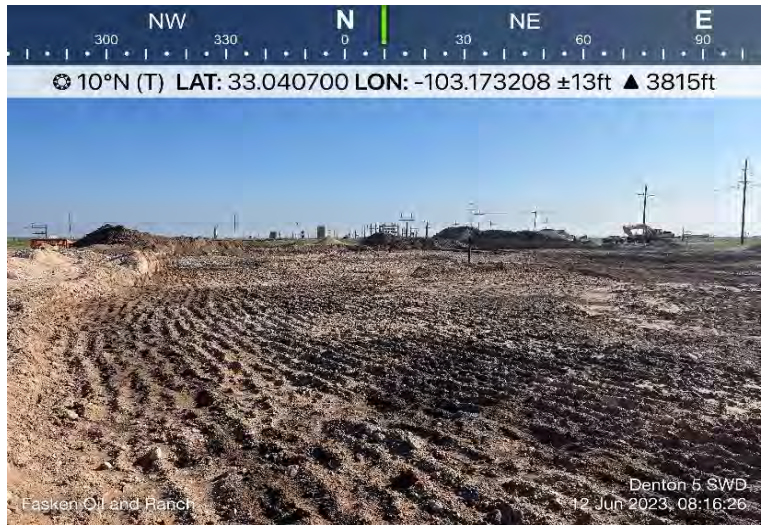
Photograph No. 5

View of the excavation, area of confirmation samples (1-26) & (44-46).

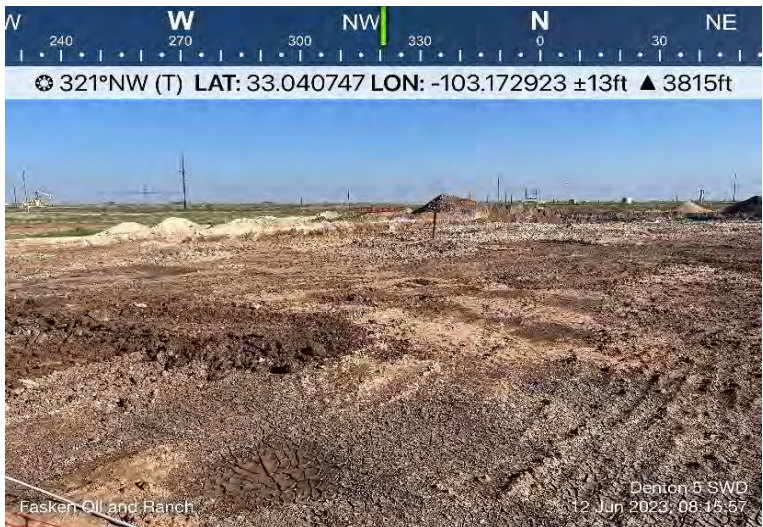
Photograph No. 6

View of the excavation, area of confirmation samples (1-22) & (44-46).

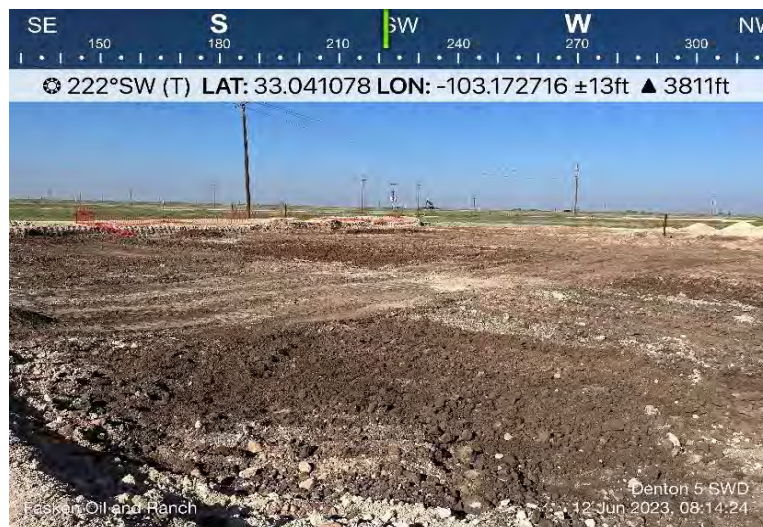
View of the excavation, area of confirmation samples (1-26) & (44-46).

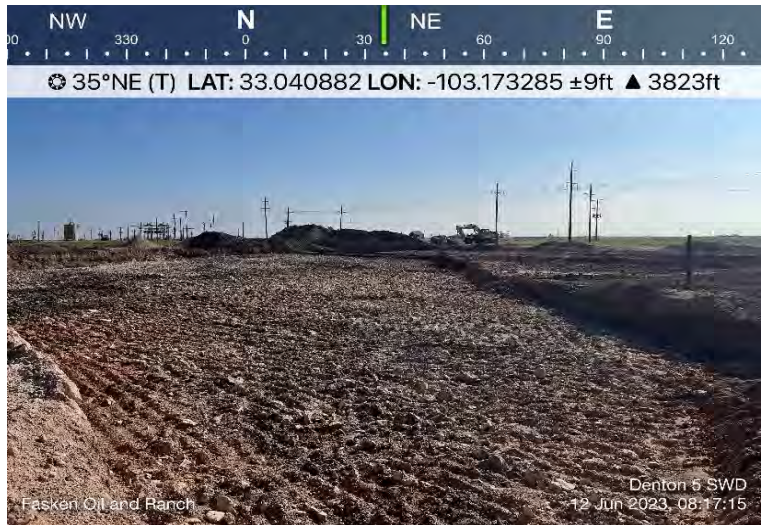
Photograph No. 8

View of the excavation, area of confirmation samples (27-43), (47-63) & (82-94).

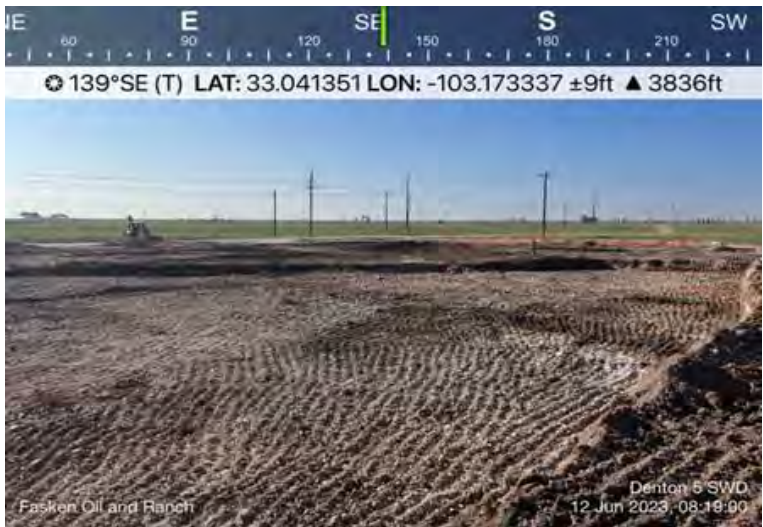
Photograph No. 9

View of the excavation, area of confirmation samples (27-40), (53-60) & (82-84).

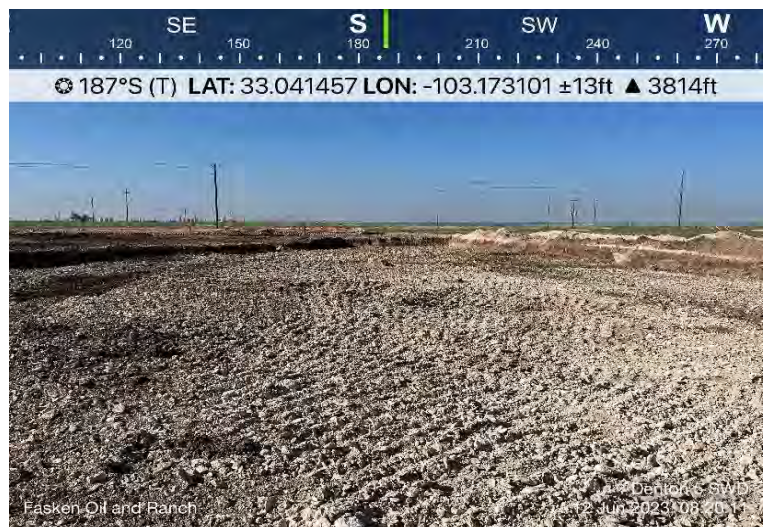
View of the excavation, area of confirmation samples (27-43), (47-63) & (82-94).

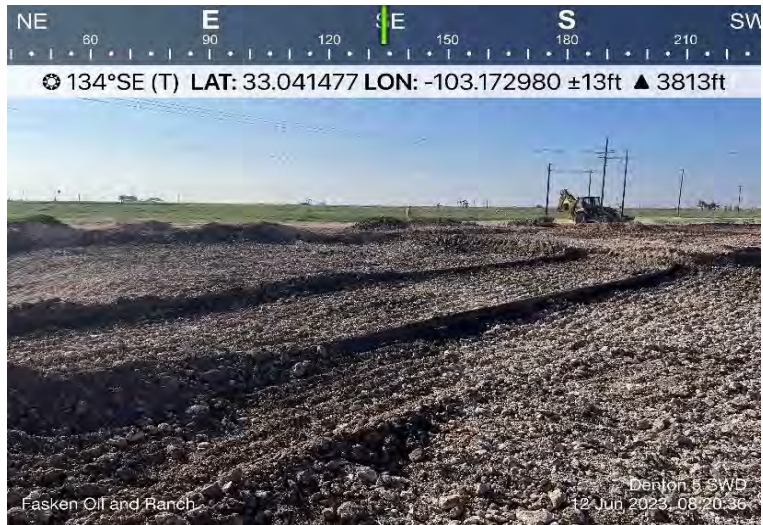
Photograph No. 11

View of the excavation, area of confirmation samples (64-81).

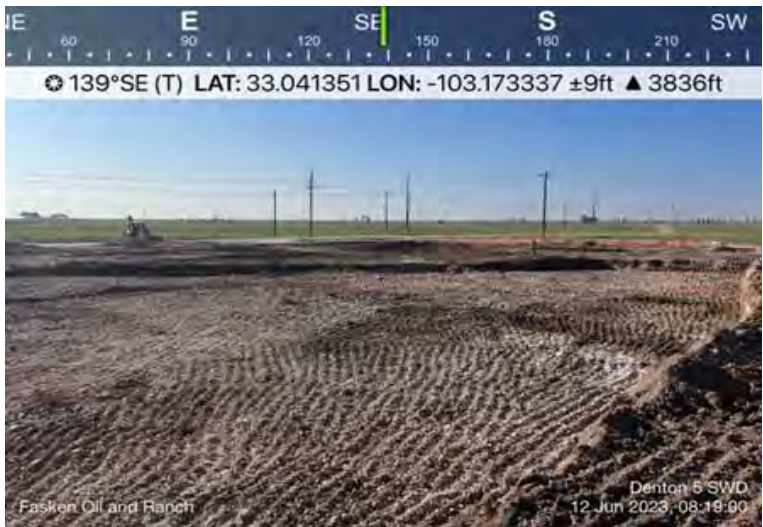
Photograph No. 12

View of the excavation, area of confirmation samples (27-40), (53-60) & (82-84).

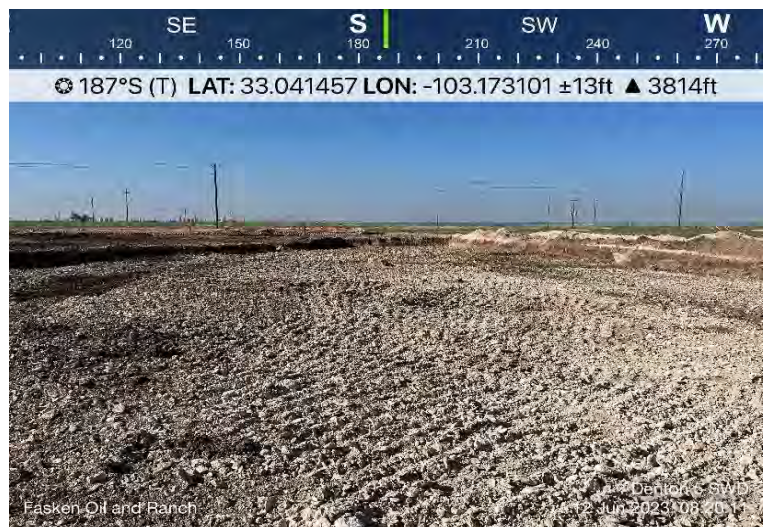
View of the excavation, area of confirmation samples (27-43), (47-63) & (82-94).

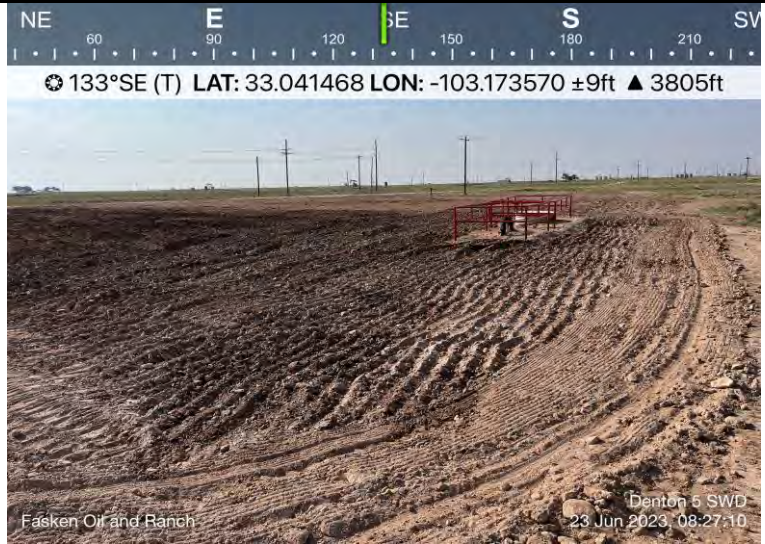
Photograph No. 14

View Southeast, of the the reclamation area reseeded.

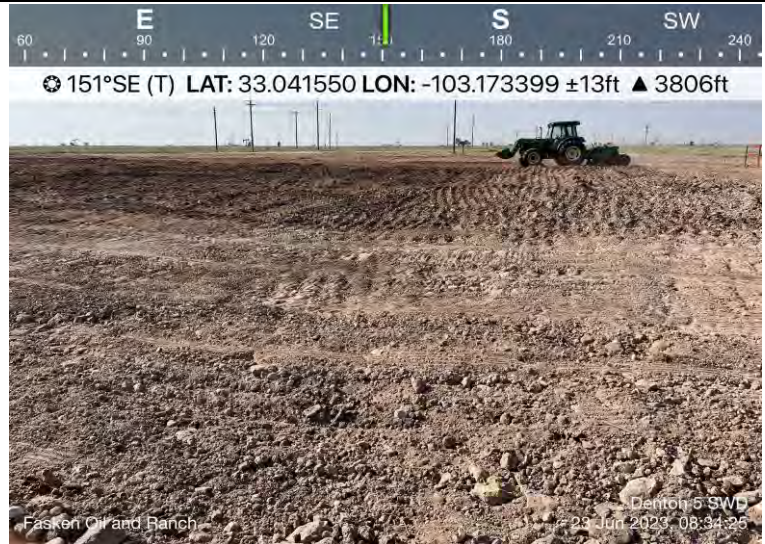
Photograph No. 15

View Southeast, of the tractor reseeding the reclamation area.

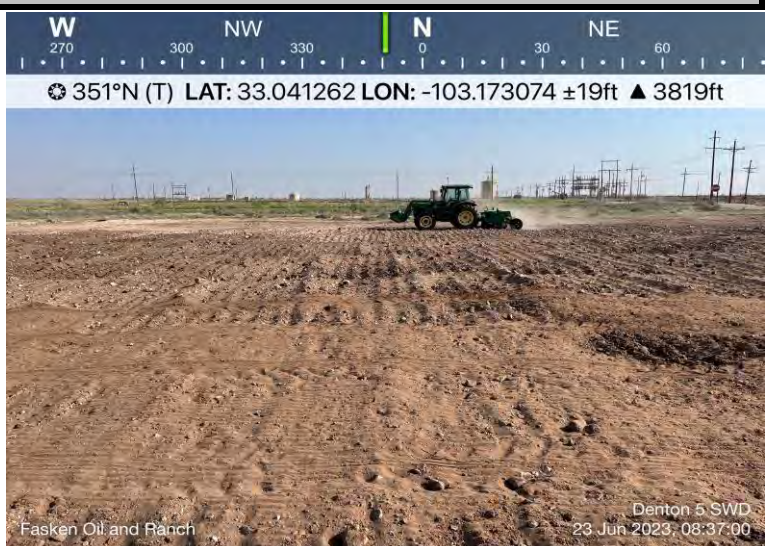
View North, of the tractor reseeding the reclamation area.

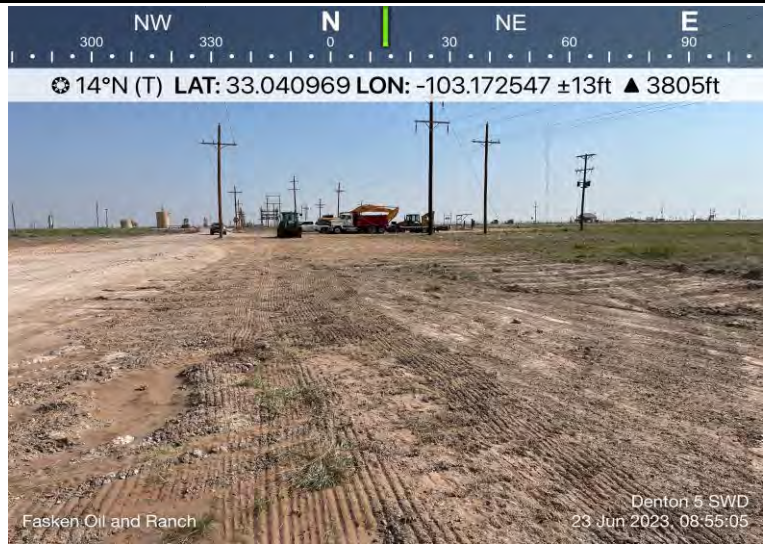
Photograph No. 17

View North of a disturbed area after being reseeded.

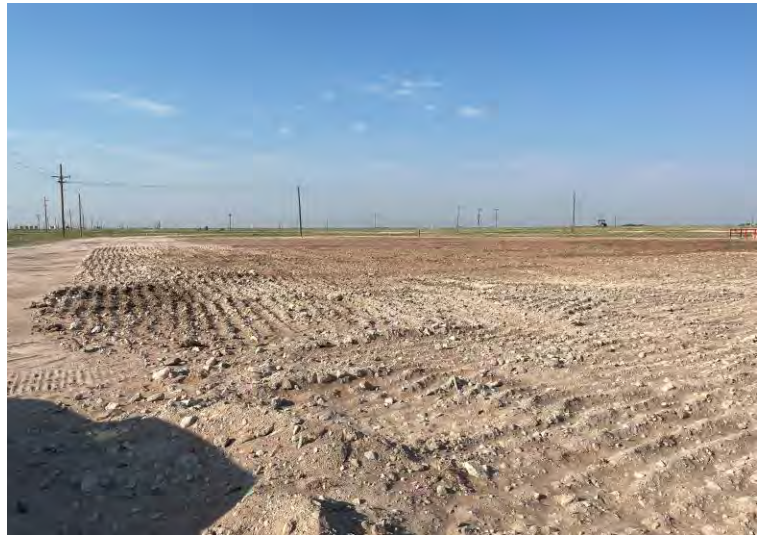
Photograph No. 18

View South of the lease road and the reseeded reclamation area.

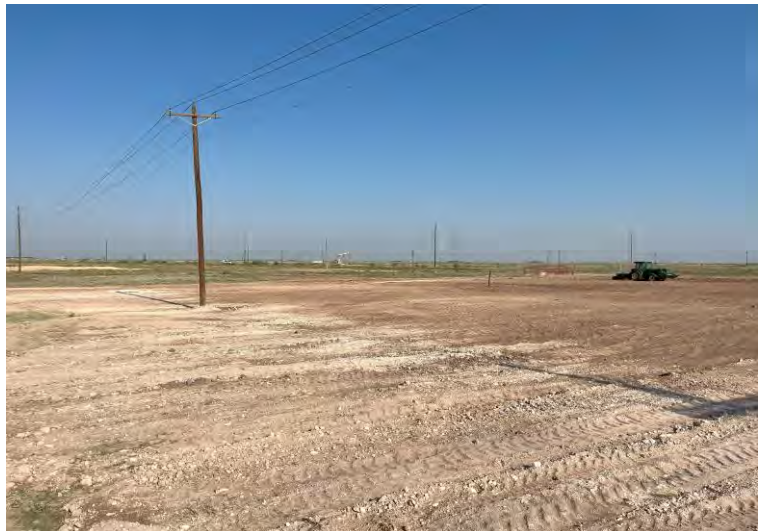
View Northwest, of the reseeded reclamation area.

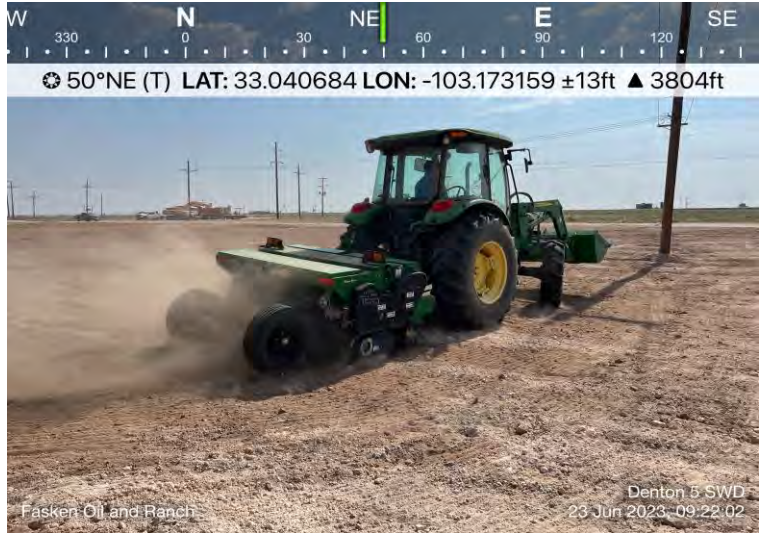
View Northeast of reseeding
