**Re: Remediation and Reclamation Closure Report
Chevron Mid Continent Business Unit
Cicada Unit #022H Flowline Release
Unit Letter D, Section 35, Township 25 South, Range 27 East
Eddy County, New Mexico
nAPP2420727981 and nAPP2424378052
DOR: 7/19/2024 and 8/30/2024
Landowner: BLM**

Remediation and Reclamation Closure Report
March 4, 2025

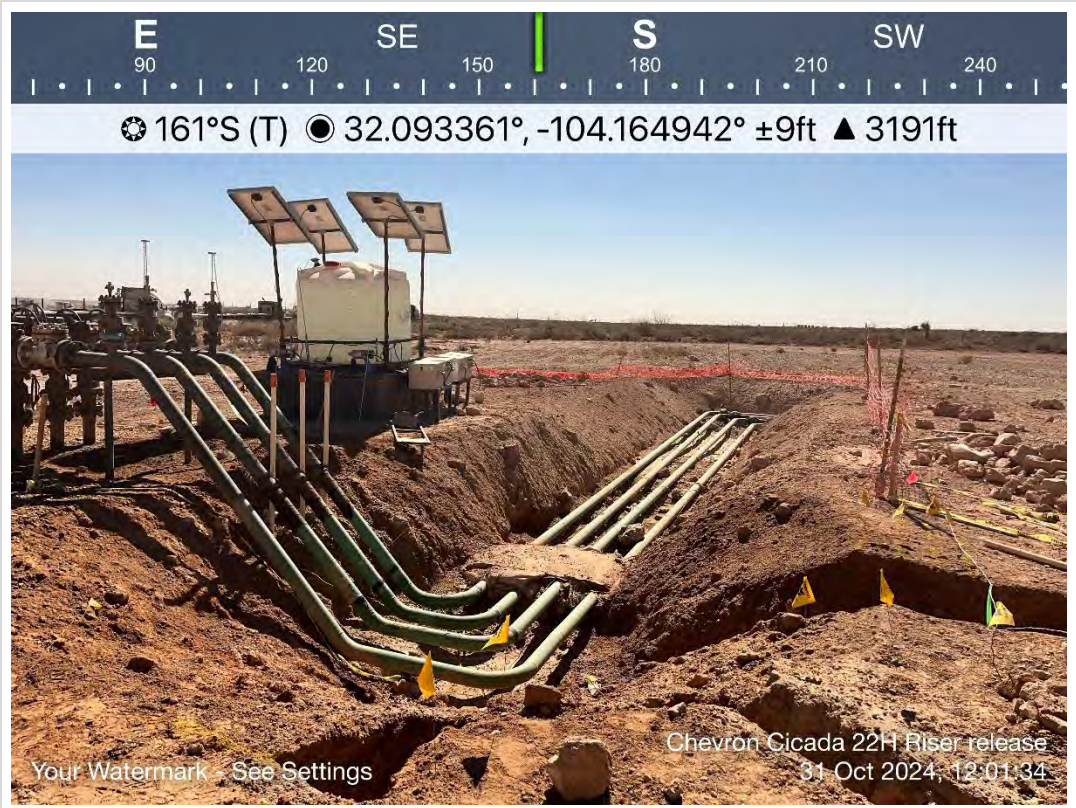
TETRA TECH, INC. PROJECT NO. 212C-MD-03753	DESCRIPTION	View south-southeast of excavation activities in pipeline repair area.	1
	SITE NAME	Cicada #022H Riser Releases	10/31/2024

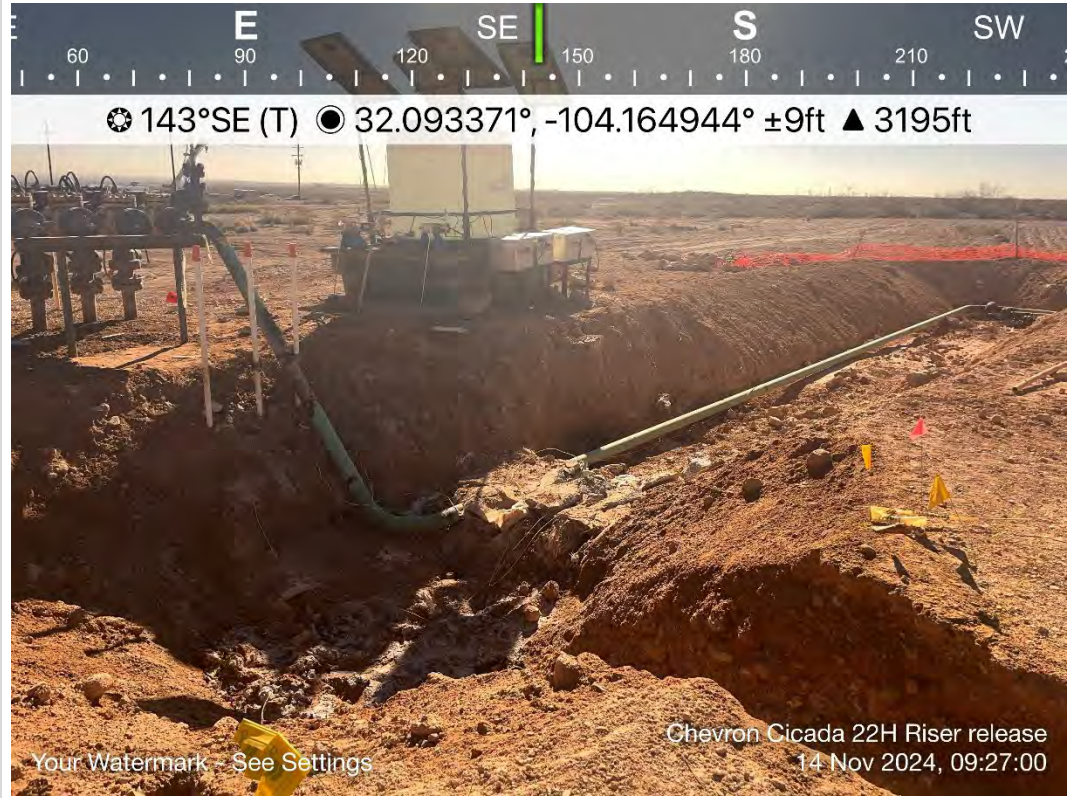
TETRA TECH, INC. PROJECT NO. 212C-MD-03753	DESCRIPTION	View southeast of excavation activities in pipeline repair area.	2
	SITE NAME	Cicada #022H Riser Releases	11/14/2024

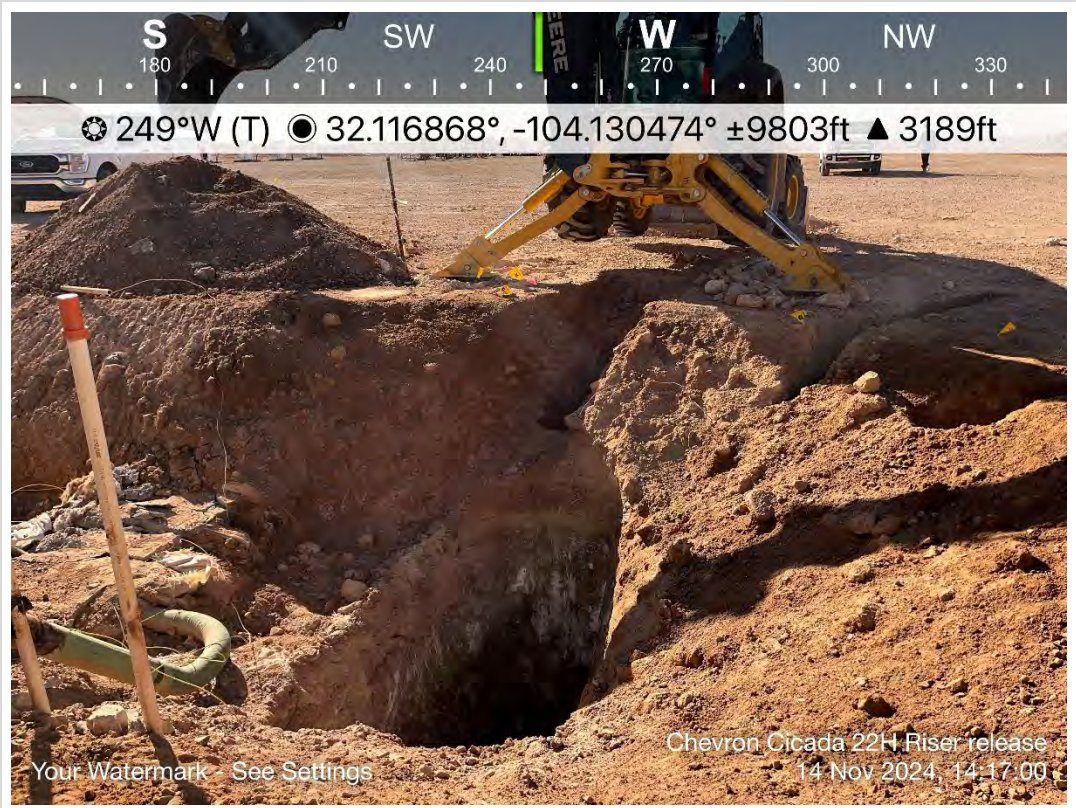
TETRA TECH, INC. PROJECT NO. 212C-MD-03753	DESCRIPTION	View west-southwest of excavation activities in pipeline repair area.	3
	SITE NAME	Cicada #022H Riser Releases	11/14/2024

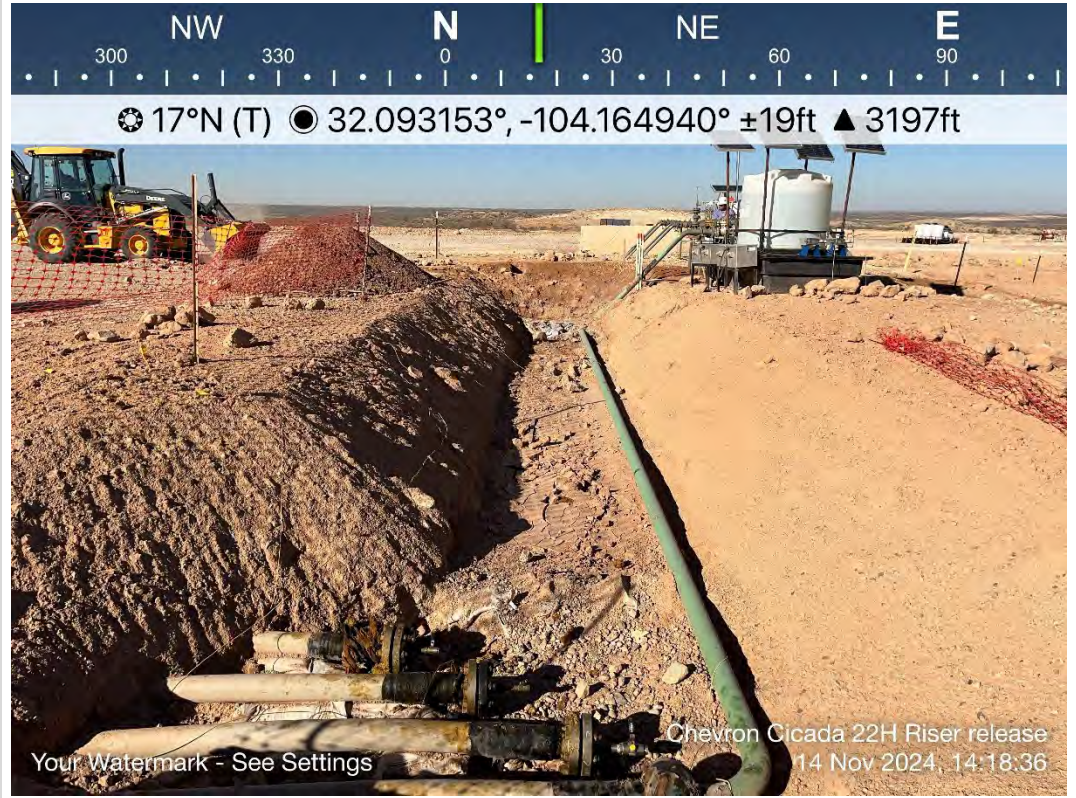
TETRA TECH, INC. PROJECT NO. 212C-MD-03753	DESCRIPTION	View north-northeast of excavation activities in pipeline repair area.	4
	SITE NAME	Cicada #022H Riser Releases	11/14/2024

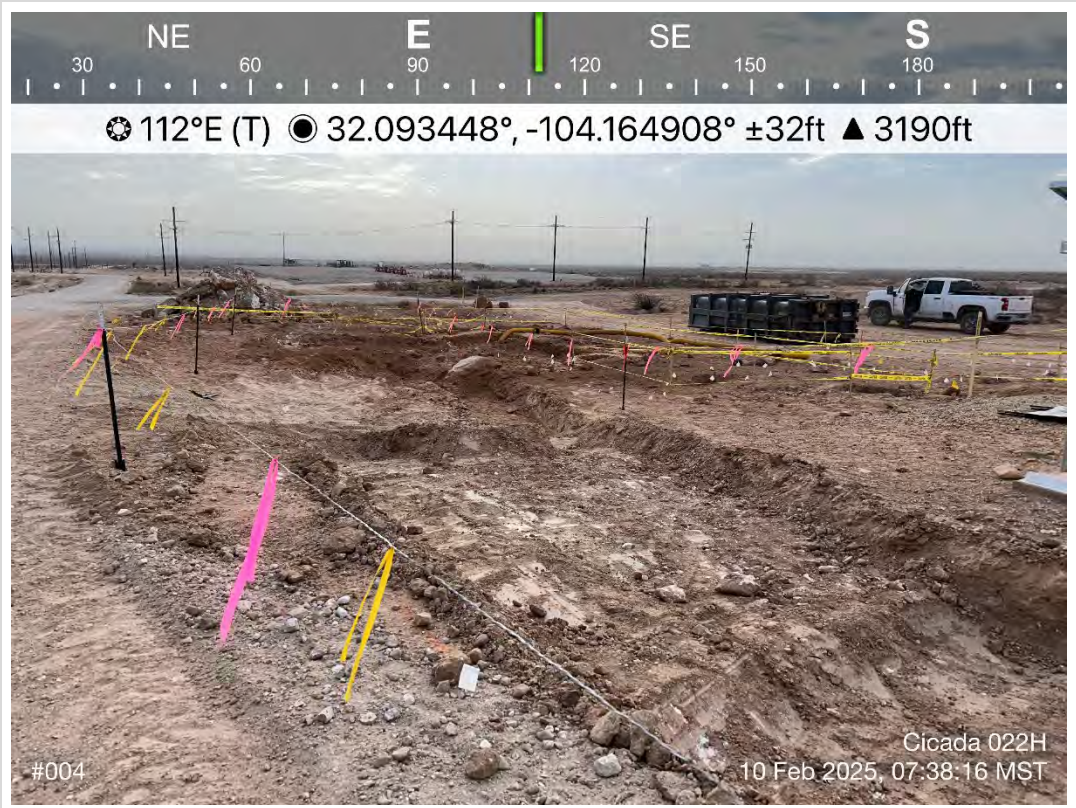
TETRA TECH, INC. PROJECT NO. 212C-MD-03753	DESCRIPTION	View east-southeast of excavation extent.	5
	SITE NAME	Cicada #022H Riser Releases	2/10/2025

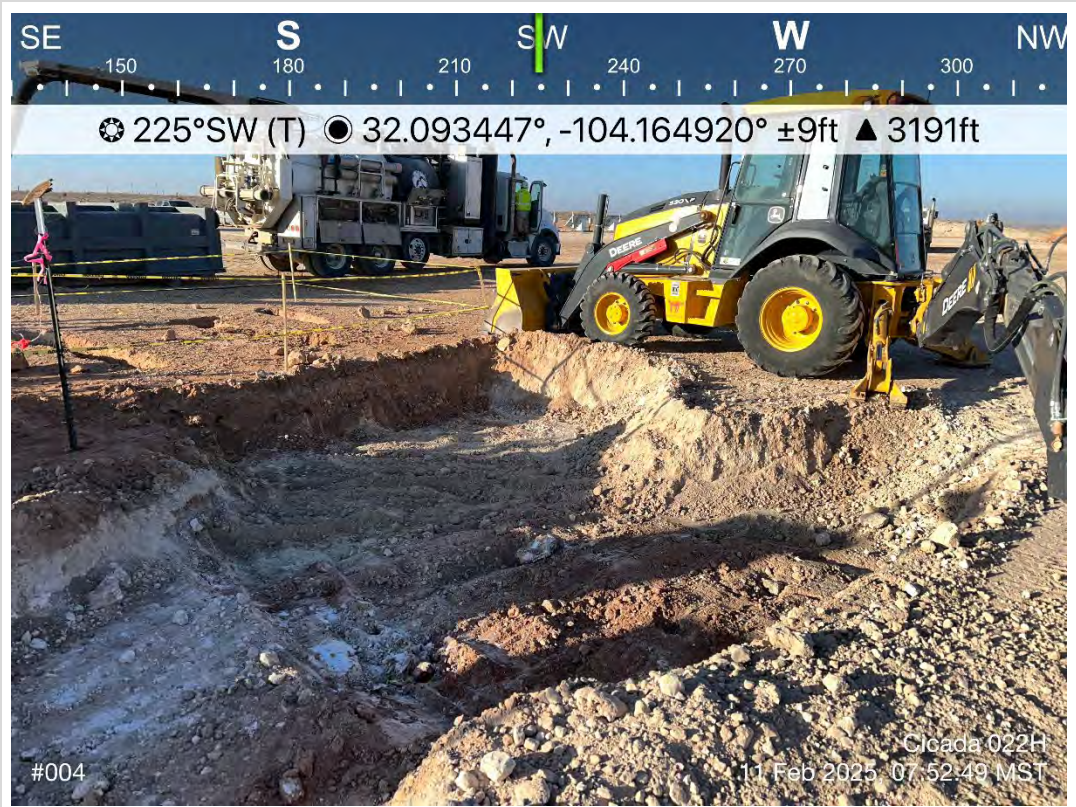
TETRA TECH, INC. PROJECT NO. 212C-MD-03753	DESCRIPTION	View southwest of excavation extent.	6
	SITE NAME	Cicada #022H Riser Releases	2/11/2025

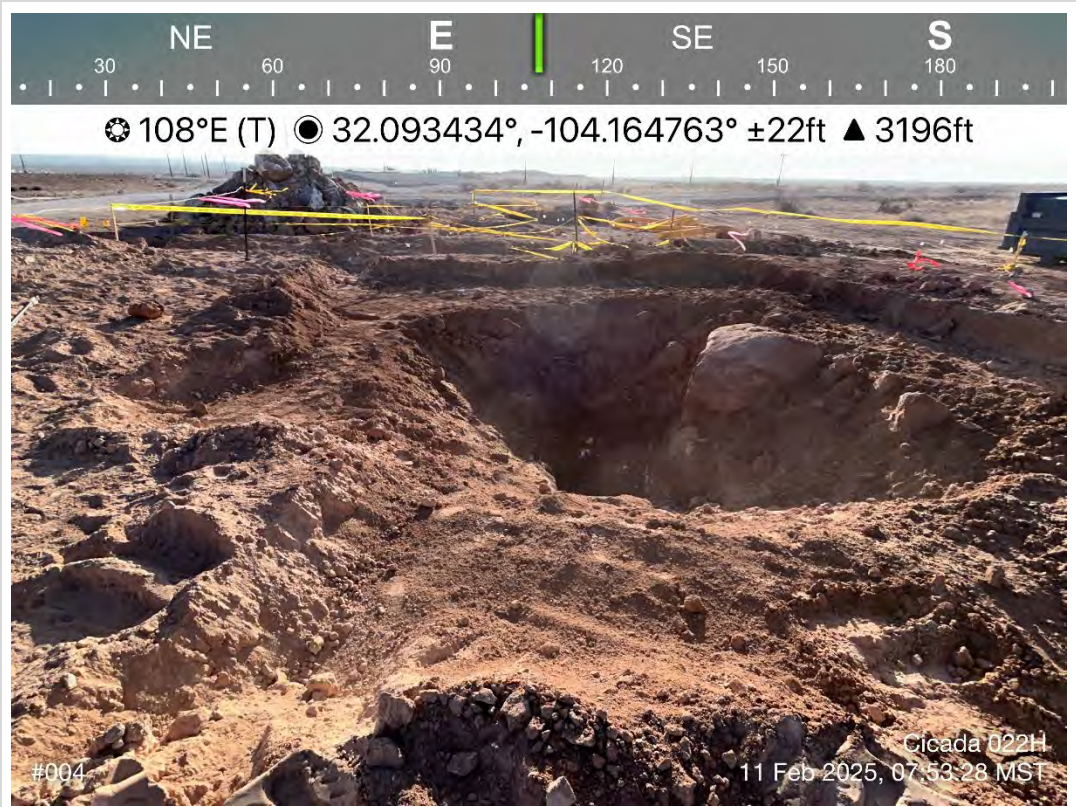
TETRA TECH, INC. PROJECT NO. 212C-MD-03753	DESCRIPTION	View east-southeast of excavation extent.	8
	SITE NAME	Cicada #022H Riser Releases	2/12/2025

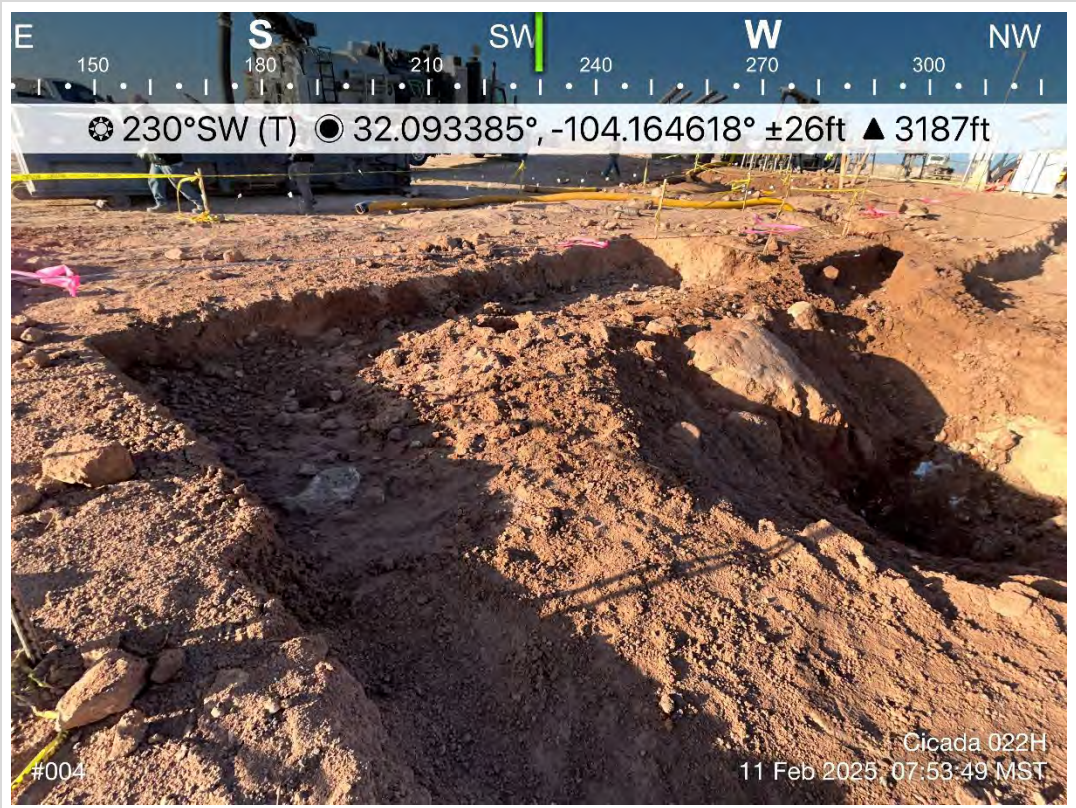
TETRA TECH, INC. PROJECT NO. 212C-MD-03753	DESCRIPTION	View southwest of excavation extent.	9
	SITE NAME	Cicada #022H Riser Releases	2/11/2025

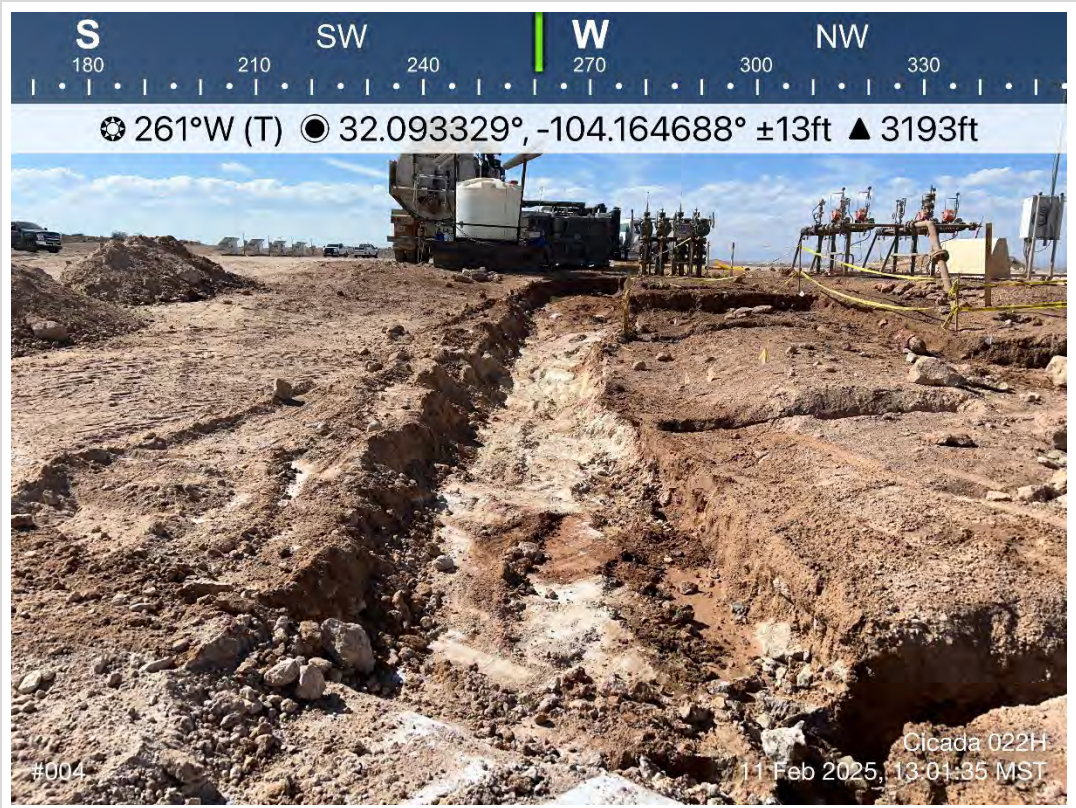
TETRA TECH, INC. PROJECT NO. 212C-MD-03753	DESCRIPTION	View west of excavation extent.	11
	SITE NAME	Cicada #022H Riser Releases	2/11/2025

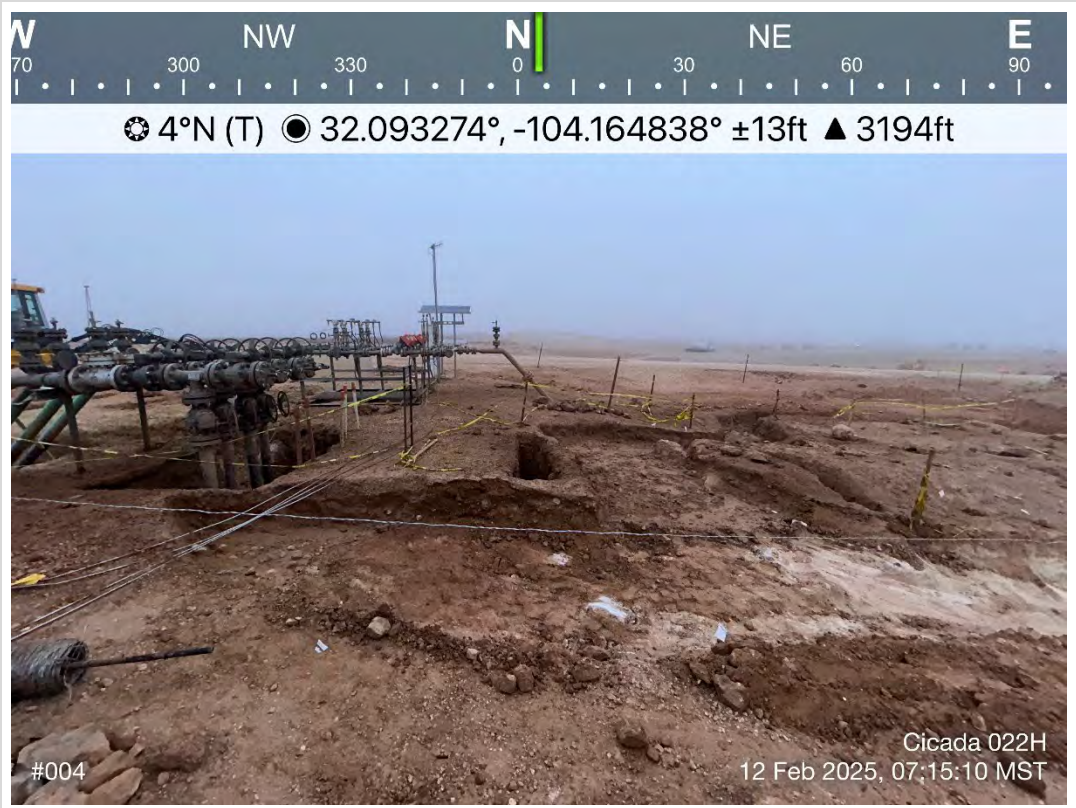
TETRA TECH, INC. PROJECT NO. 212C-MD-03753	DESCRIPTION	View north of excavation extent.	13
	SITE NAME	Cicada #022H Riser Releases	2/12/2025

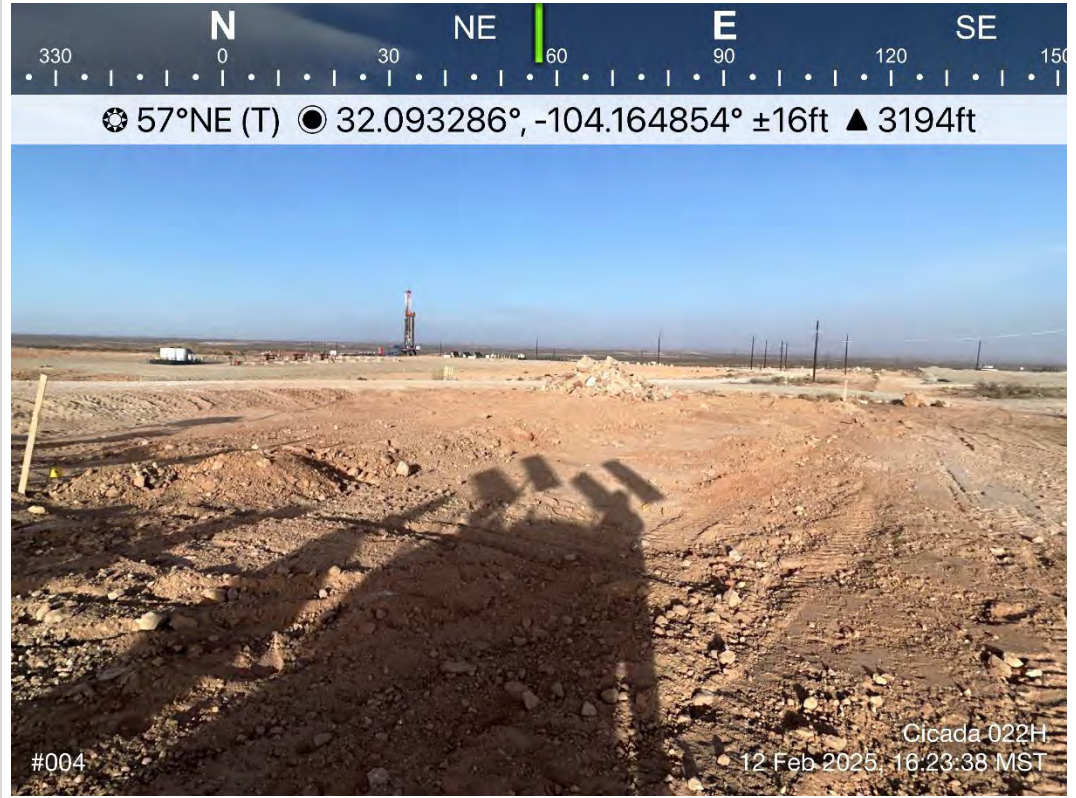
TETRA TECH, INC. PROJECT NO. 212C-MD-03753	DESCRIPTION	View northeast across backfilled excavation.	14
	SITE NAME	Cicada #022H Riser Releases	2/12/2025

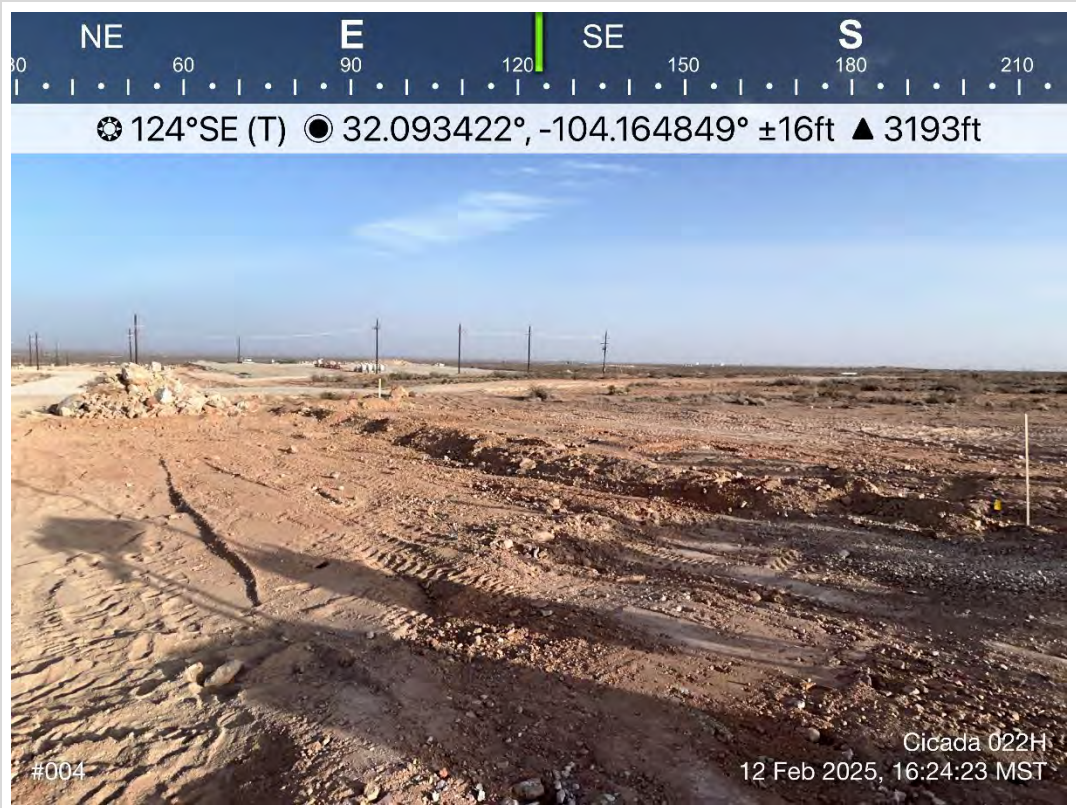
TETRA TECH, INC. PROJECT NO. 212C-MD-03753	DESCRIPTION	View southeast across backfilled excavation.	15
	SITE NAME	Cicada #022H Riser Releases	2/12/2025

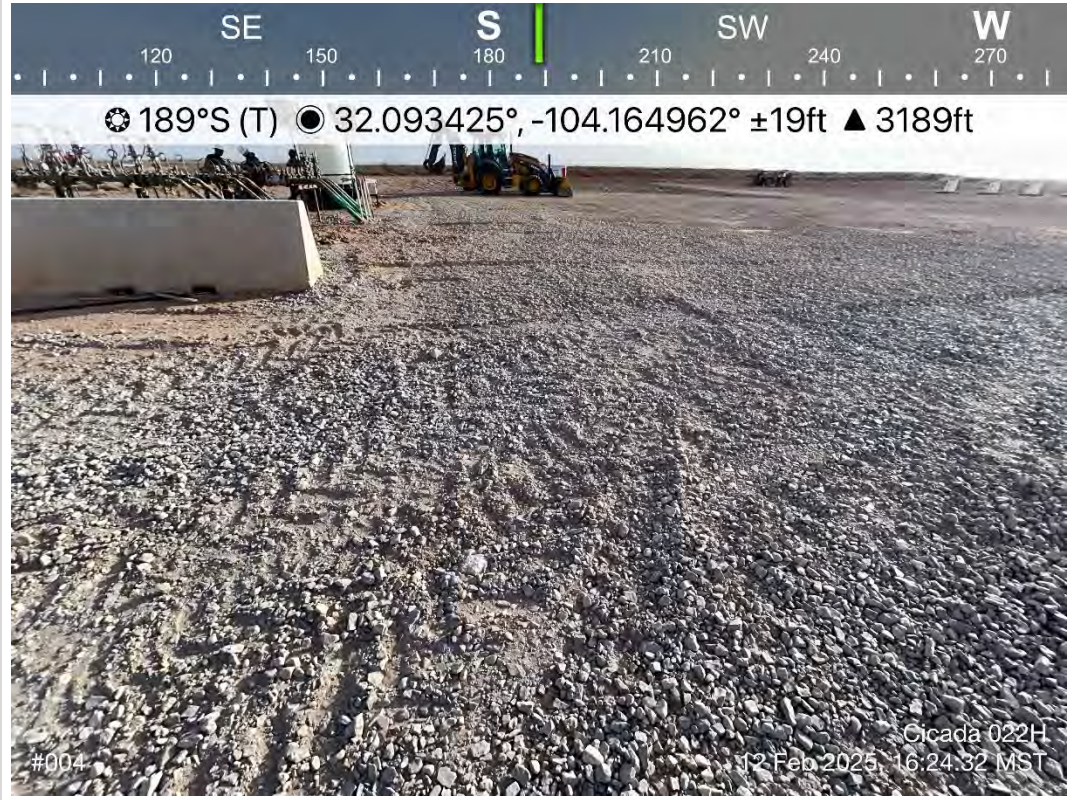
TETRA TECH, INC. PROJECT NO. 212C-MD-03753	DESCRIPTION	View south of backfilled excavation on the lease pad.	16
	SITE NAME	Cicada #022H Riser Releases	2/12/2025

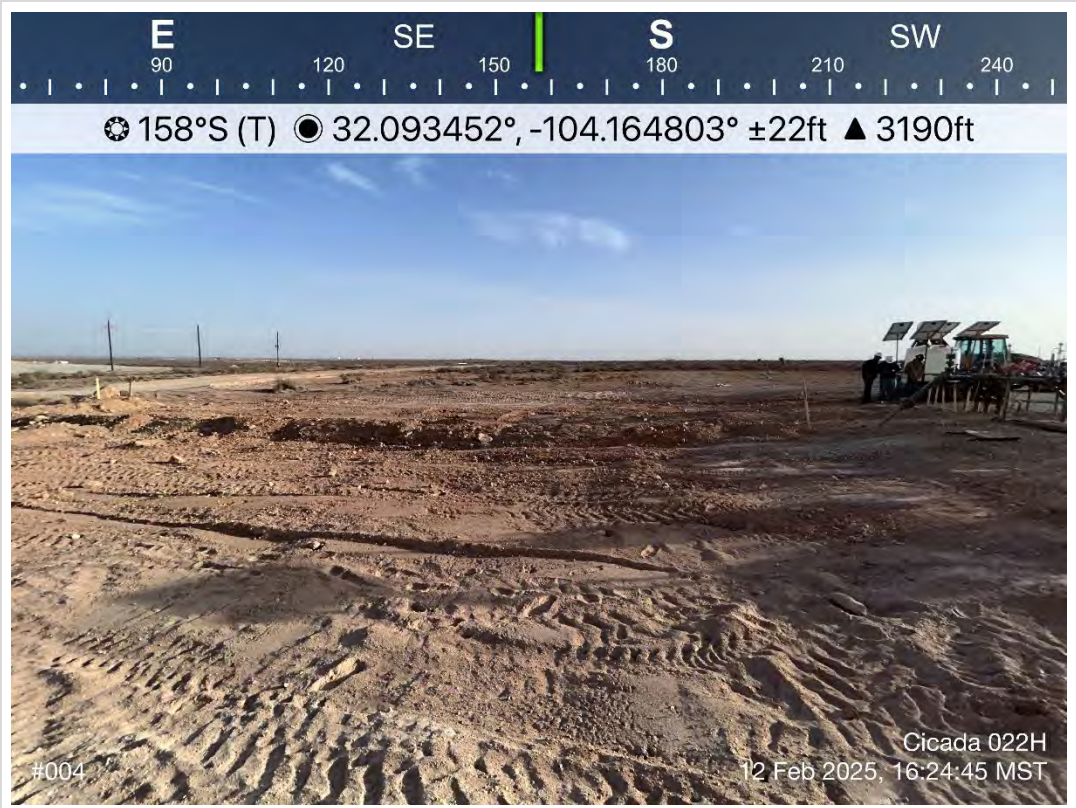
TETRA TECH, INC. PROJECT NO. 212C-MD-03753	DESCRIPTION	View south-southeast across backfilled and seeded excavation.	17
	SITE NAME	Cicada #022H Riser Releases	2/12/2025

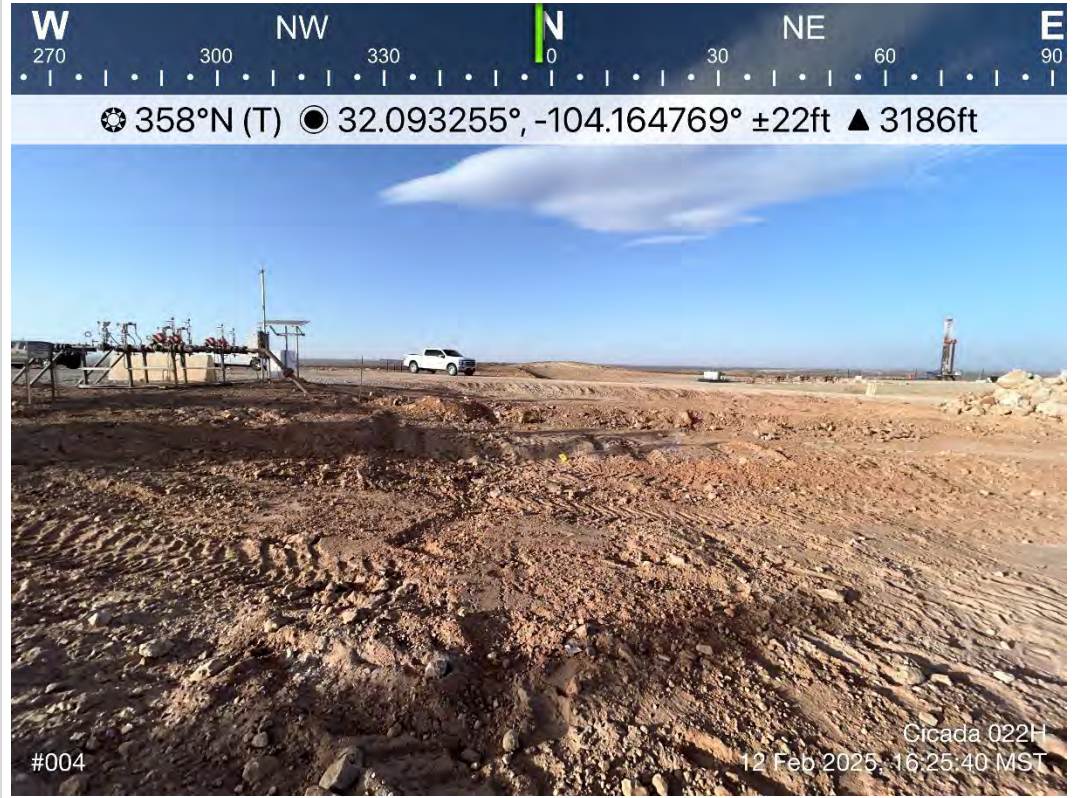
TETRA TECH, INC. PROJECT NO. 212C-MD-03753	DESCRIPTION	View north of backfilled and seeded excavation extent.	18
	SITE NAME	Cicada #022H Riser Releases	2/12/2025
