May 14, 2025

**Re: Revegetation Closure Report
ConocoPhillips
Tiger 11 Federal 001H
Unit Letter F, Section 11, Township 20 South, Range 34 East
DOR: 8/28/2024
Lea County, New Mexico
Incident ID: NAPP2426033046**

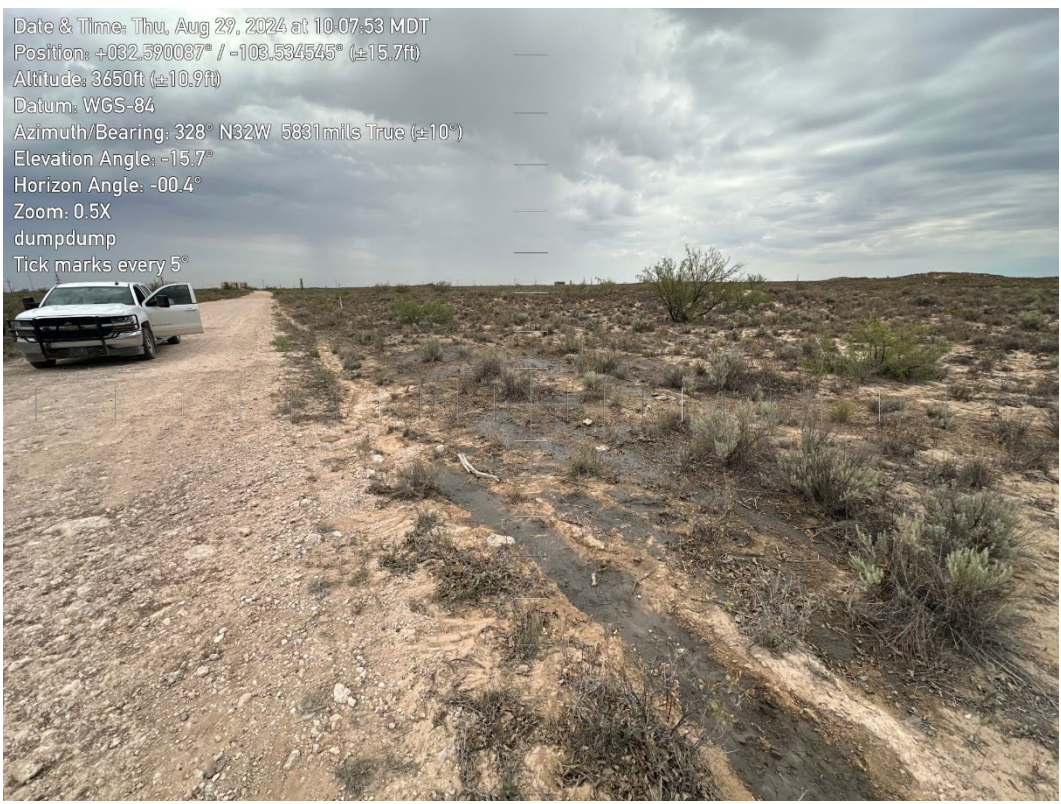
TETRA TECH, INC. PROJECT NO. 212C-MD-03607	DESCRIPTION	View of release area.	1
	SITE NAME	Tiger 11 Federal 001H	8/29/2024

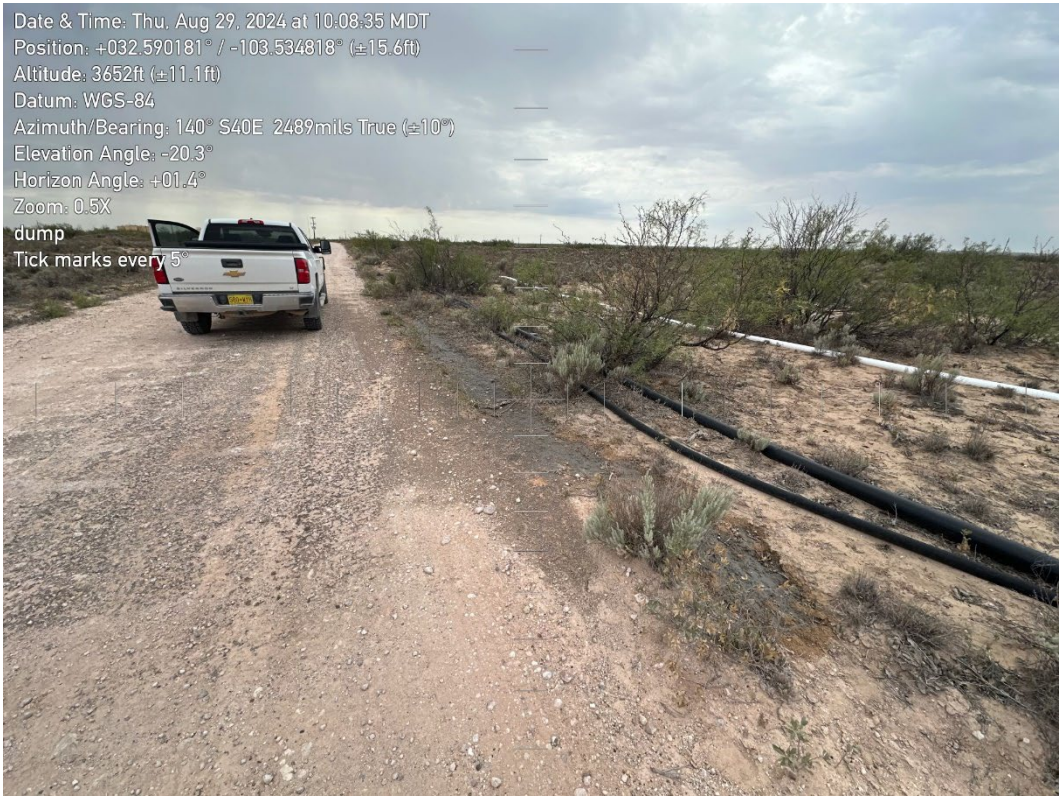
TETRA TECH, INC. PROJECT NO. 212C-MD-03607	DESCRIPTION	View of release area.	2
	SITE NAME	Tiger 11 Federal 001H	8/29/2024

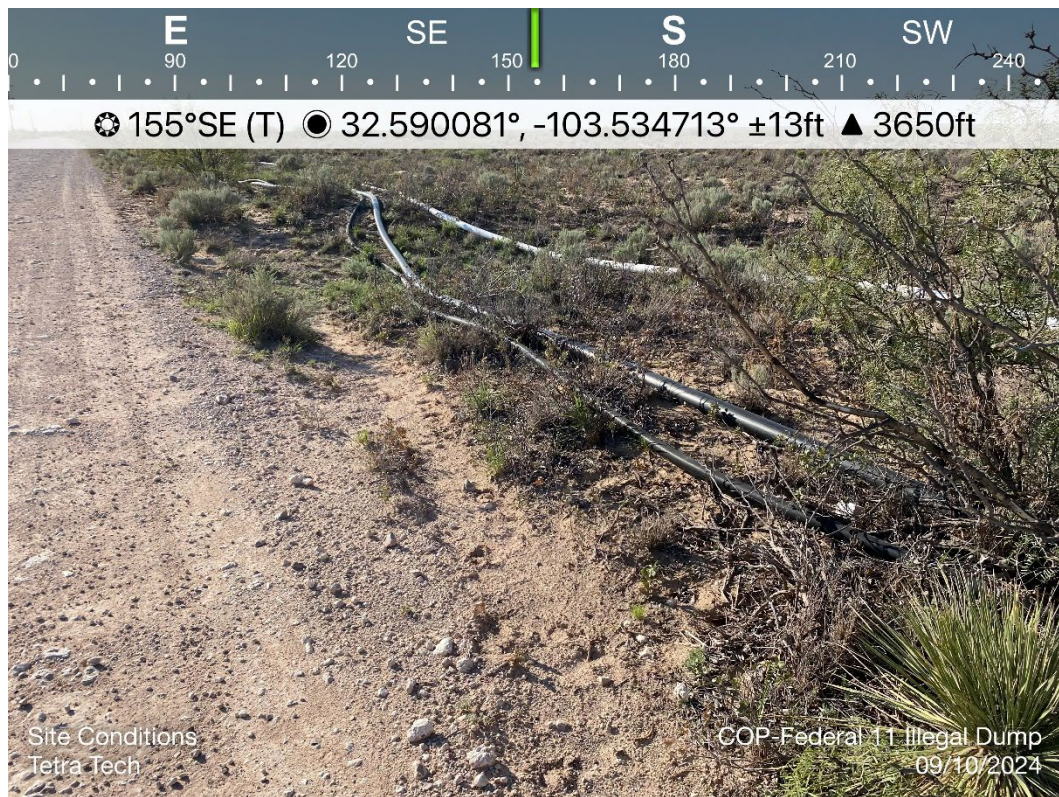
TETRA TECH, INC. PROJECT NO. 212C-MD-03607	DESCRIPTION	View southeast. View of approximate release extent. View of surface lines, vegetation present	4
	SITE NAME	Tiger 11 Federal 001H	9/10/2024

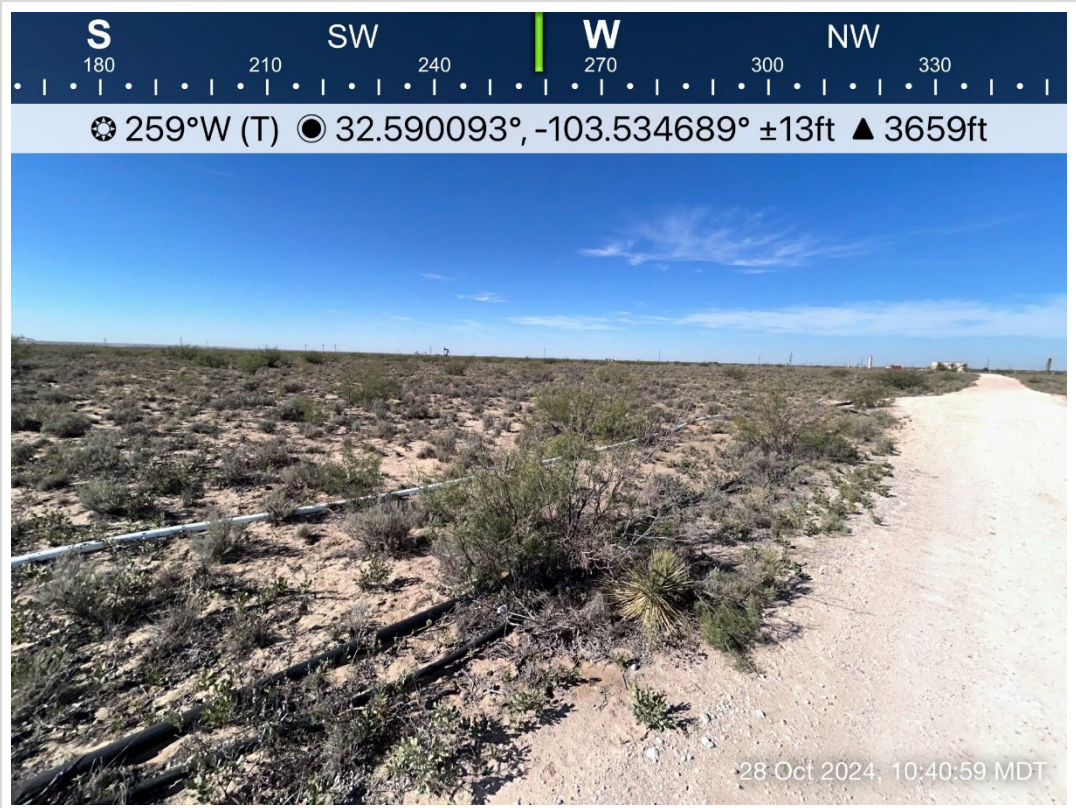
TETRA TECH, INC. PROJECT NO. 212C-MD-03607	DESCRIPTION	View west. View of release area following surface scrape. Vegetation present.	9
	SITE NAME	Tiger 11 Federal 001H	10/28/2024

The analytical data from the assessment was well below reclamation requirements of 600 mg/kg for chlorides and 100 mg/kg for TPH. ConocoPhillips elected to conduct a scrape of the impacted area to remove any surficial discoloration. During the surface scrape, personnel were cautious around existing vegetation as the release had not impacted the established vegetation. Therefore, based on 19.15.29.13 NMAC, areas disturbed by the remediation have been reclaimed, as the responsible party has restored the impacted surface areas to the condition that existed prior to the release.

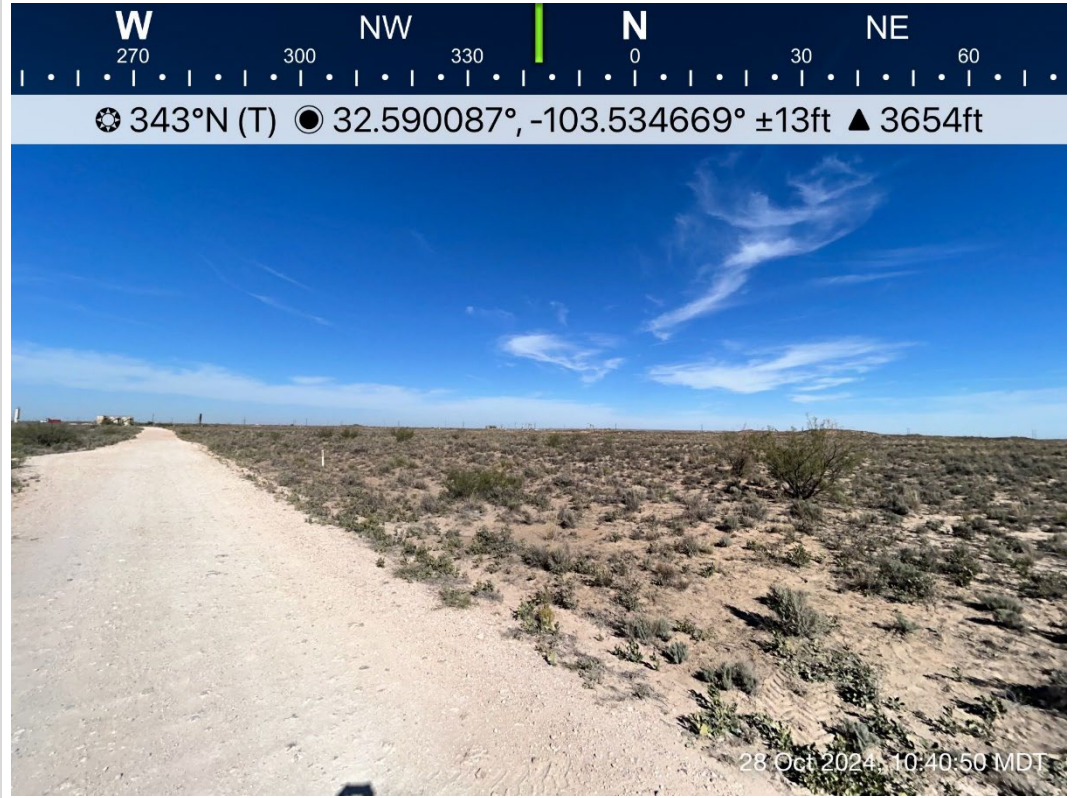
TETRA TECH, INC. PROJECT NO. 212C-MD-03607	DESCRIPTION	View north. View of release area following surface scrape. Vegetation present.	10
	SITE NAME	Tiger 11 Federal 001H	10/28/2024

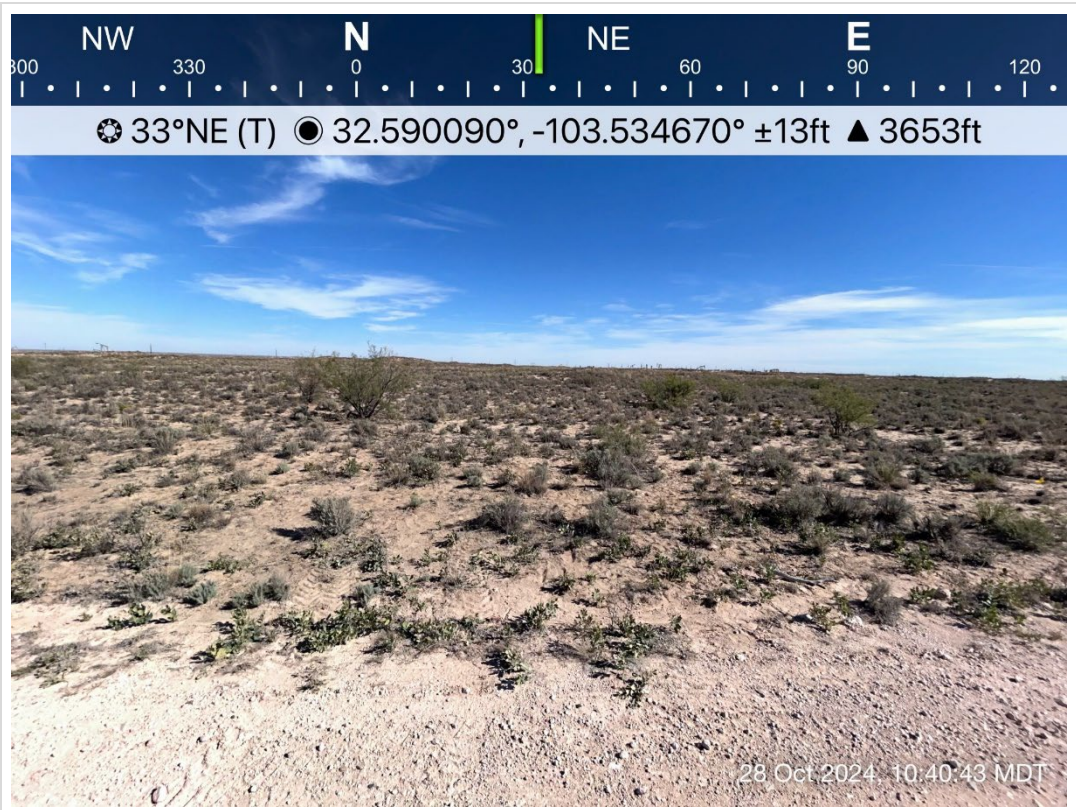
TETRA TECH, INC. PROJECT NO. 212C-MD-03607	DESCRIPTION	View northeast. View of release area following surface scrape. Vegetation present.	11
	SITE NAME	Tiger 11 Federal 001H	10/28/2024

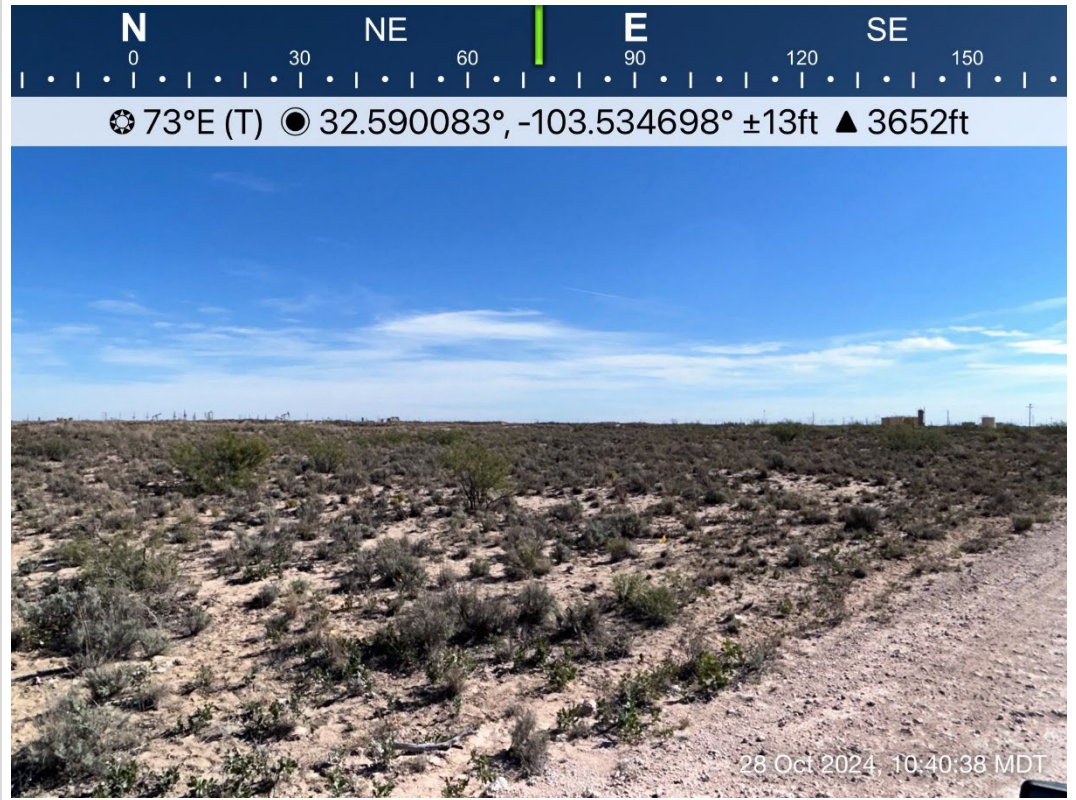
TETRA TECH, INC. PROJECT NO. 212C-MD-03607	DESCRIPTION	View east. View of release area following surface scrape. Vegetation present.	12
	SITE NAME	Tiger 11 Federal 001H	10/28/2024
