| Facility ID: | fKJ1518128159 | Incident #: | nAPP2510756154 |
| Facility Name: | North Hobbs NIB | Flare Date: | 04/11/2025 |

C-141 EVENT SUMMARY & VARIANCE REQUEST:

North Injection Battery HP Flare

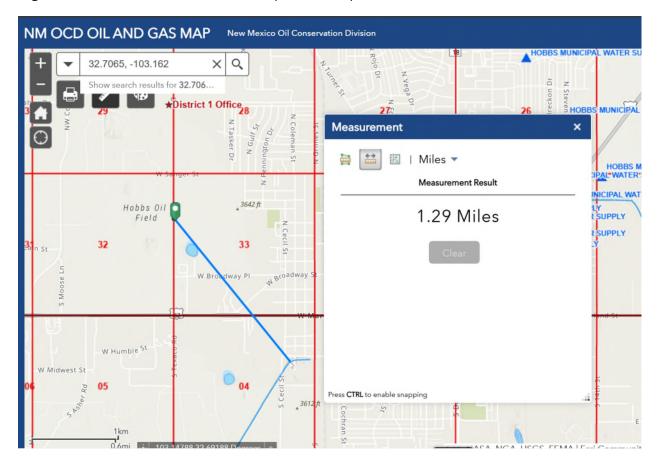
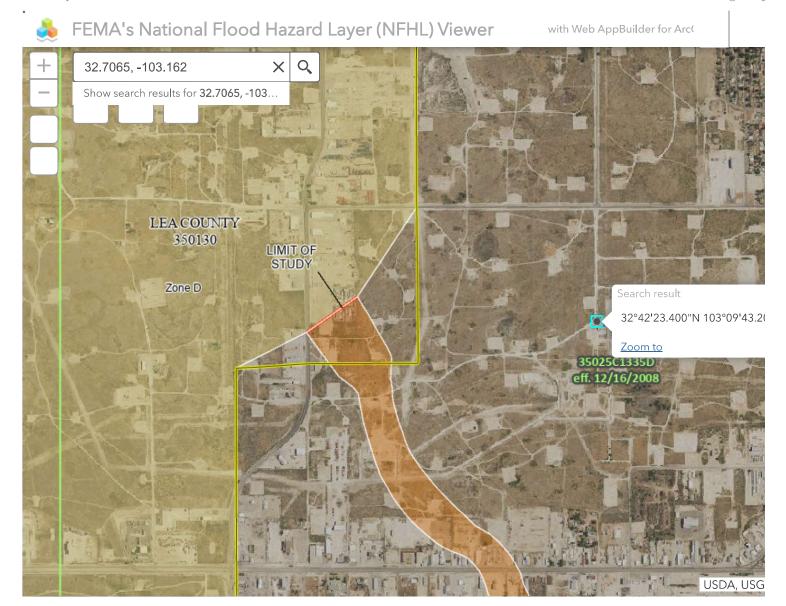
Significant Watercourse: ~1.29 miles (~6811 feet)

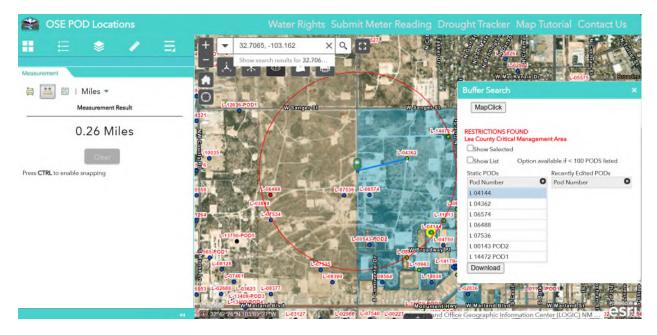
Fresh water well – Domestic: 0.26 miles (~1357)

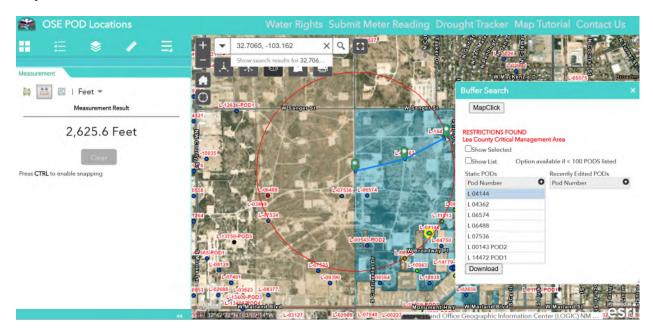
Any other fresh water well: ~2625 feet

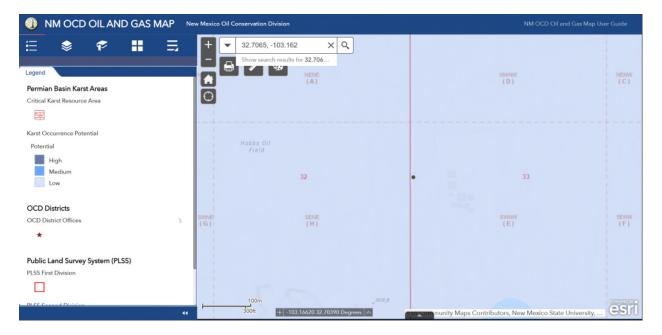
Karst: Low

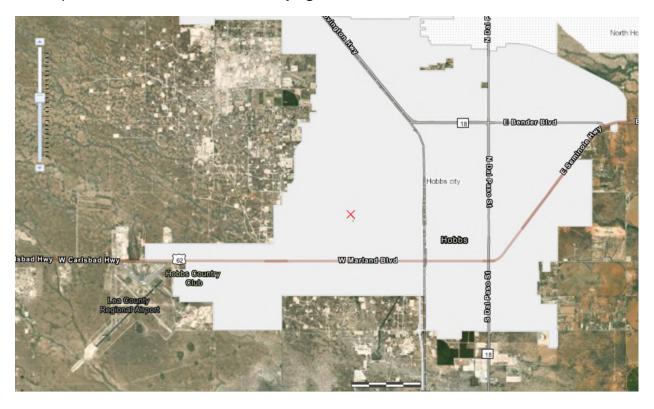
Municipal Boundaries: Zero, within the lying area

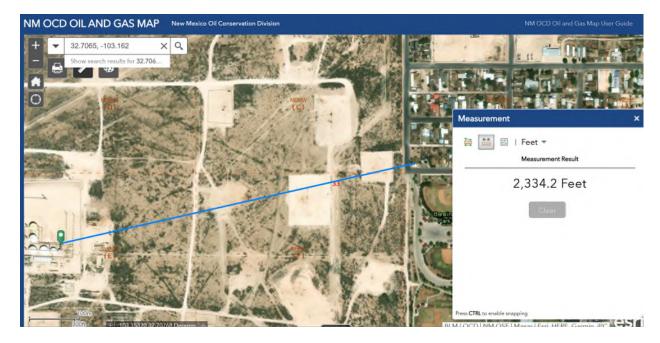
Residence Map: ~2334 feet

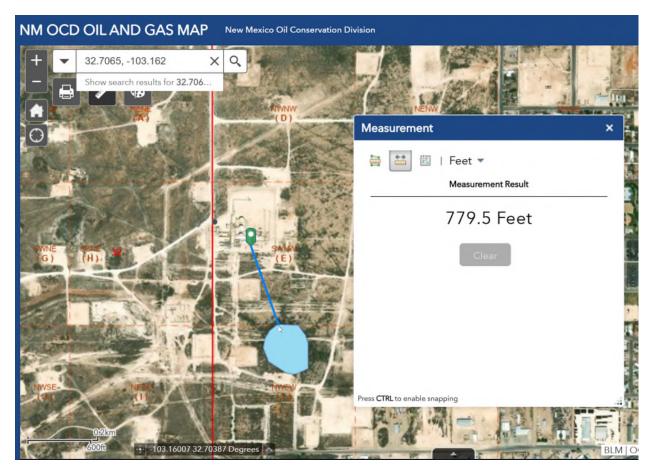
Body of water: ~779 feet

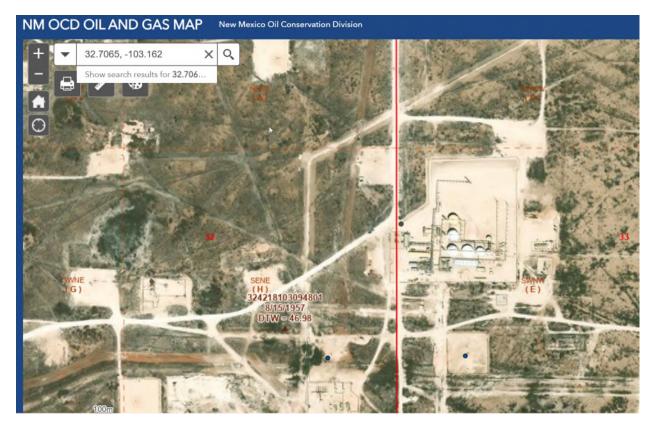
Depth to water: 26-50 feet, USGS
