RECLAMATION REQUEST REPORT

WPX Energy Permian, LLC

RDX 15 #012

Incident Number nAPP2327248298

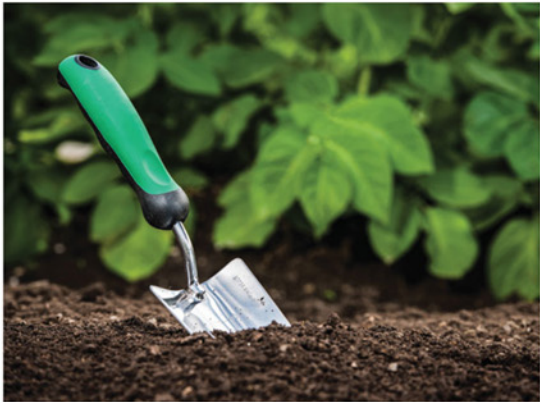
- 1. Remove cap from the green capped tube.
 - 2. Fill tube with soil to the first line.
 - 3. Carefully open a green capsule and pour powder into the tube.
 - 4. Add water (preferably distilled) to the fourth line.
 - 5. Cap tube and shake thoroughly.
 - 6. Allow soil to settle and color to develop for about a minute.
 - 7. Compare color of solution to the pH color chart.
- Repeat for remaining capsules.

pH 7.5 - Alkaline

pH 7.0 - Neutral

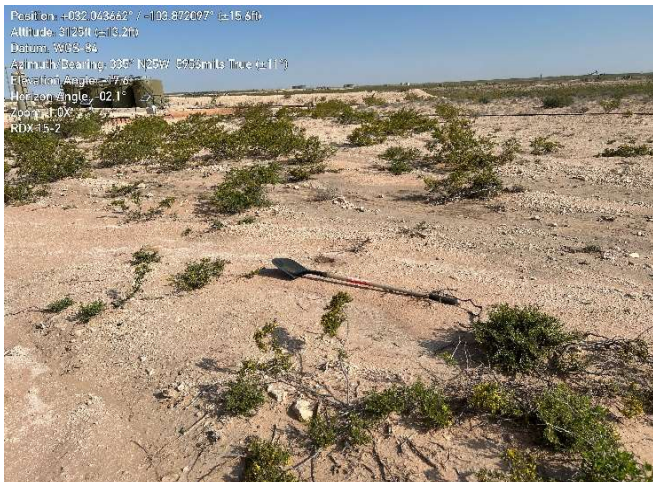
Photograph 5

Description: Northwestern view of background soil sampling area.

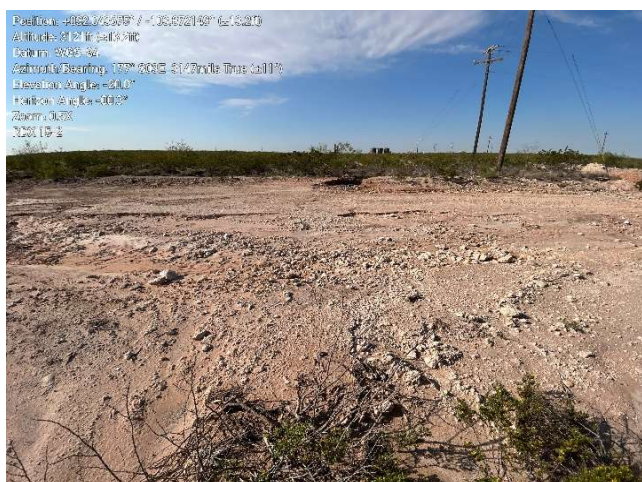
Photograph 6

Description: Southern view of soil cover sampling area.

On May 9, 2025, Etech assessed the backfill material for its capacity to host vegetative growth. One representative 5-point composite soil sample was collected from the soil cover within the excavation area (SC01) and one discrete soil sample was collected in a native soil area outside of the excavation area (BG01) at 0.25-foot bgs via hand shovel and field screened for volatile organic compounds (VOCs) utilizing a calibrated photoionization detector (PID) and chloride using Hach® chloride QuanTab® test strips, and qualitatively evaluated for nutrient density of pH, Nitrogen (N), Phosphorus (P), and Potassium (K) utilizing a HoldAll® Soil Test Kit according to the operating manual, which is included in **Appendix C**.

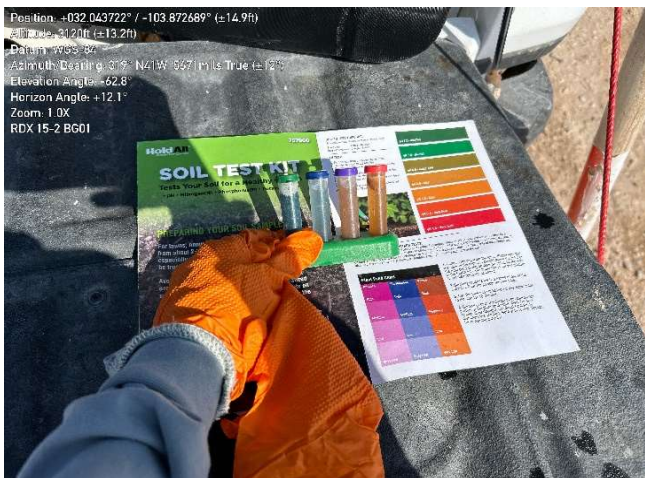
Photograph 7

Description: View of nutrient sampling results for background (BG01).
