**C-141 - CO2 GAS RELEASE ONLY (No Liquids)**  
**EVENT SUMMARY, VARIANCE REQUEST & CLOSURE REQUEST REPORT**

| <b>Facility Name:</b> | North Hobbs RCF | <b>Flare Date:</b> | 09/10/2025 |

**C-141 EVENT SUMMARY & VARIANCE REQUEST:**

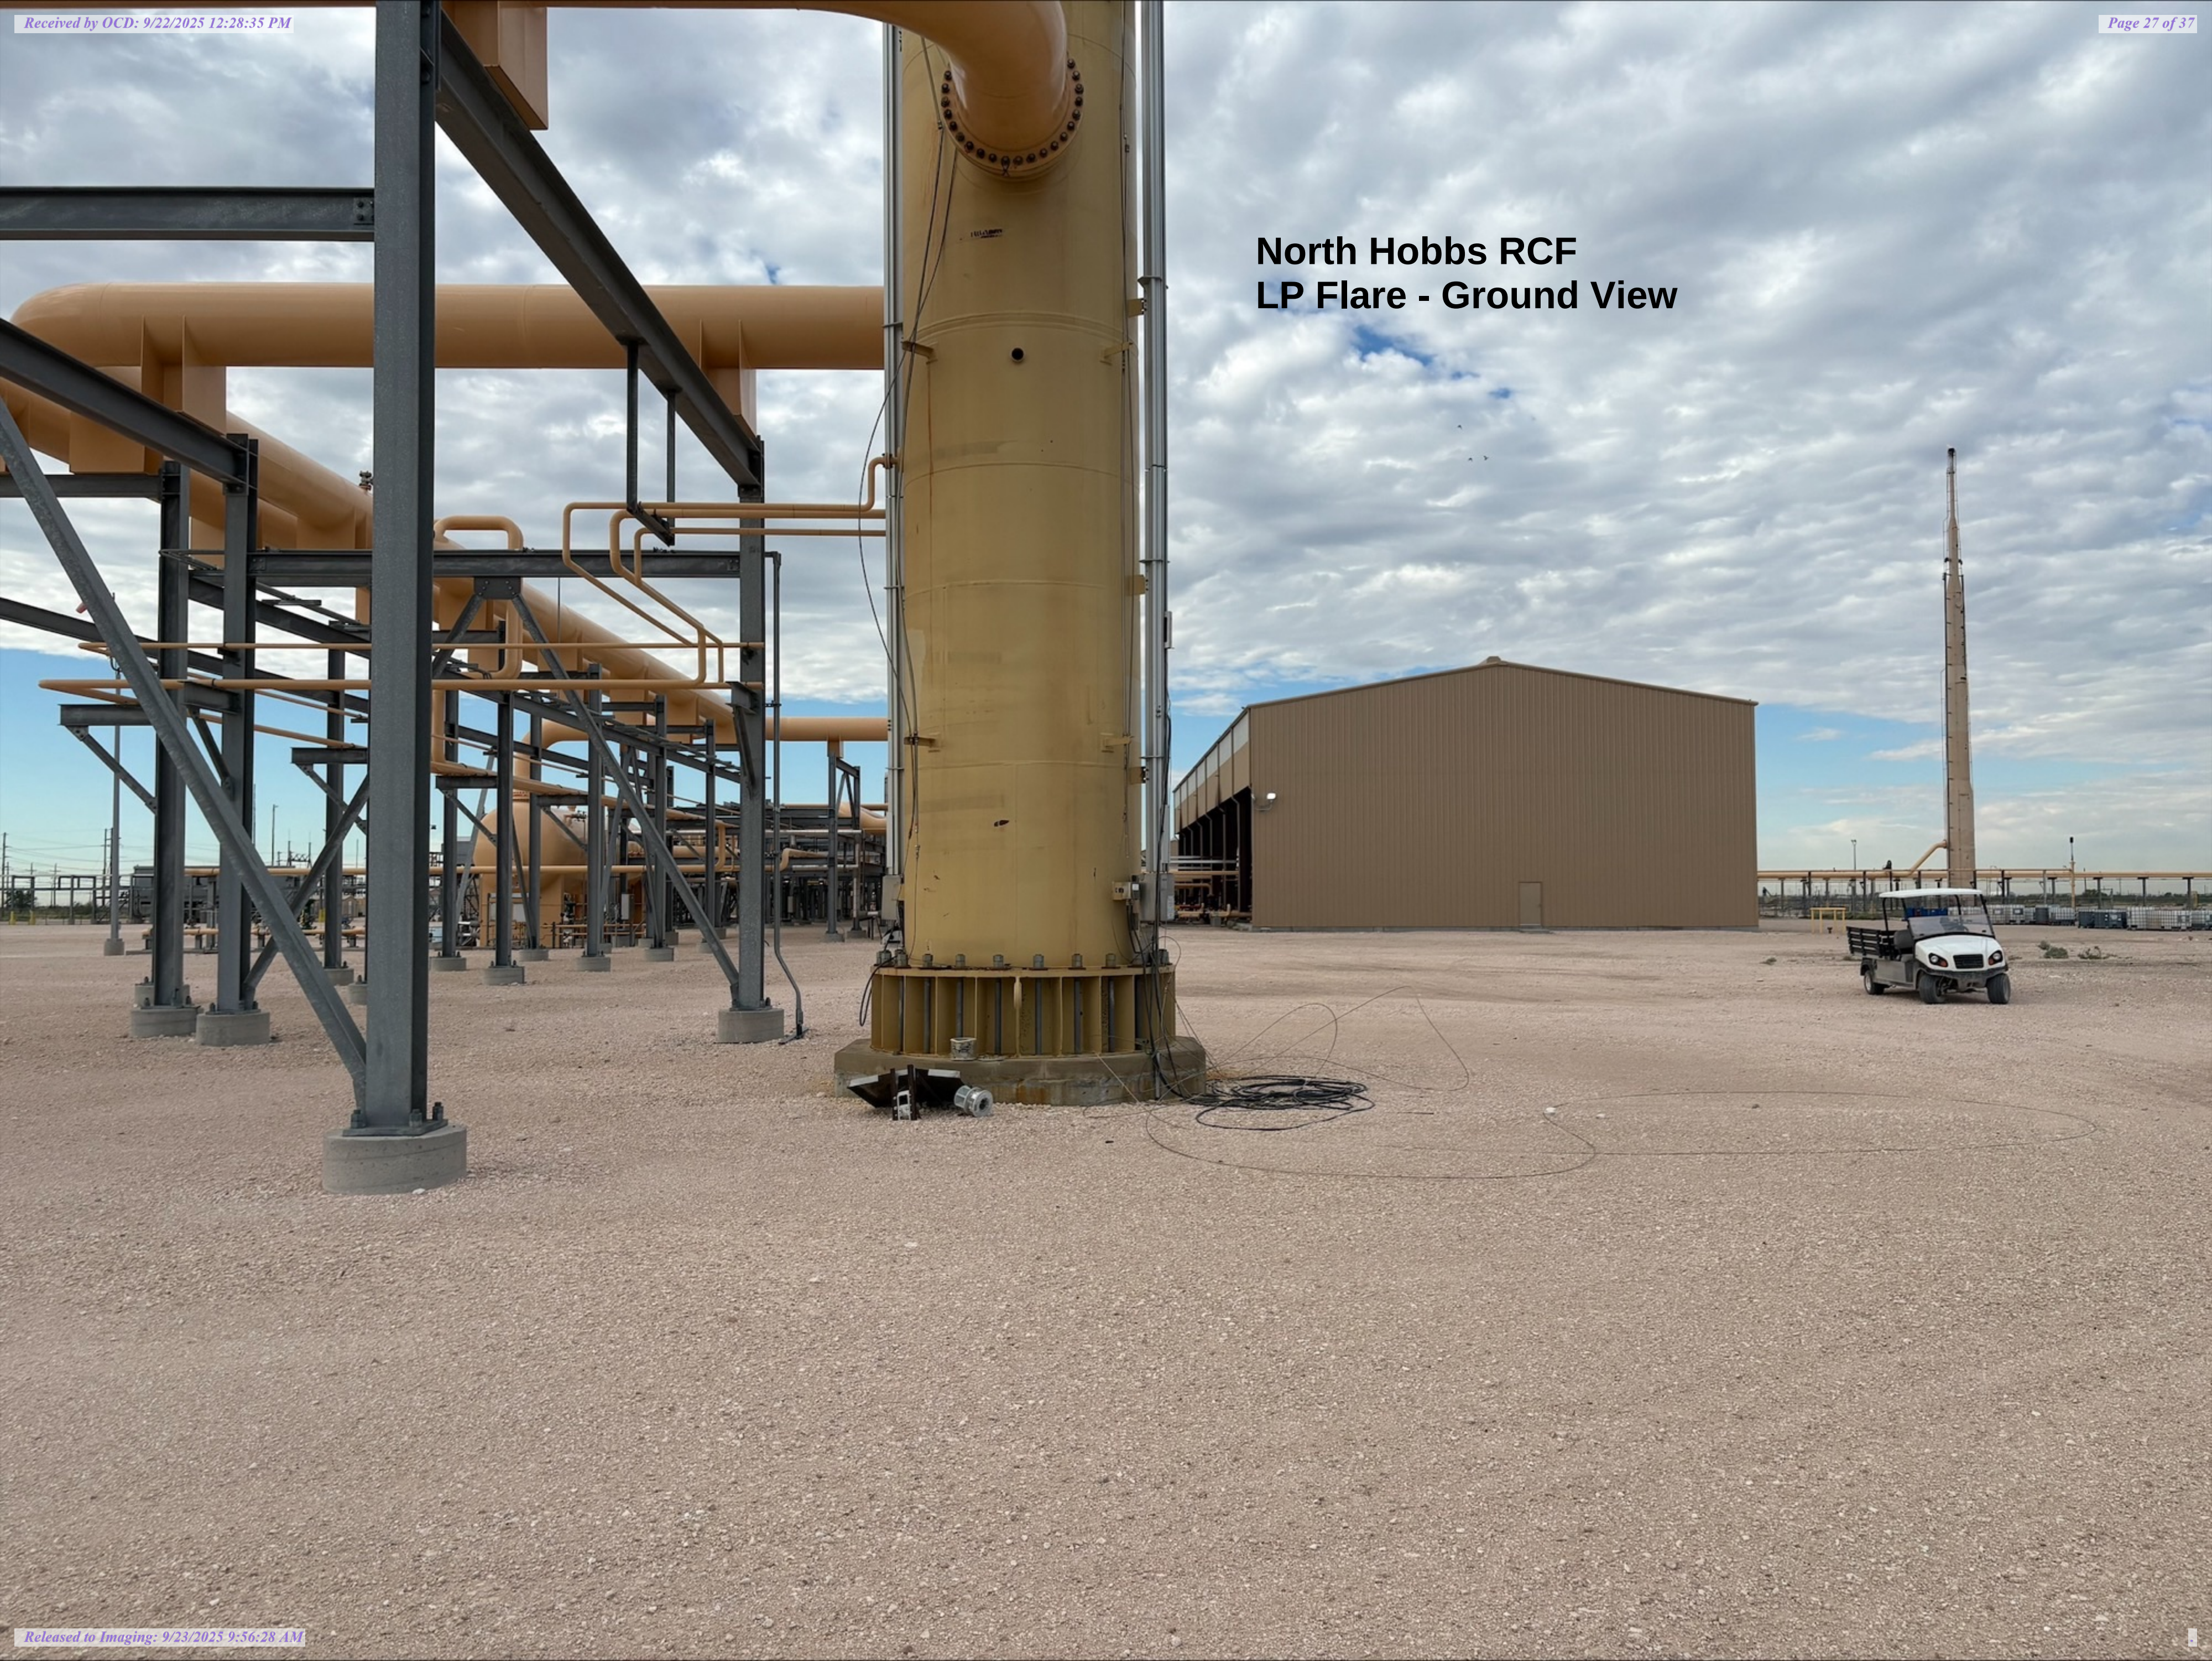
**North Hobbs RCF  
LP Flare - Ground View**

# North Hobbs RCF LP Flare
