Re: NMOCD nAPP2518652058  
Bootleg Ridge Compressor Station  
32.30893, -103.74018  
U/L A, Section 14, Township 23 South, Range 31 East

Re: NMOCD #nAPP2518652058  
Bootleg Ridge Compressor Station  
32.30893, -103.74018  
U/L A, Section 14, Township 23 South, Range 31 East

## **Section 1: Event Details**

## Bootleg Ridge Compressor Station Fire Event Photo Page

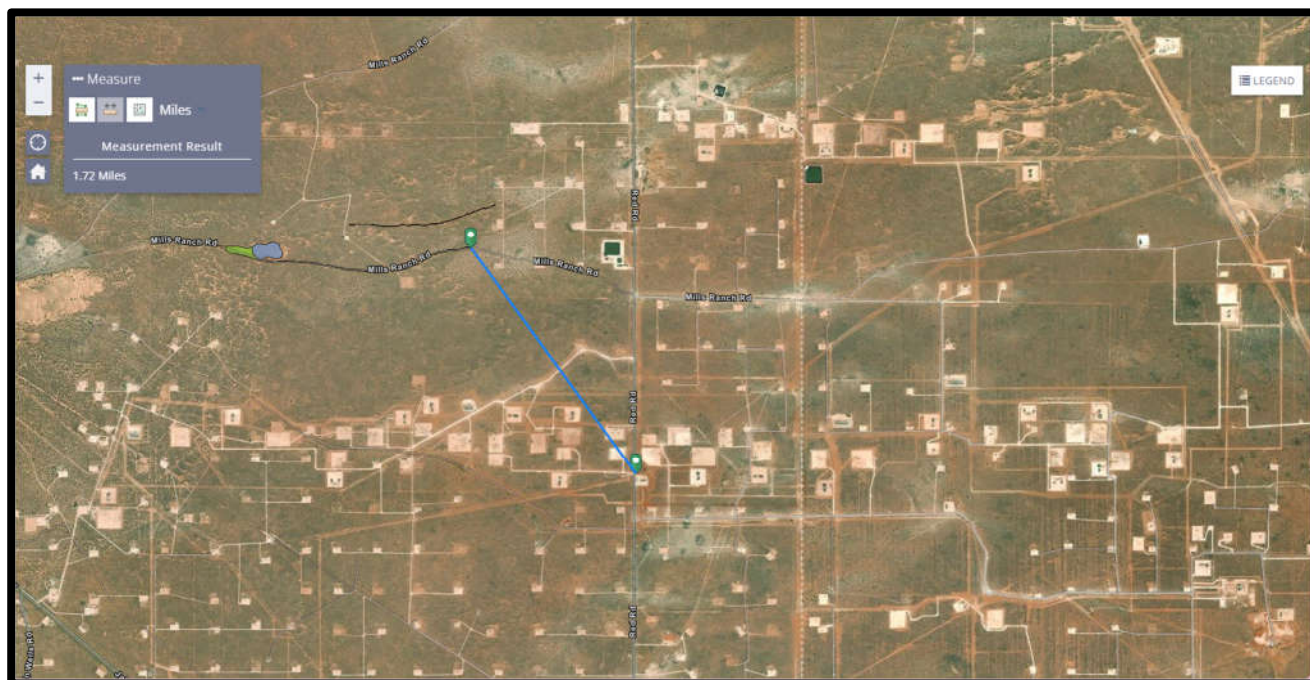
**Figure 4**

Targa reviewed aerial imagery and the National Wetland Inventory Map, published by the U.S. Fish and Wildlife Service, for wetlands and NMOCD database for surface water in the vicinity of the site. The nearest surface water is located 1.72 miles from the site. The location of the nearest wetland is 2.57 miles northwest of the site. Surface water is illustrated on Figure 4 and wetland on Figure 5.

**US Fish and Wildlife Wetlands Map**

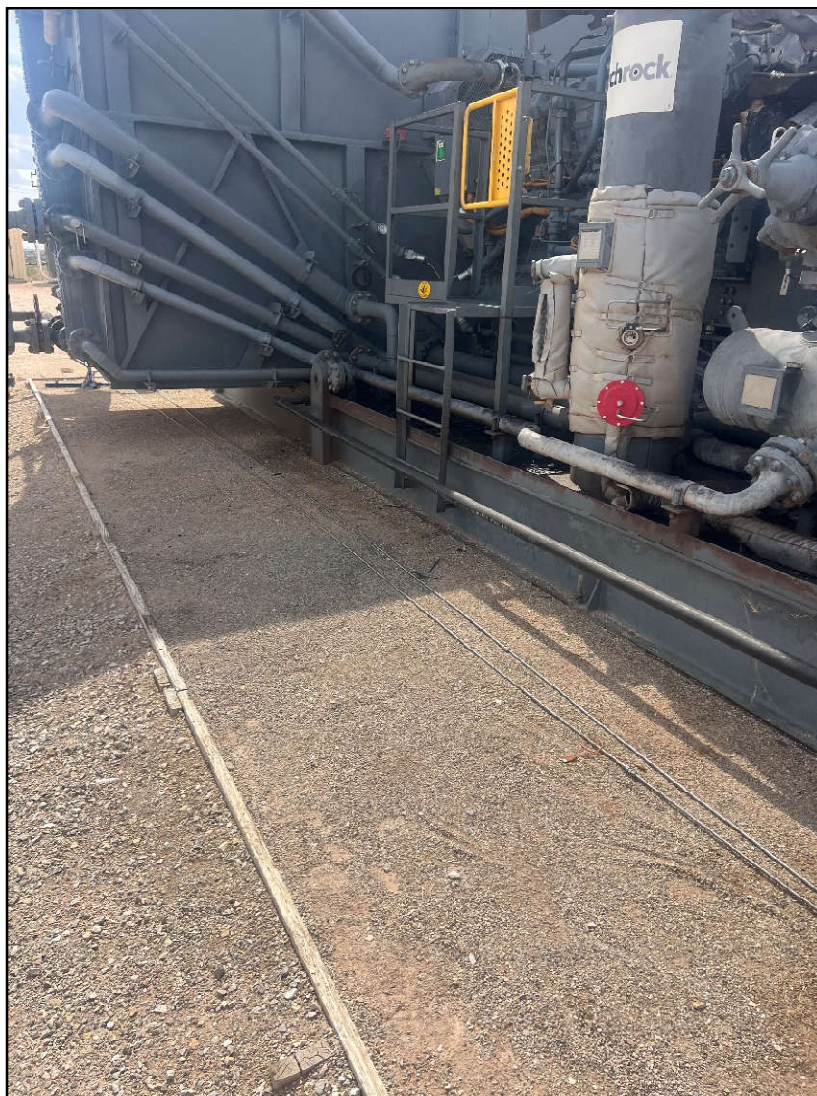
Photo of compression unit 804992 facing south.

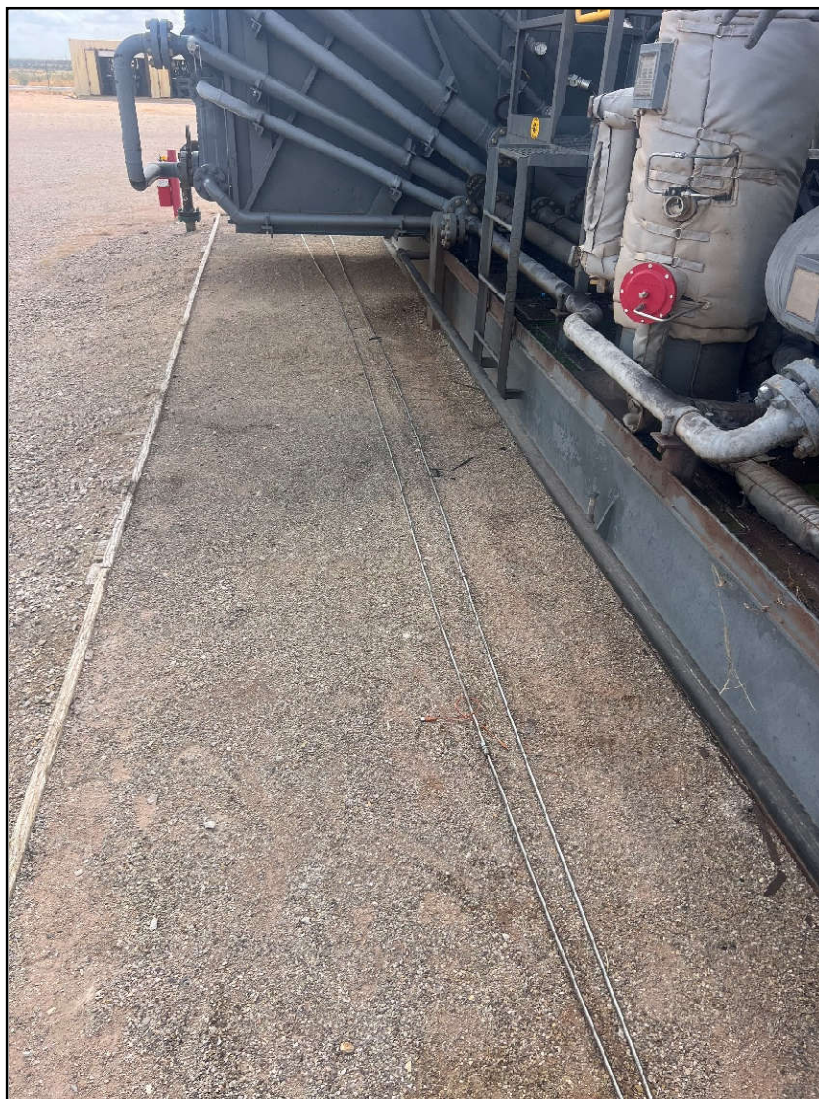
**Photo indicating no soil was impacted during this fire event.**

This was an above ground fire event with no gas released to atmosphere and no liquids released to surface, photographs are shown in Appendix C illustrating no staining to soil. This event was an incipient fire and extinguished utilizing a fire extinguisher. Targa is respectfully requesting a variance to NMAC Part 29 sampling requirements due to the absence of liquids released. Photographs indicating no soil impact are shown in Appendix C.

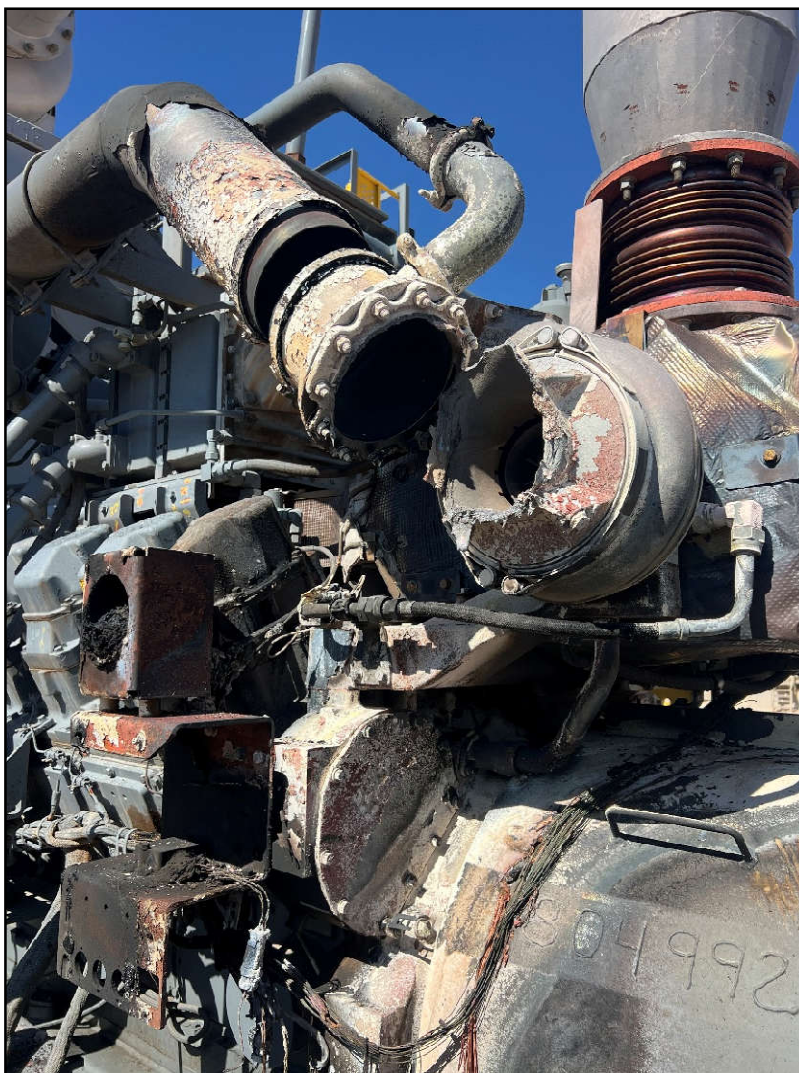
NMOCD Incident #nAPP2518652058 pertains to a fire that occurred at Targa's Bootleg Ridge Compressor Station. Targa personnel were restarting the compressor when they noticed an incipient fire near the turbos of unit 804992. The cause contributing to this event was a loose elbow on the unit turbo. The loose elbow caused oil and coolant to encounter the turbo acting as a fuel source. There was no gas released to atmosphere and no liquids released to surface.

**Photo of loose elbow on the turbo for unit 804992**

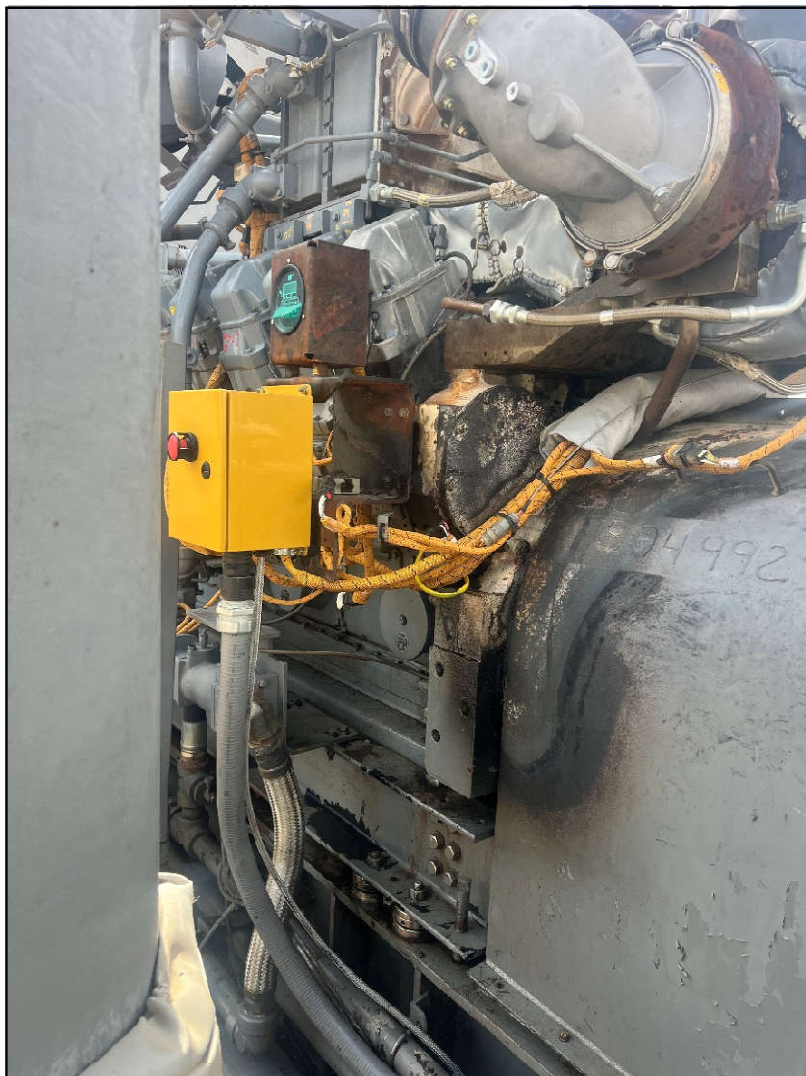
**Photo of unit 804992 after the replacement of equipment following the event**
