**C-141 - CO2 GAS RELEASE ONLY (No Liquids)**  
**EVENT SUMMARY, VARIANCE REQUEST & CLOSURE REQUEST REPORT**

**Facility ID:**fjXK1530631838

**Facility Name:** South Hobbs CTB**Flare Date:** 12/14/2025**Duration of Event:** 38minutes**MCF Flared:**229 MCF**Start Time:** 10:42AM**End Time:**11:20AM**Cause:** controlled release of gas only, no liquids involved - combusted in a flare to reduce emissions;

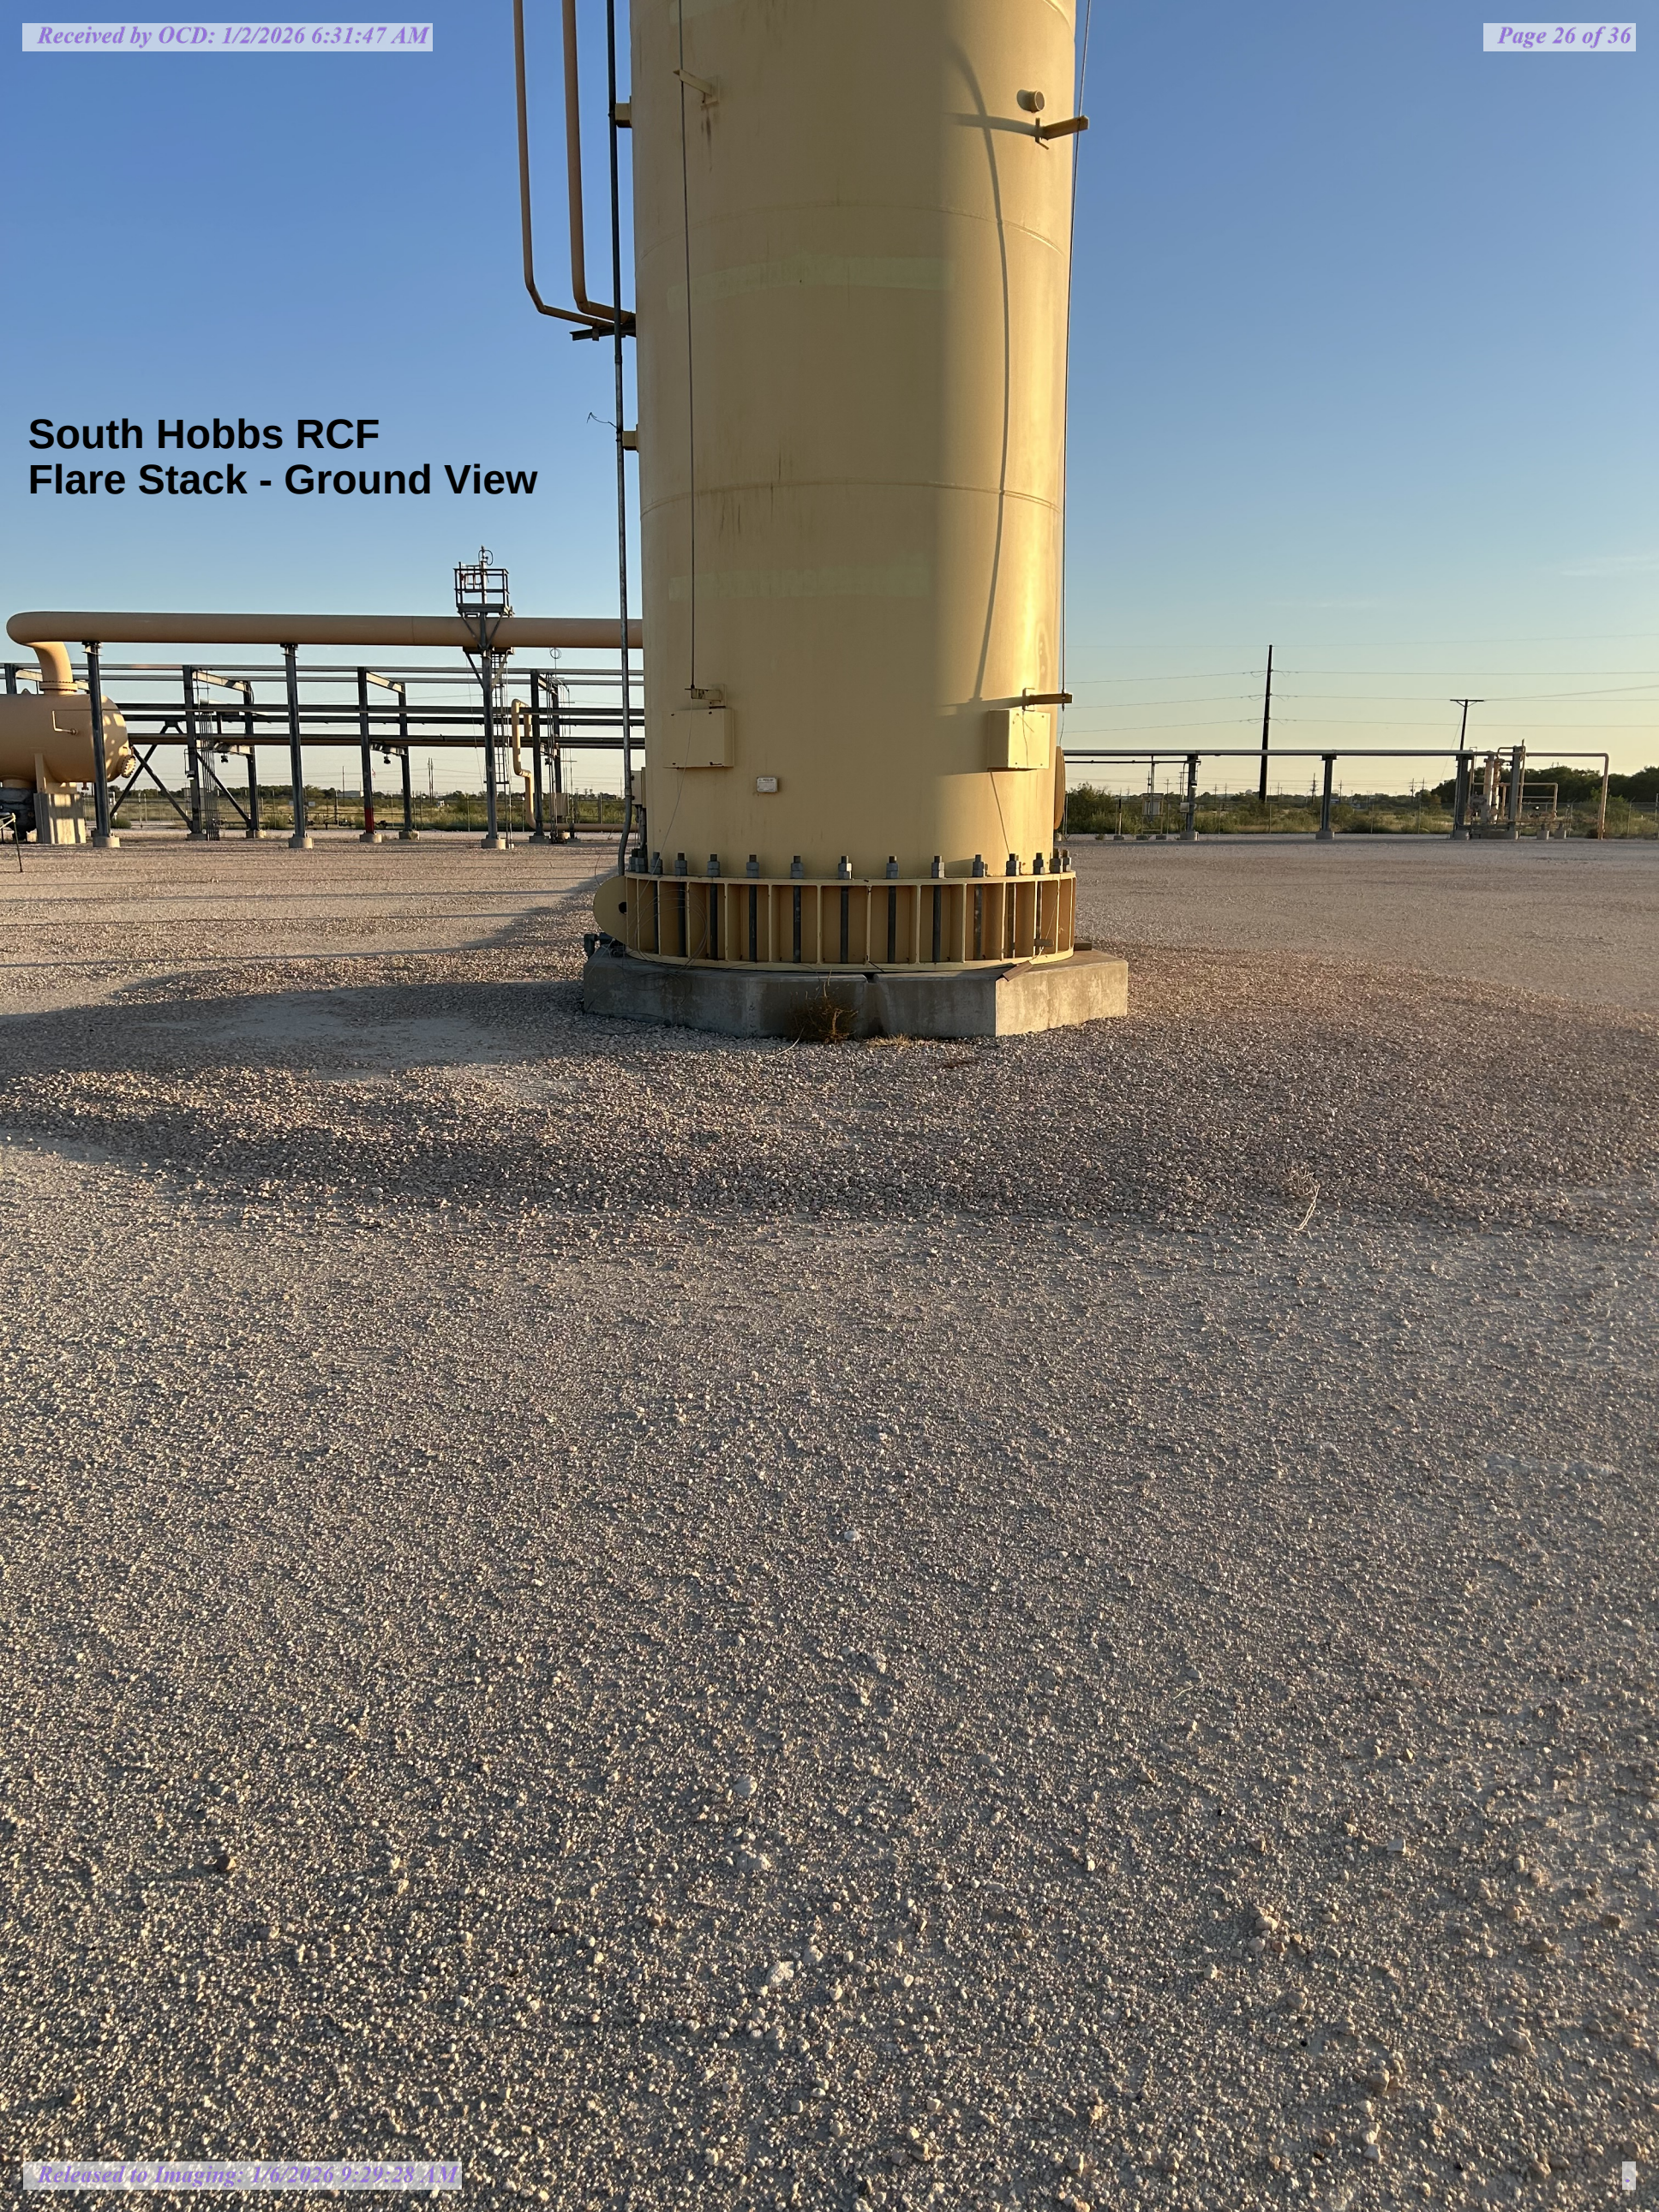
**South Hobbs RCF  
Flare Stack - Ground View**

- I. This flaring event was a controlled release of gas only, no liquids involved - combusted in a flare to reduce emissions; due to an unavoidable process upset at the facility involving CO2 gas.

# South Hobbs RCF Flare Stack
