RE: **Nailed It B CTB - Closure Request Report**  
Incident Number: nAPP2519532647  
GPS: 32.002686°, -103.842251°  
Eddy County, New Mexico  
ESRR Project No. 422

# **Environmental Karst Study Report Nailed It B CTB Eddy County, New Mexico**

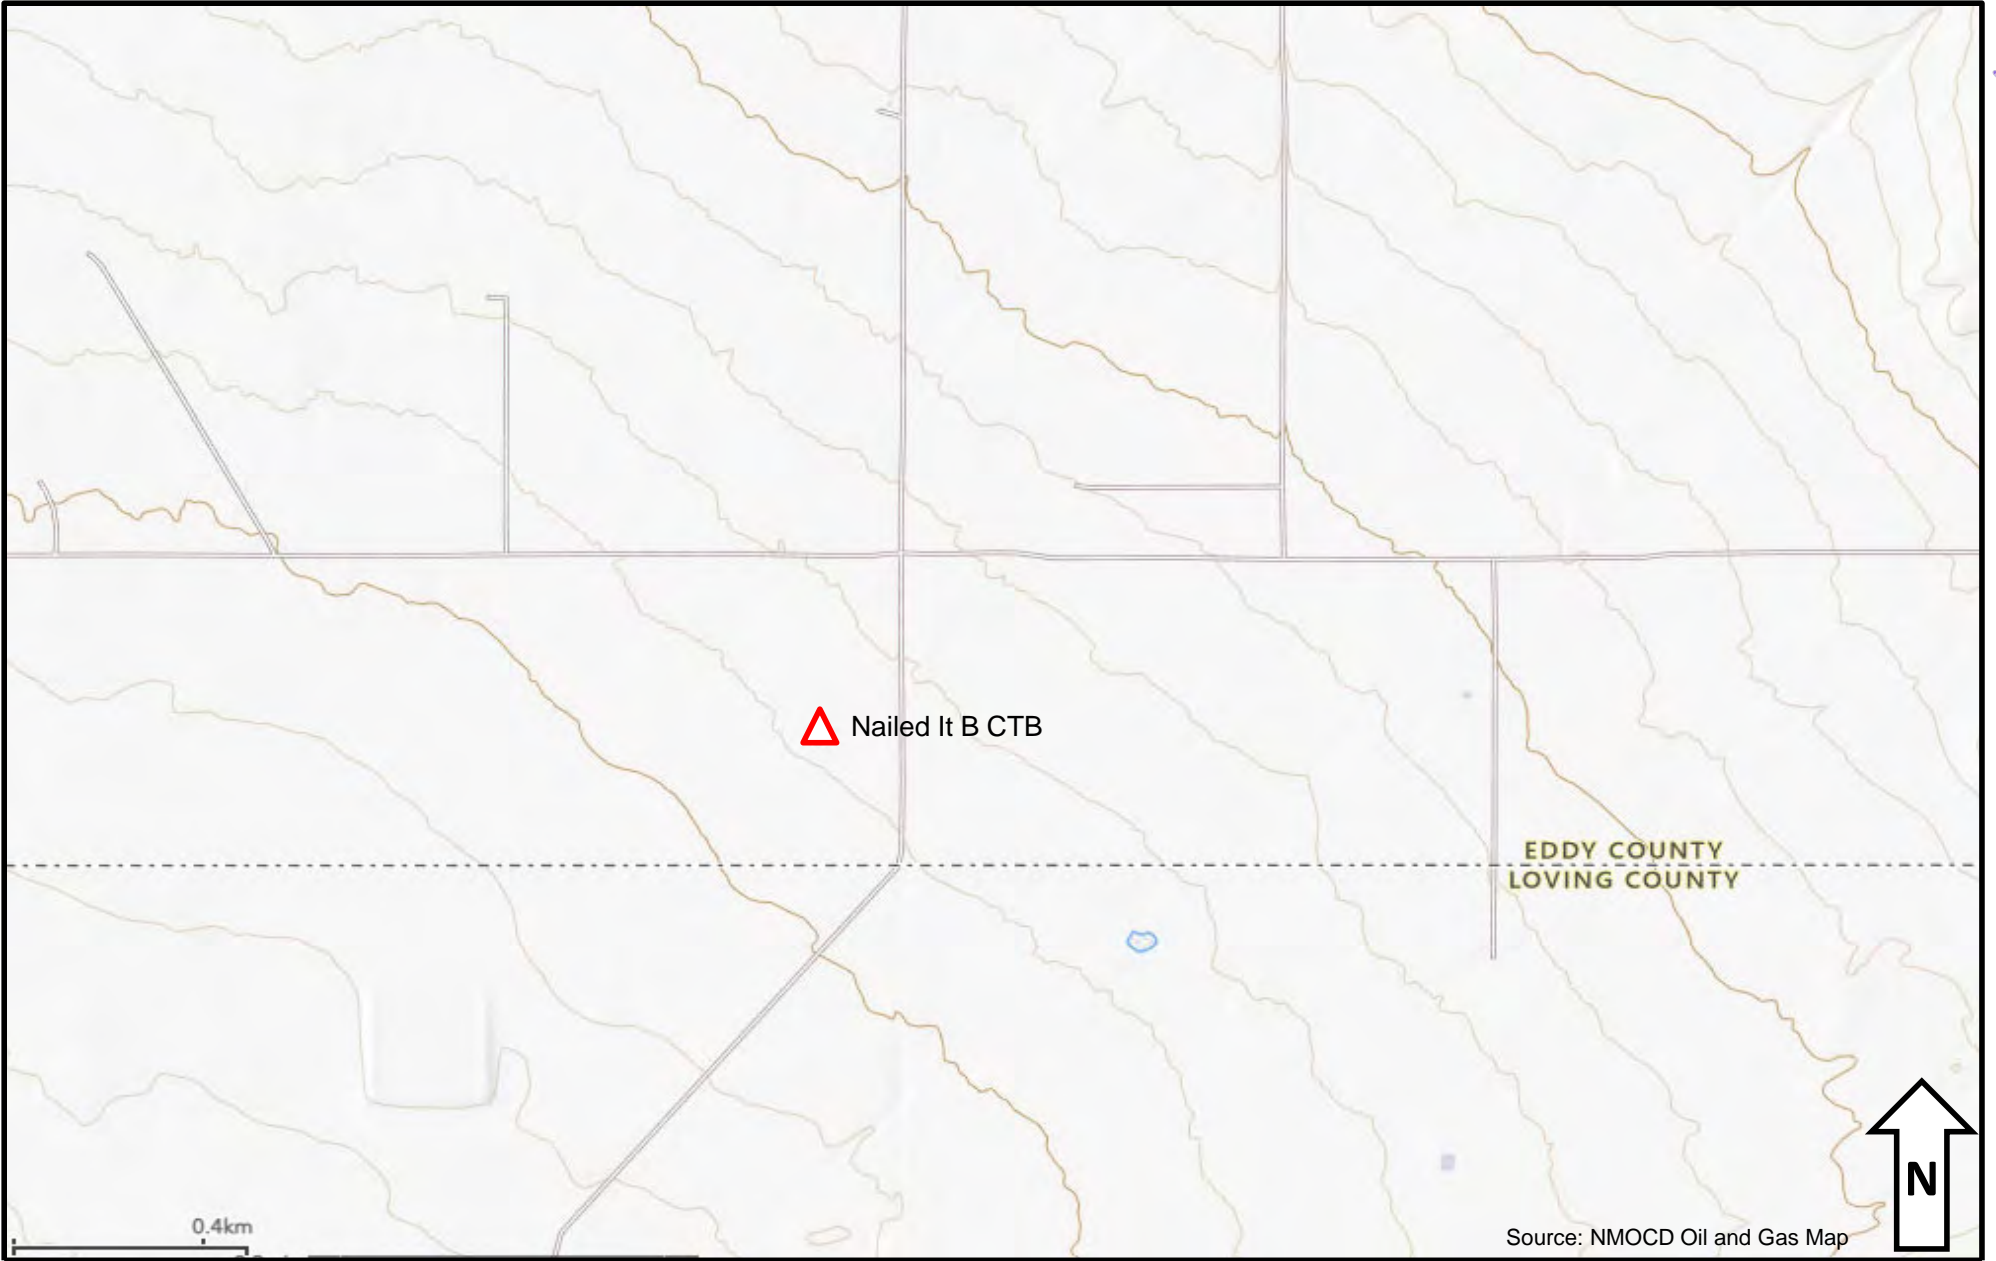
**Figure 1 – Site Map**

The Site is located in Unit D, Section 36, Township 26 South, Range 30 East, in Eddy County, New Mexico (32.002686°, -103.842251°) and is associated with oil and gas exploration and production operations on State Land managed by the New Mexico State Land Office (NMSLO) (**Figure 1**).

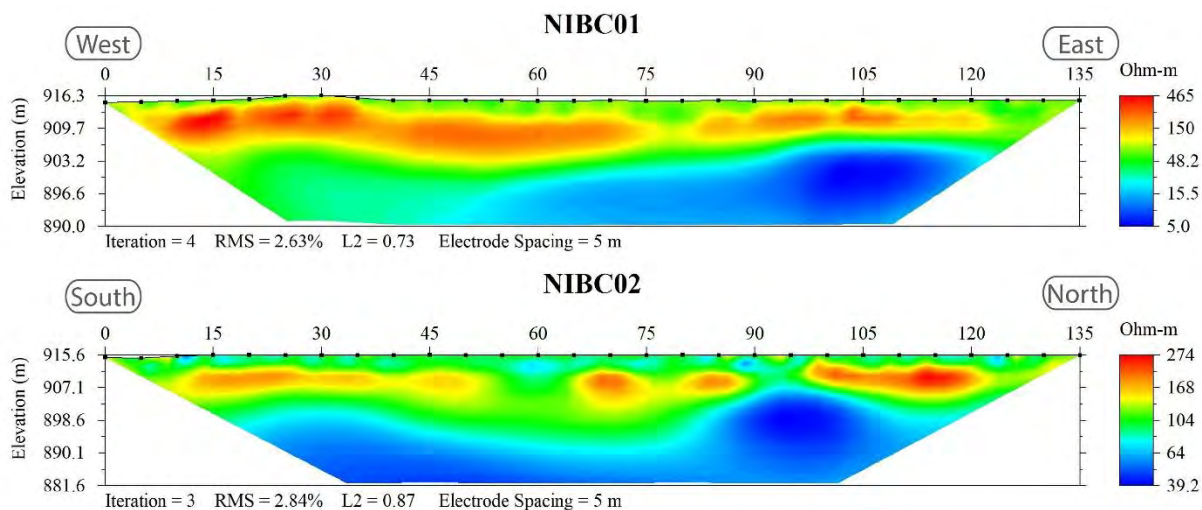
The results of this study indicate a well-layered geologic system with low resistivities between 5.0 and 465 Ohm-m (**Figure 7**). Please keep in mind when viewing the 2D inverted resistivity sections that color maps can be widely different for each view. Always check the color map located on the right side of the image when viewing the 2D images to ensure you understand the range of resistivities presented. Distances along the top and depths along the left side are in meters. The color map along the right side is in Ohm-m. Due to the nature of the survey, shallower zones have higher resolution between electrodes than deeper zones; therefore, small features at depth will not be visible.

**Figure 7: 2D inverted resistivity sections. Reds and oranges indicate higher resistivity values. Yellows and greens are medium-resistivity values. Blues are low-resistivity values. Please note that the color scale is relative.**

No surface karst features and no anomalies consistent with air-filled subsurface voids are found within the NIBC survey area. However, small solutionally enlarged voids or fractures at or near the resolution limit of the survey (2.5 – 3.0 meters) may be present. Slightly higher-than-average resistivity areas less than 10 meters beneath the surface are interpreted as sand, caliche, or gypsite soils. Due to their much lower resistivity values when compared with significant subsurface voids, these features should not be a concern during remediation efforts.

Areas of moderate resistivity (yellows, and greens) near the surface are interpreted as sand, caliche, or sandstone of the Dewey Lake Formation; or dry caliche soils and gypsum or dolomite bedrock Rustler Formation <sup>[18]</sup> (**Figure 7** and **Figure 8**). The low-resistivity area at a depth of approximately 12 - 15 meters beneath the surface across both lines is likely a layer of either clay and halite lenses or moist or saturated layers within the Dewey Lake or Rustler Formations. (**Figure 7** and **Figure 8**).

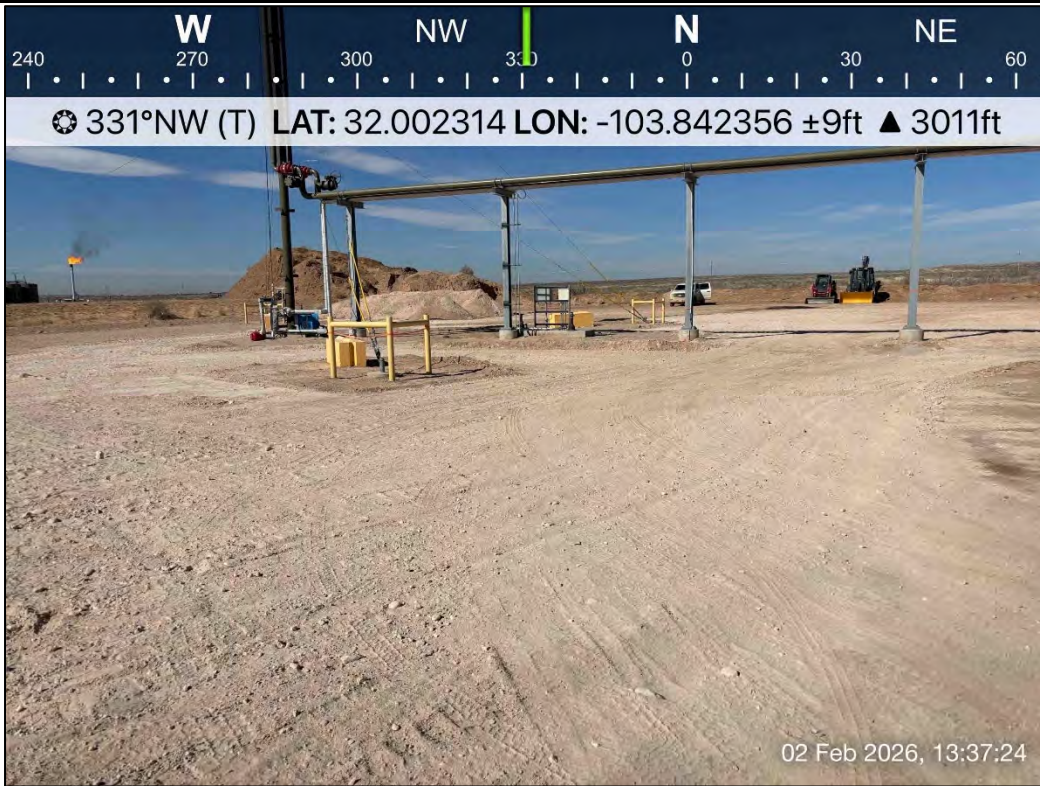
PHOTO 13: Northwestern view of excavation extent. 2/02/2026
