MULE 23-11 FED COM #822H

nAPP2305244923 Reclamation Closure Report

For Devon Energy Production, LP
By Pima Environmental Services, LLC

**Re: Reclamation Closure Report
Mule 23-11 Fed Com 822H
API No. 30-015-49388
GPS: Latitude 32.7556763 Longitude -103.9067688
ULSTR - O - 7 - 18S - 31E 330 FSL 1980 FEL Eddy County, NM
NMOCD Incident ID nAPP2305244923**

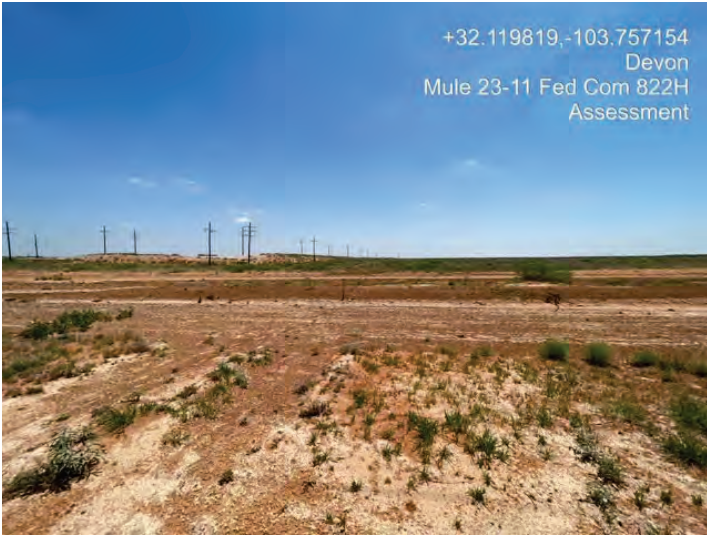
West side looking east

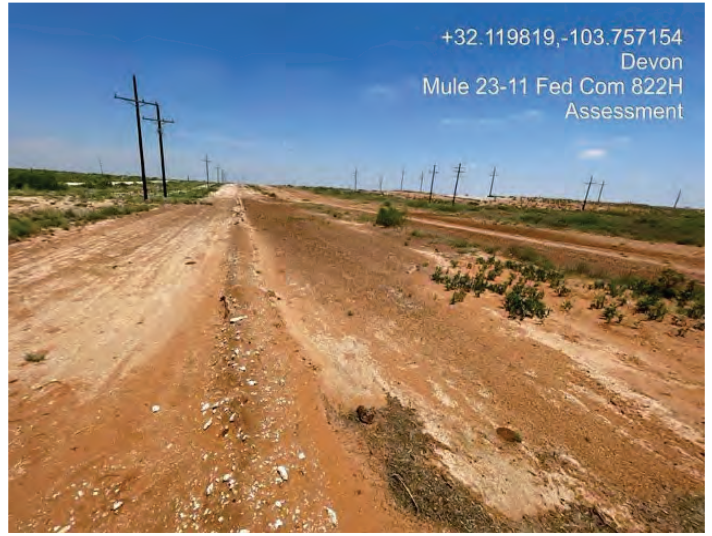
South side looking north

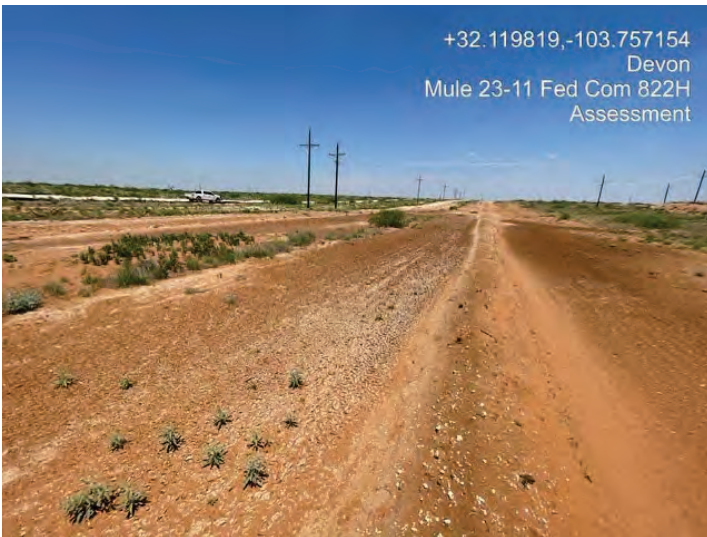
Further south looking north

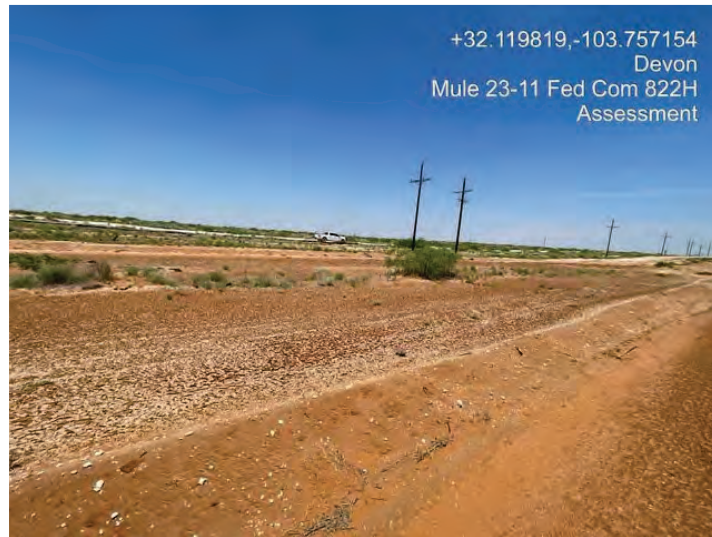
Southeast side looking northwest

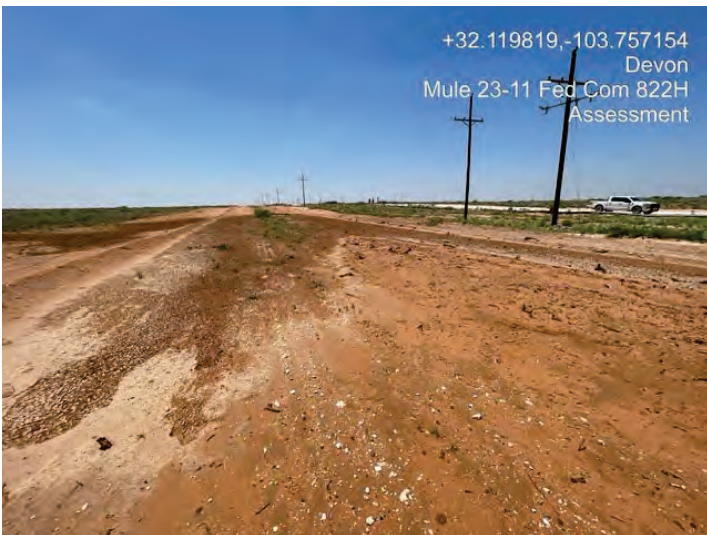
North side looking south

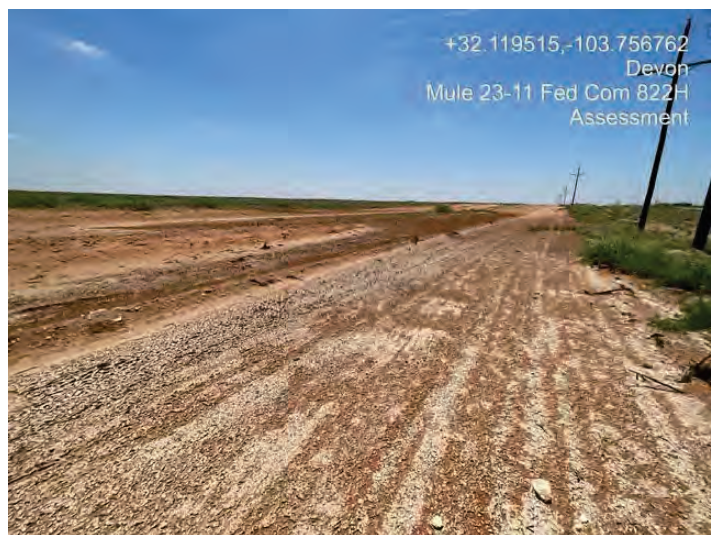
Northwest side looking southeast

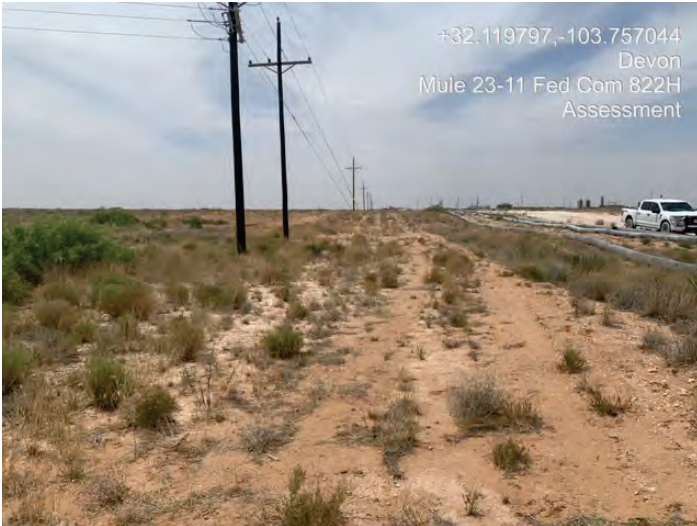
+32.119797,-103.757044
Devon
Mule 23-11 Fed Com 822H
Assessment

North side looking south

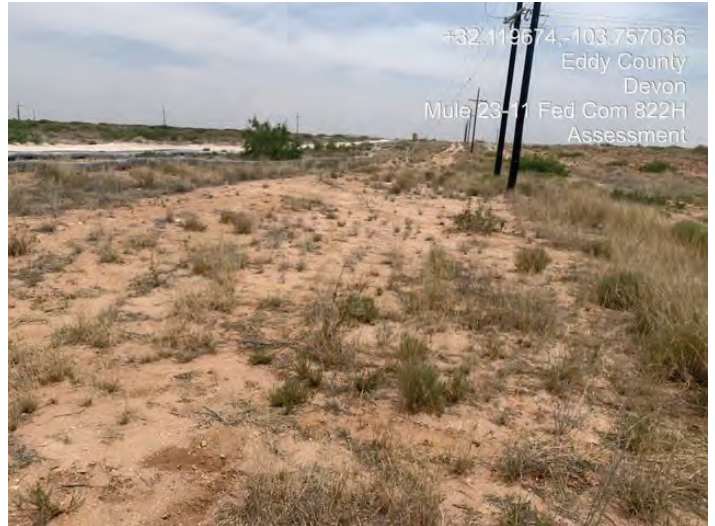
+32.119674,-103.757036
Eddy County
Devon
Mule 23-11 Fed Com 822H
Assessment

South side looking north

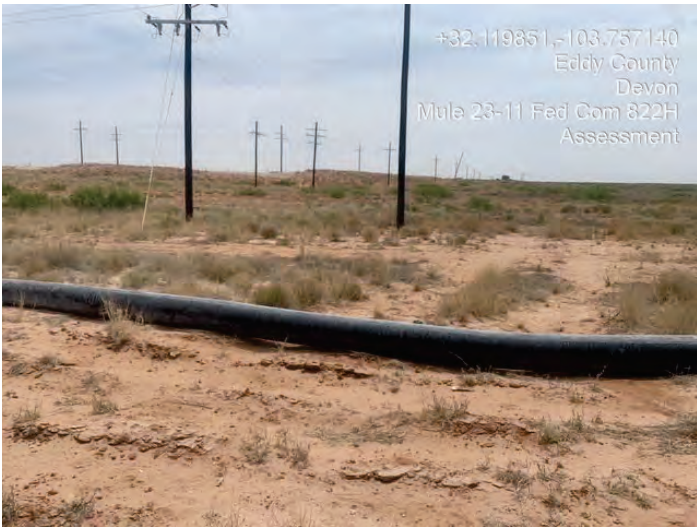
+32.119851,-103.757140
Eddy County
Devon
Mule 23-11 Fed Com 822H
Assessment

West side looking east

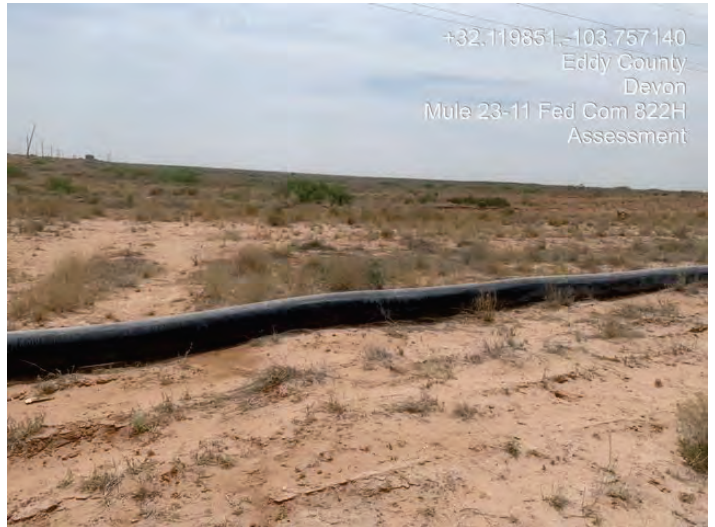
+32.119851,-103.757140
Eddy County
Devon
Mule 23-11 Fed Com 822H
Assessment

West side looking southeast
