**Closure Report**  
**Red Light 27 34 State Com #002H**  
**Incident ID: nAPP2508438017**  
**Eddy County, New Mexico**  
**Unit D Sec 27 T23S R26E**  
**32.281726°, -104.286554°**

**Crude Oil and Produced Water Release**  
**Point of Release: Equipment Failure on Separator**  
**Release Date: 03/24/2025**  
**Volume Released: 2 Barrels of Crude Oil and 11 Barrels of Produced Water**  
**Volume Recovered: 2 Barrels of Crude Oil and 11 Barrels of Produced Water**

**Re: Closure Report**  
**Red Light 27 34 State Com #002H**  
**Incident ID: nAPP2508438017**  
**Marathon Oil Permian, LLC**  
**Site Location: Unit D, S27, T23S, R26E**  
**(Lat 32.281726°, Long -104.286554°)**  
**Eddy County, New Mexico**

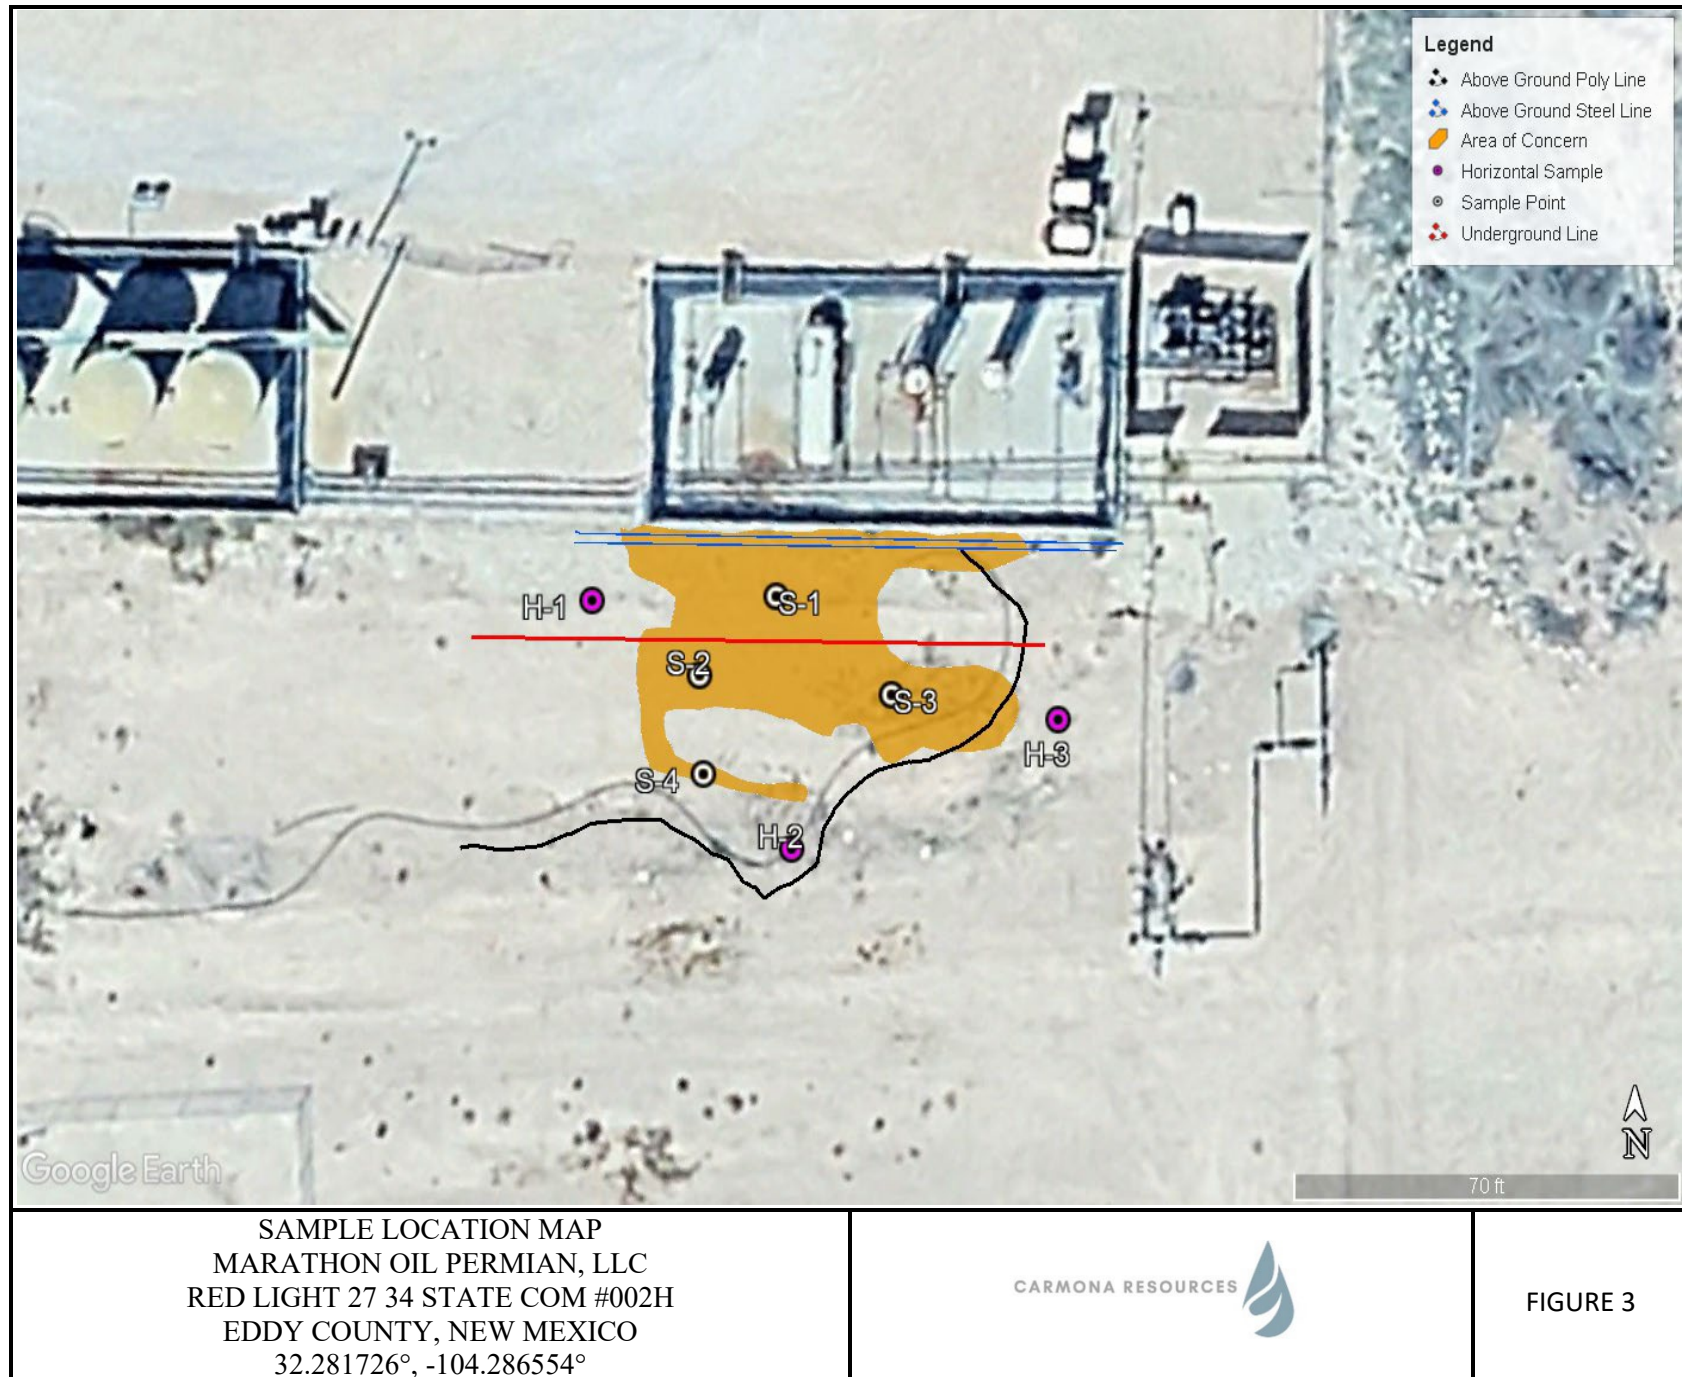
On April 17, 2025, Carmona Resources, LLC performed site assessment activities to evaluate soil impacts stemming from the release. A total of four (4) sample points (S-1 through S-4) and three (3) horizontal sample points (H-1 through H-3) were installed to total depths ranging from surface to 3' bgs inside and surrounding

the release area to evaluate the vertical and horizontal extent. See Figure 3 for the sample locations. For chemical analysis, the soil samples were collected and placed directly into laboratory-provided sample containers, stored on ice, and transported under the proper chain-of-custody protocol to Eurofins Laboratories in Midland, Texas. The samples were analyzed for total petroleum hydrocarbons (TPH) by EPA method 8015, modified benzene, toluene, ethylbenzene, and xylenes (BTEX) by EPA Method 8021B, and chloride by EPA method 300.0. The laboratory reports, including analytical methods, results, and chain-of-custody documents, are attached in Appendix E.

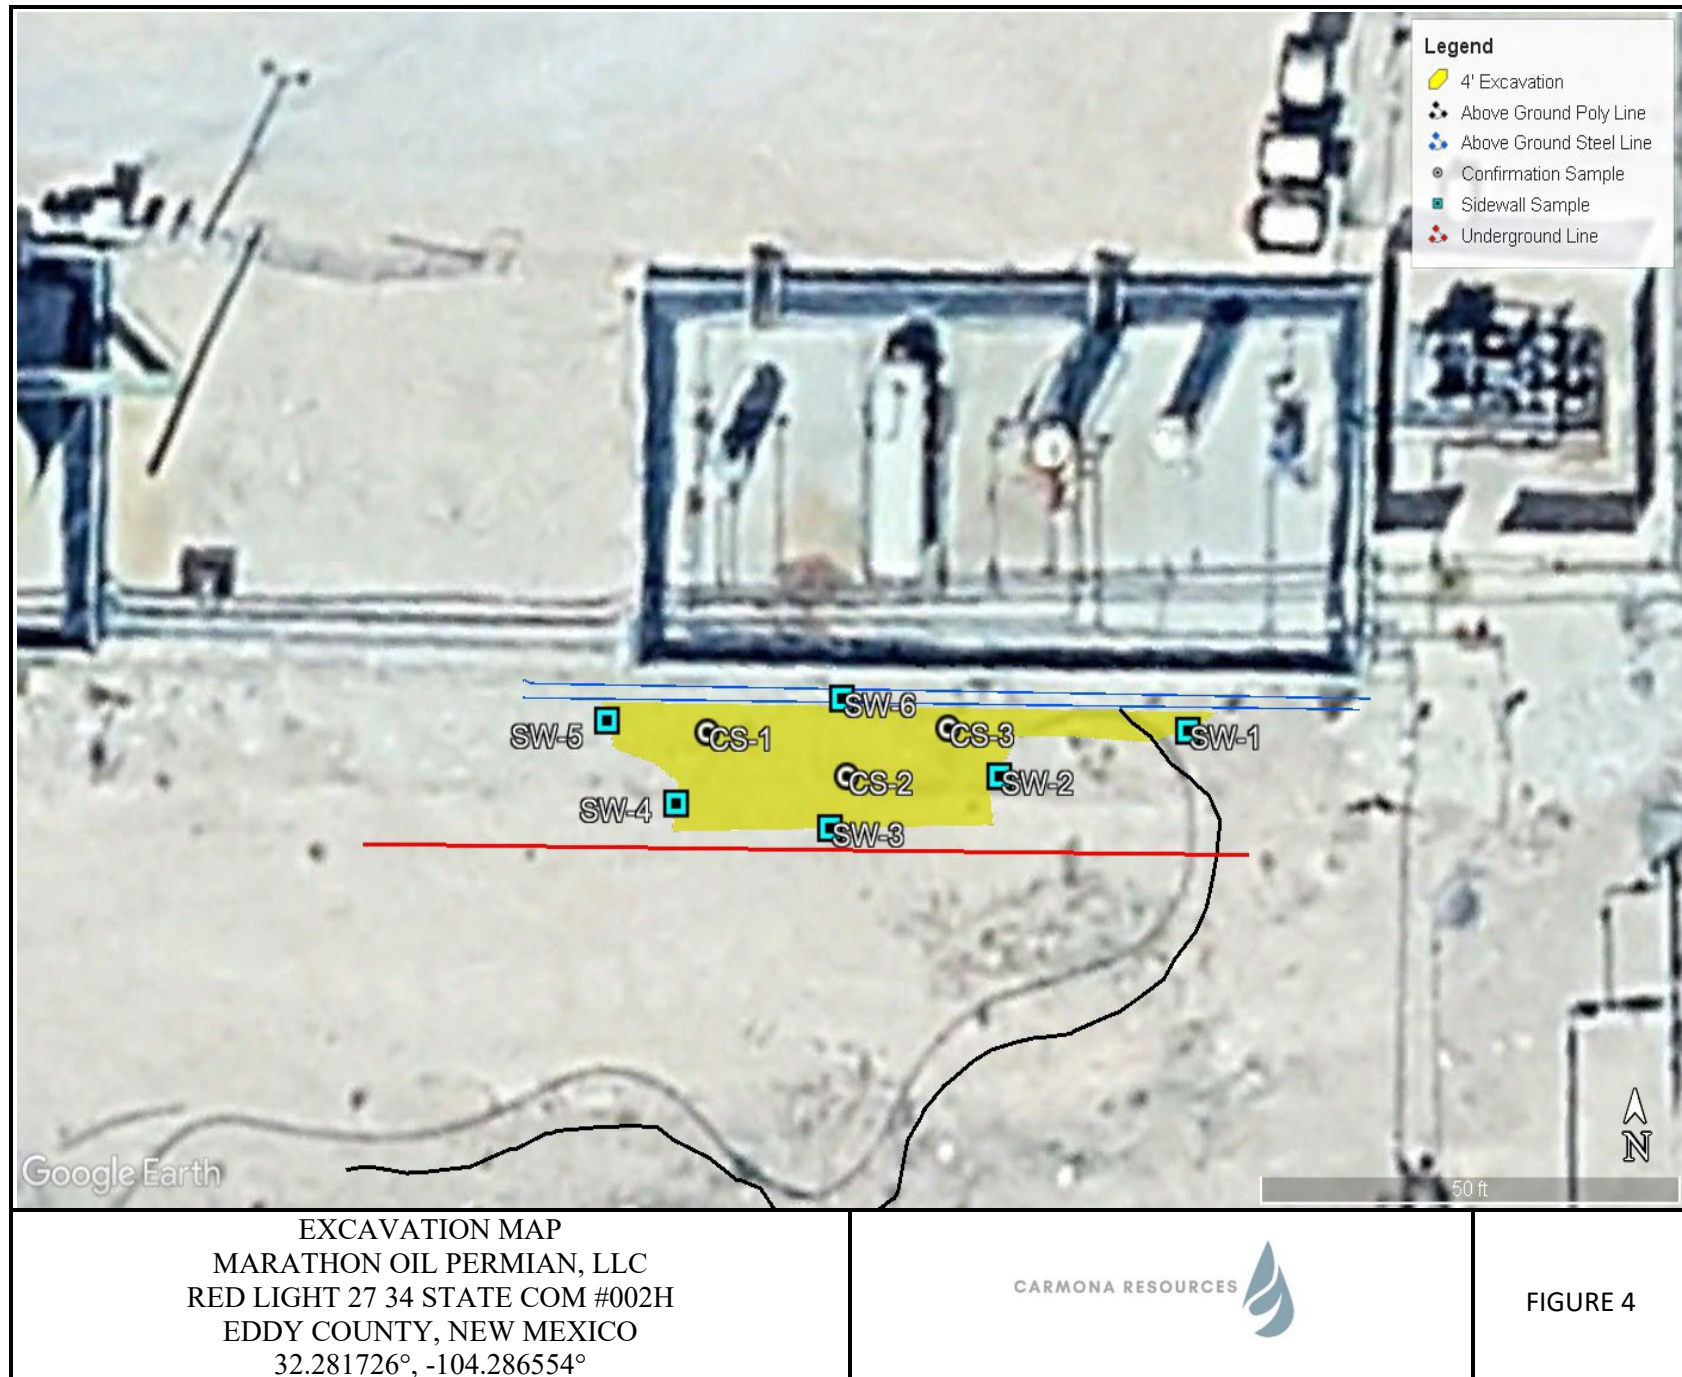
Carmona Resources personnel were on site to guide excavation activities, collect confirmation samples and document backfill activities. Before collecting composite confirmation samples, the NMOCD division office was notified via NMOCD portal on June 4, 2025, per Subsection D of 19.15.29.12 NMAC. See Appendix C for the sampling notification. A total of three (3) confirmation floor samples were collected (CS-1 through CS-3), and six (6) sidewall samples (SW-1 through SW-6) were collected every 200 square feet to ensure the proper removal of the contaminated soils. All collected samples were analyzed for TPH analysis by EPA method 8015 modified, BTEX by EPA Method 8021B, and chloride by EPA method 300.0. Copies of laboratory analysis and chain-of-custody documentation are included in Appendix E. The excavation depths and confirmation sample locations are shown in Figure 4.

All final confirmation samples were below the regulatory requirements for TPH, BTEX, and chloride. Refer to Table 2 for the analytical results.

Approximately 105 cubic yards of material were excavated and transported off-site for proper disposal.

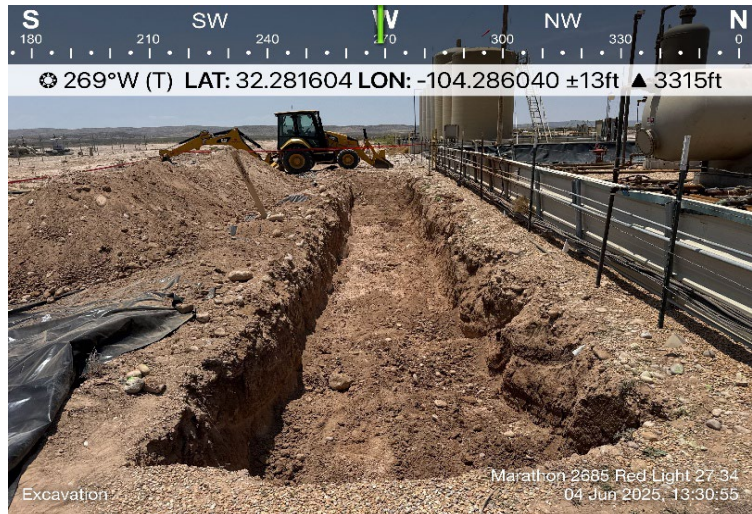
View East, area of CS-1 through CS-3.

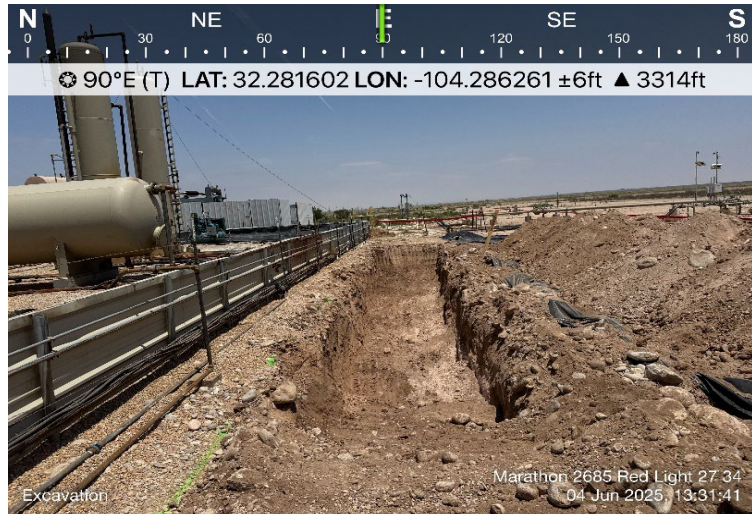
## Photograph No. 2

View West, area of CS-1 through CS-3.

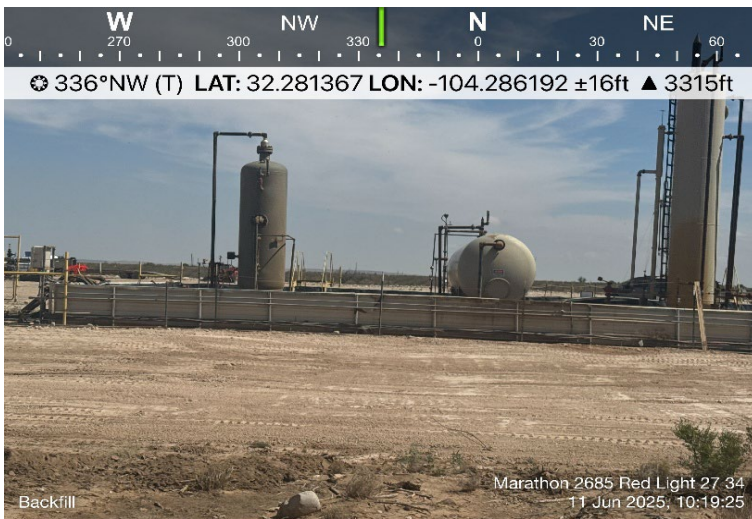
## Photograph No. 3

View Northwest of backfilled area.

Once the remediation activities were completed, the excavated area was backfilled with clean material to surface grade. The material utilized for backfill was sourced locally. The composite pit sample was analyzed for TPH analysis by EPA method 8015 modified, BTEX by EPA Method 8021B, and chloride by EPA method 300.0. Copies of laboratory analysis and chain-of-custody documentation are included in Appendix E.

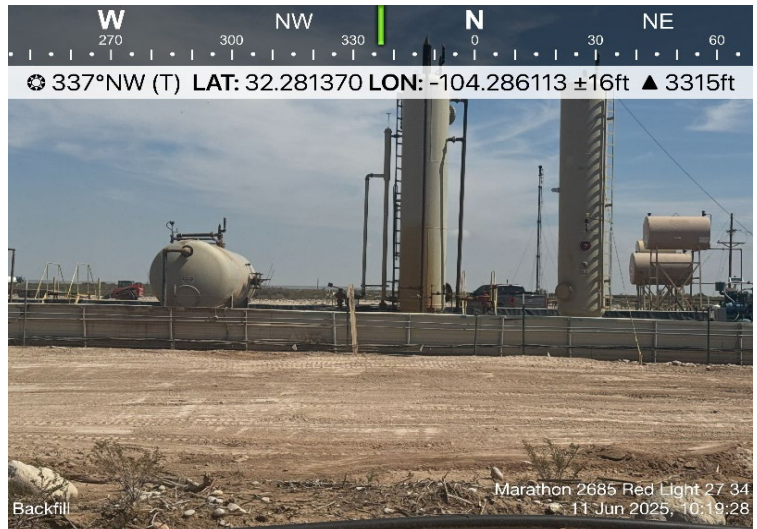
**Description:**  
View Northwest of backfilled area.
