Re: [EXTERNAL] Re: FAE II Operating LLC - STATE A A/C 1 #065. Final Reclamation Report nAPP2327749668 - Denied.

**Subject:** FAE II Operating LLC - STATE A A/C 1 #065. Final Reclamation Report - Denied.

**RE:** 30-025-09394 (Active )/ FAE II Operating LLC; STATE A A/C 1 #065; A009830004/ KERR-MCGEE O/G ONSHORE, LP

**Incident Number:** nAPP2327749668

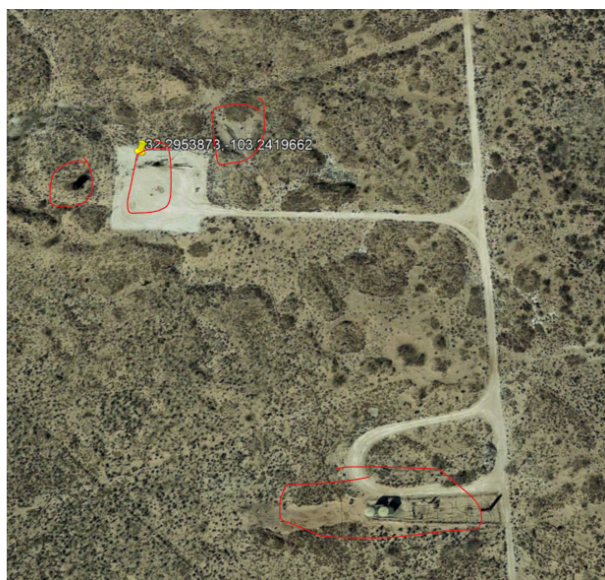
However, ECO has identified areas of concern at State A A/C #1 and the tank battery south of #1. There appears to be an abandoned tank west of the #1 well pad, exposed pipeline east of the #1, and a large unreported spill at the tank battery south of the #1. These all require assessment and remediation under approved workplans and reporting to NMOCD as required by 19.15.29 NMAC
