**RE: Second Quarter 2026 Monitoring and Sampling Report** (Ensolum, June 30, 2026)  
Chaco Plant 3 Phase Separator (7/22/20)  
Enterprise Field Services L.L.C  
P.O Box 4324, Houston TX 77210-4324  
Chaco Plant, San Juan County, NM  
Site Coordinates: N 36.481637, W 108.120470  
Incident Number: NRM2021235744

**Re: Second Quarter 2026 Monitoring and Sampling Report**

Chaco Plant 3 Phase Separator (7/22/20)  
San Juan County, New Mexico  
NMOCD Incident ID No. NRM2021235744

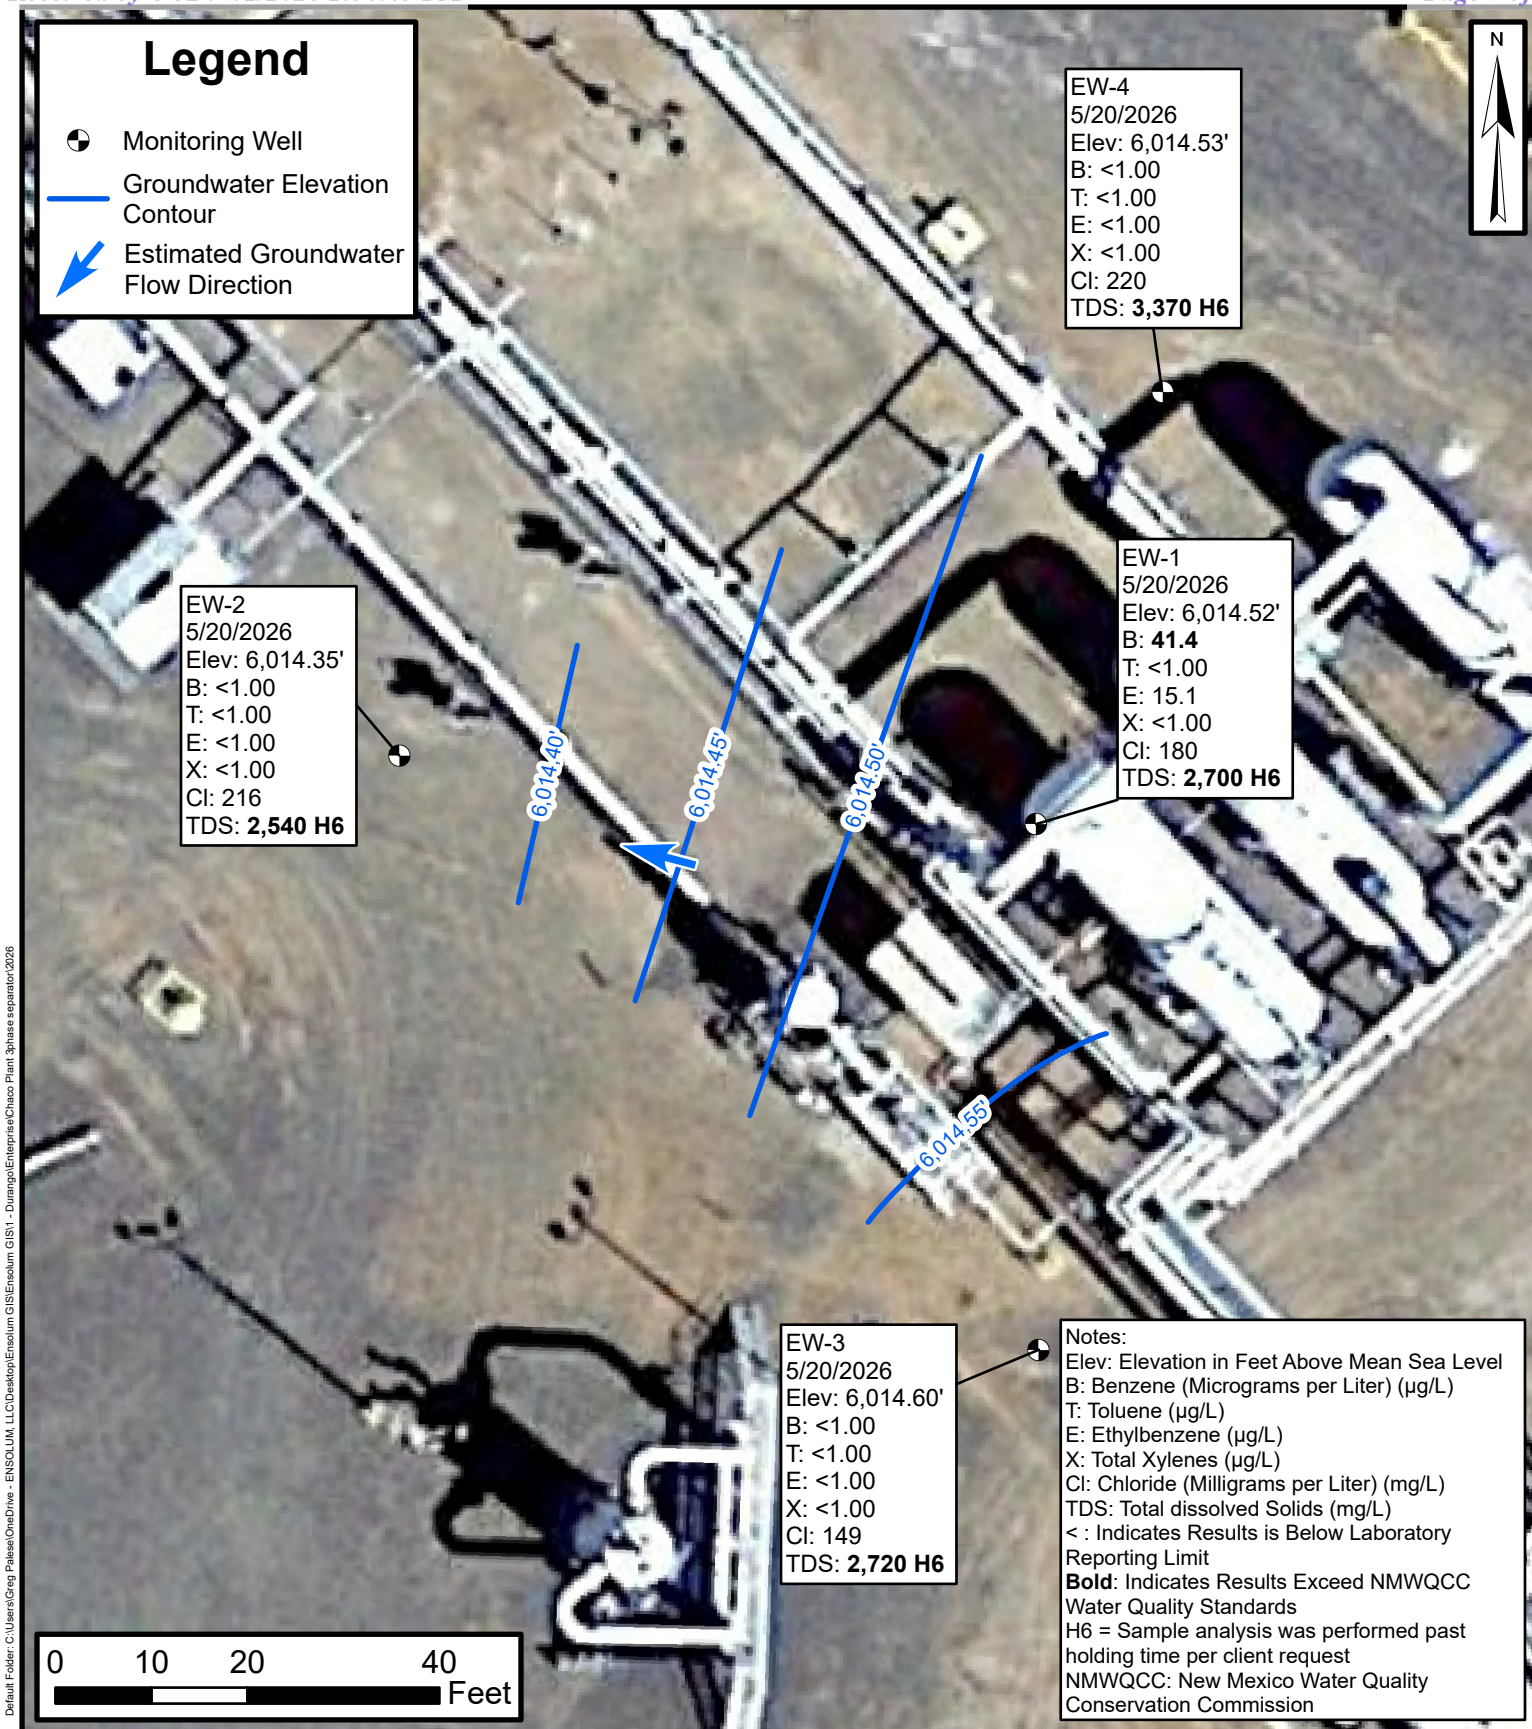
**FIGURE  
3**

Measured depths to groundwater and calculated groundwater elevations are summarized in **Table 1**. A groundwater elevation map constructed from these data (**Figure 2**) indicated a groundwater flow direction generally to the west, as interpreted from groundwater elevation contours, which is consistent with historical events. The calculated hydraulic gradient was approximately 0.002 feet per foot (ft/ft) during the second quarter 2026 monitoring event.

### Groundwater Elevation and Analytical Results (May 2026)

Analytical results are summarized in **Table 2 and Table 3** and are depicted on **Figure 2**, with complete laboratory analytical reports provided in **Appendix A**.
