**Hobbs Water Station Injection Line**

**nAPP2613655309**

**Remediation Closure Request**

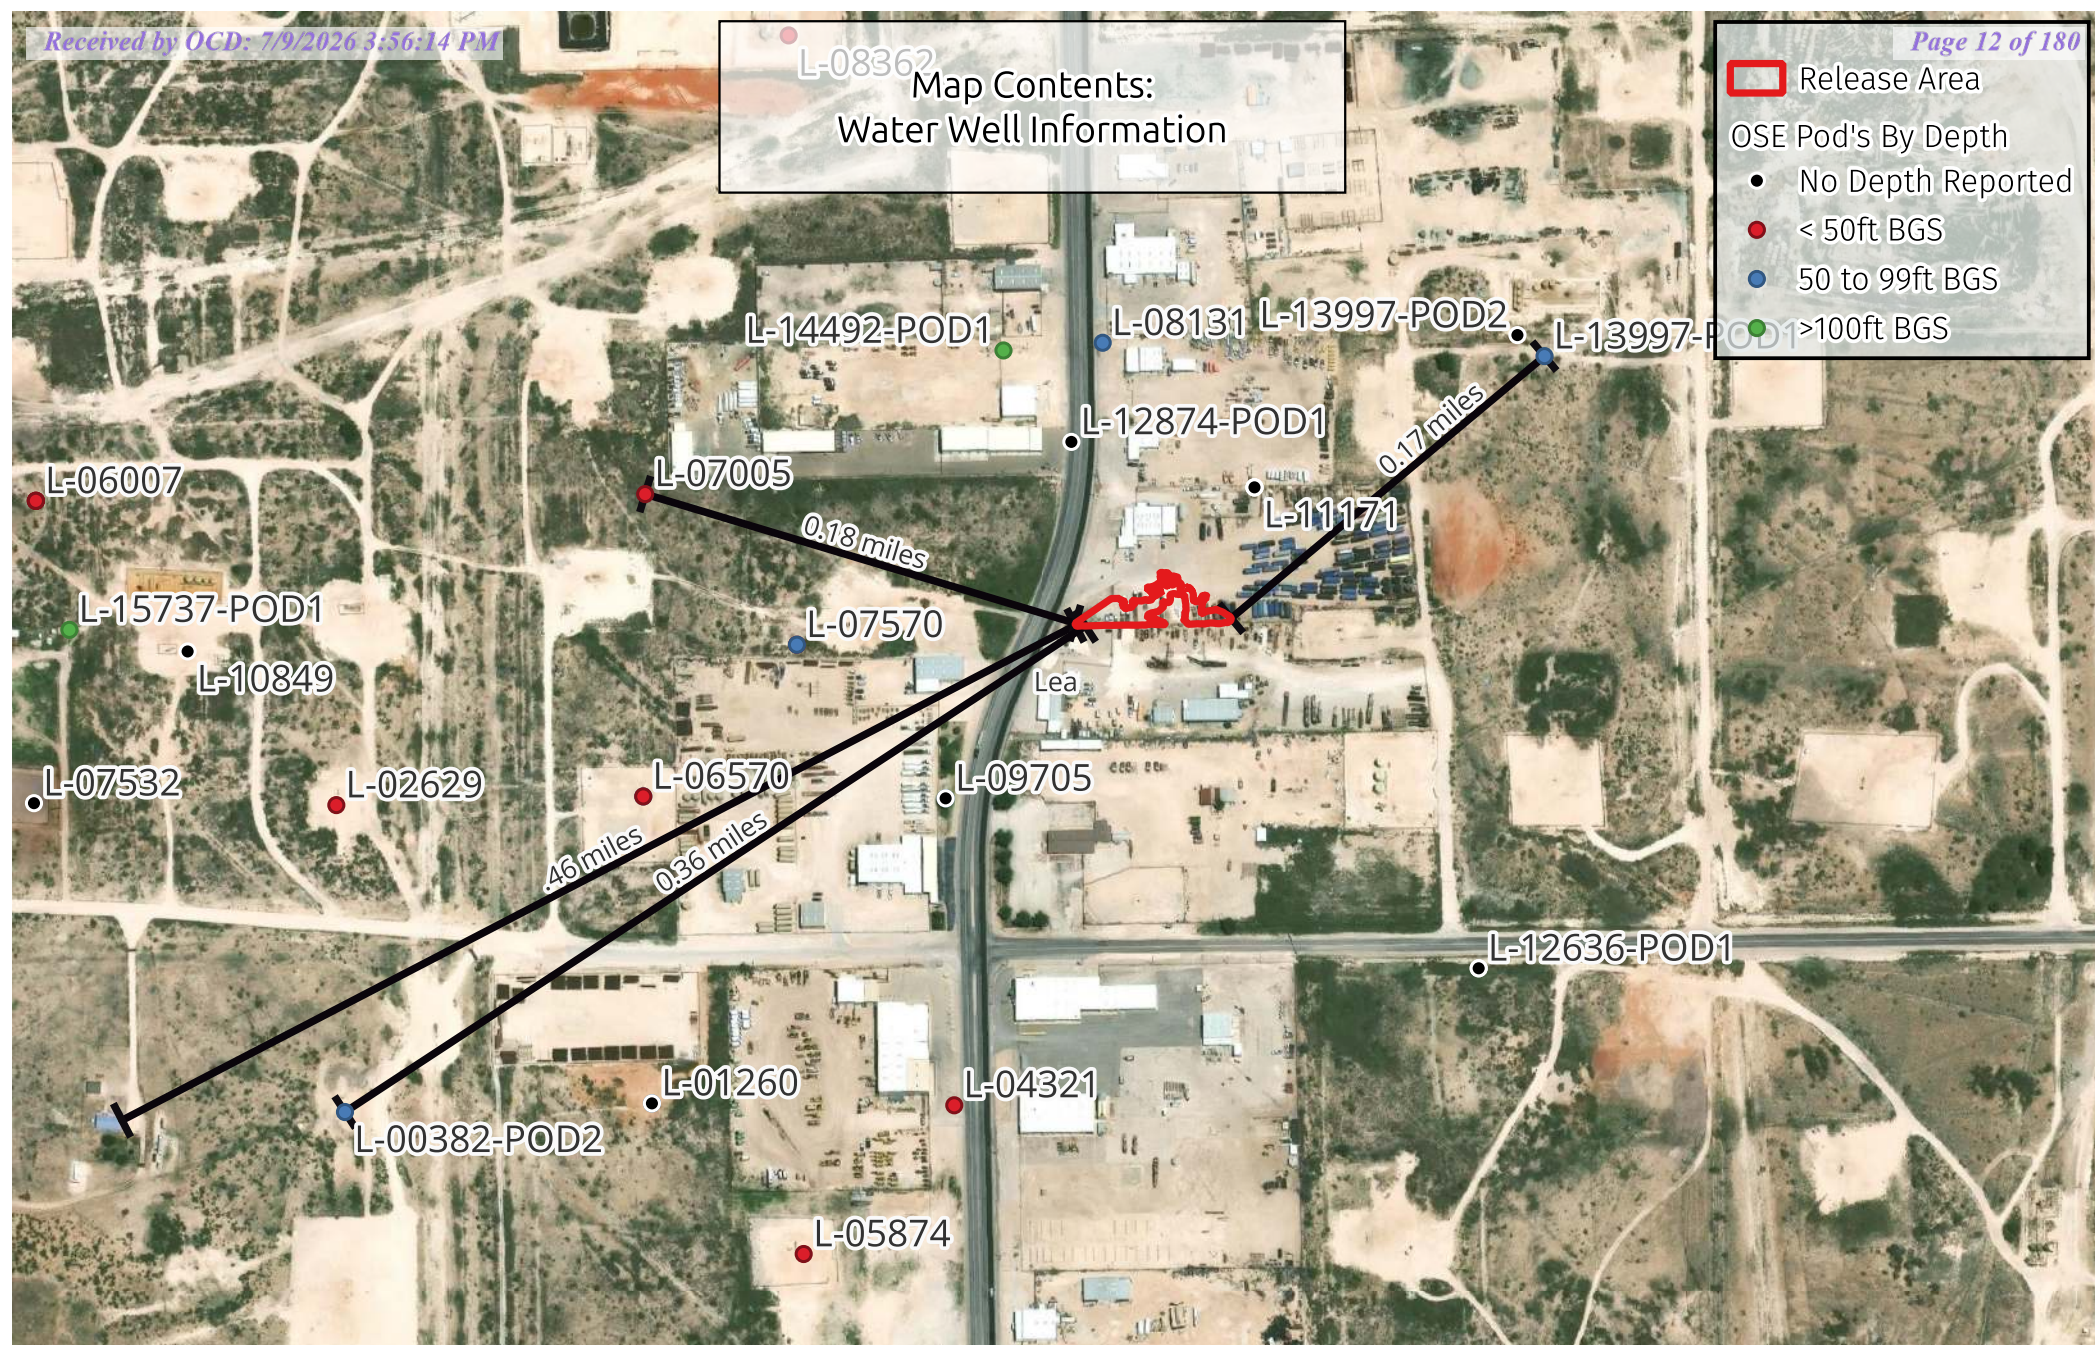
Map Contents:  
Water Well Information

- Release Area
- OSE Pod's By Depth
- No Depth Reported
  - < 50ft BGS
  - 50 to 99ft BGS
  - >100ft BGS

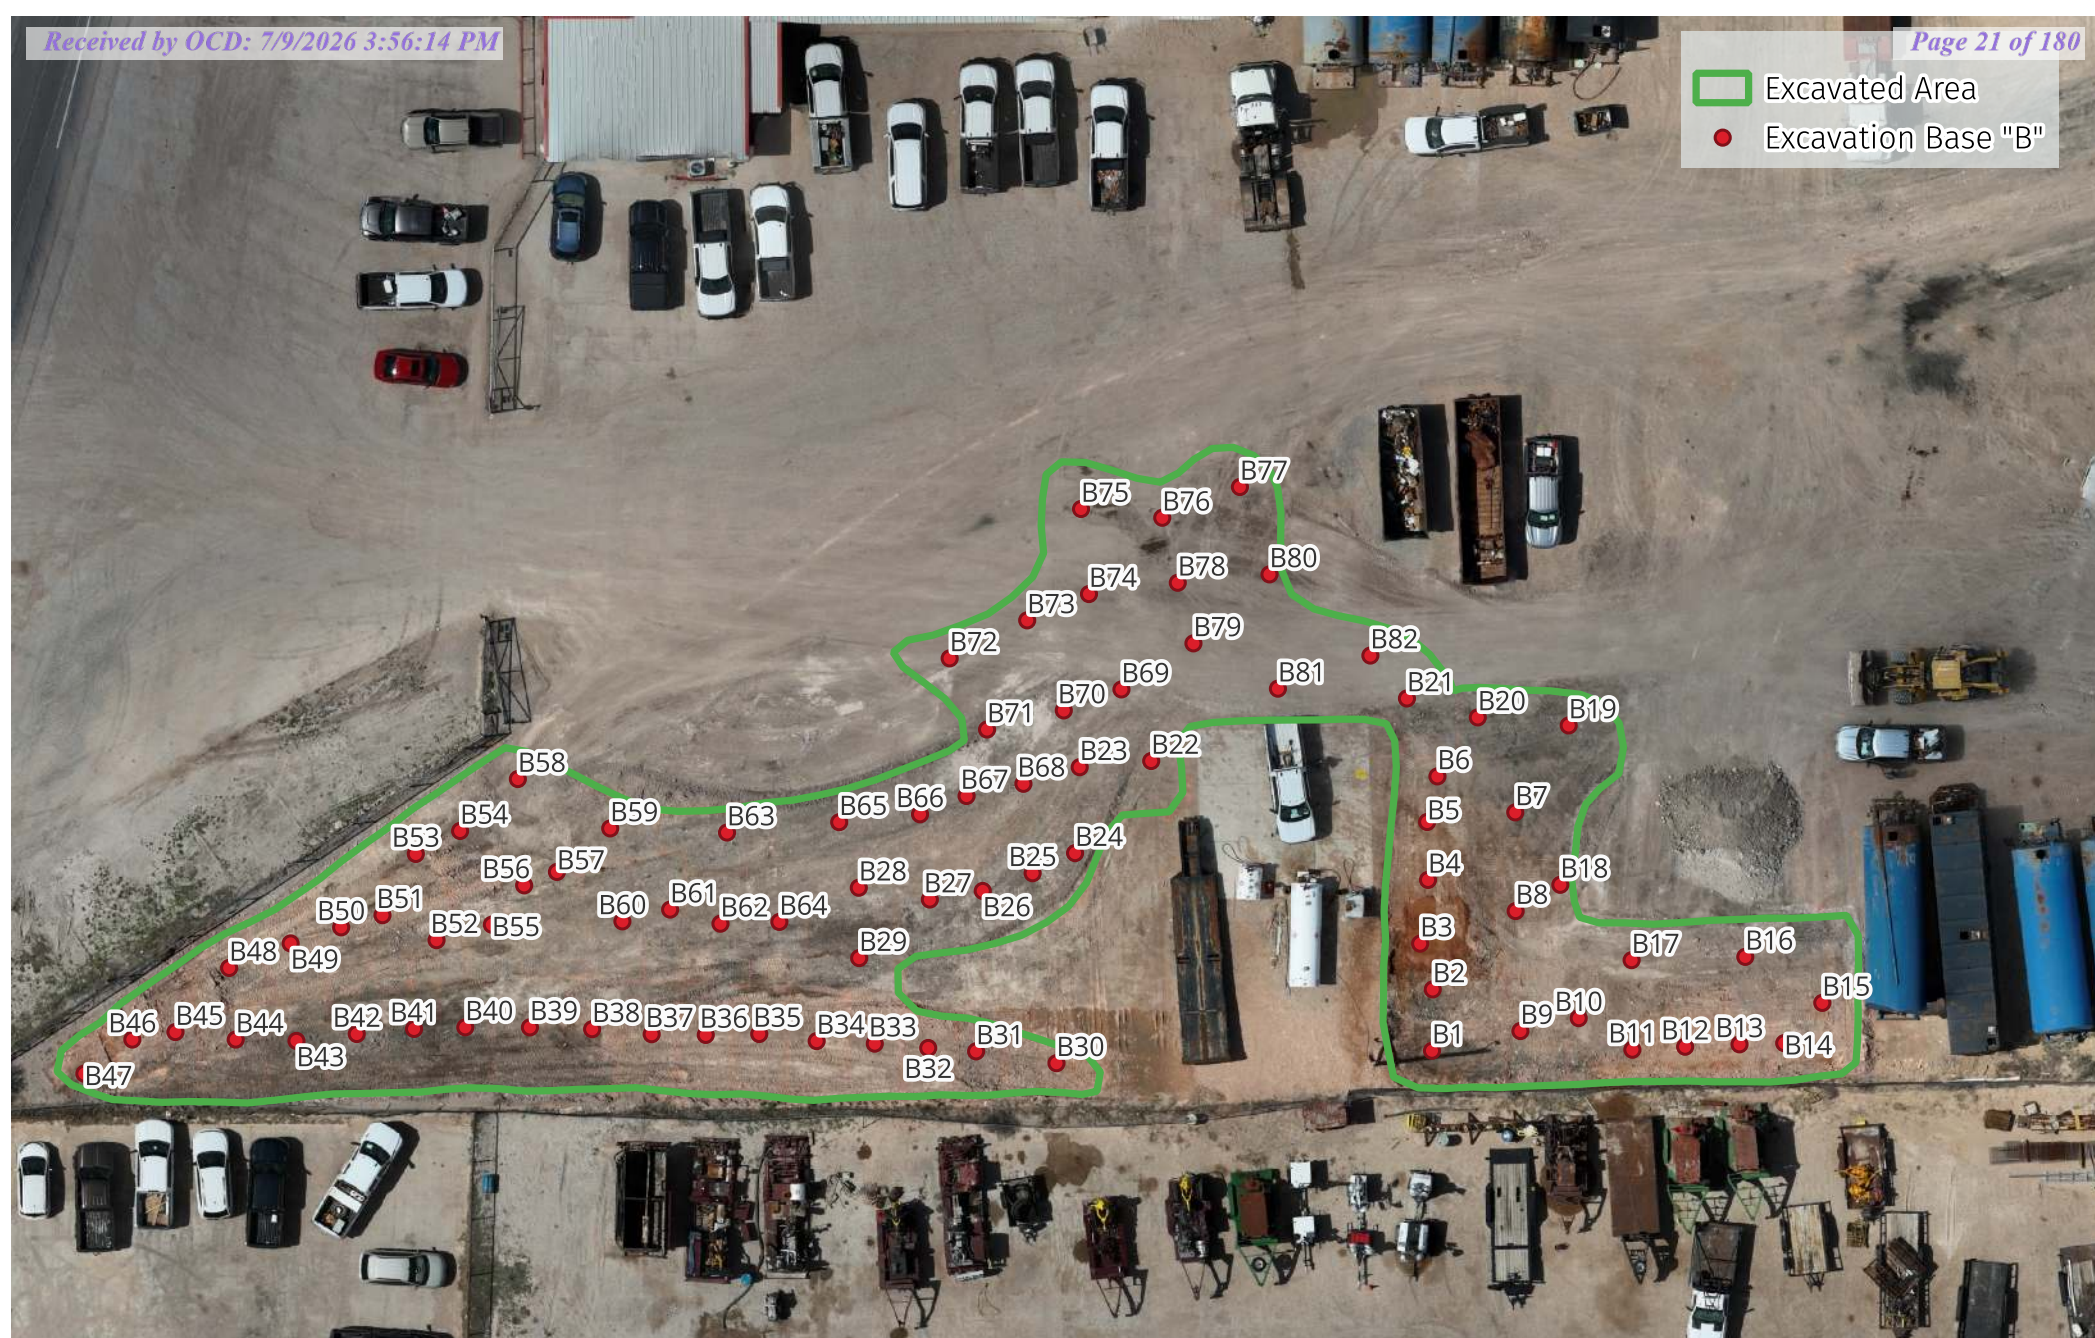
The highlighted samples exceeded the applicable RRALs. These areas have since been excavated and resampled.

- Excavated Area
- Excavation Base "B"

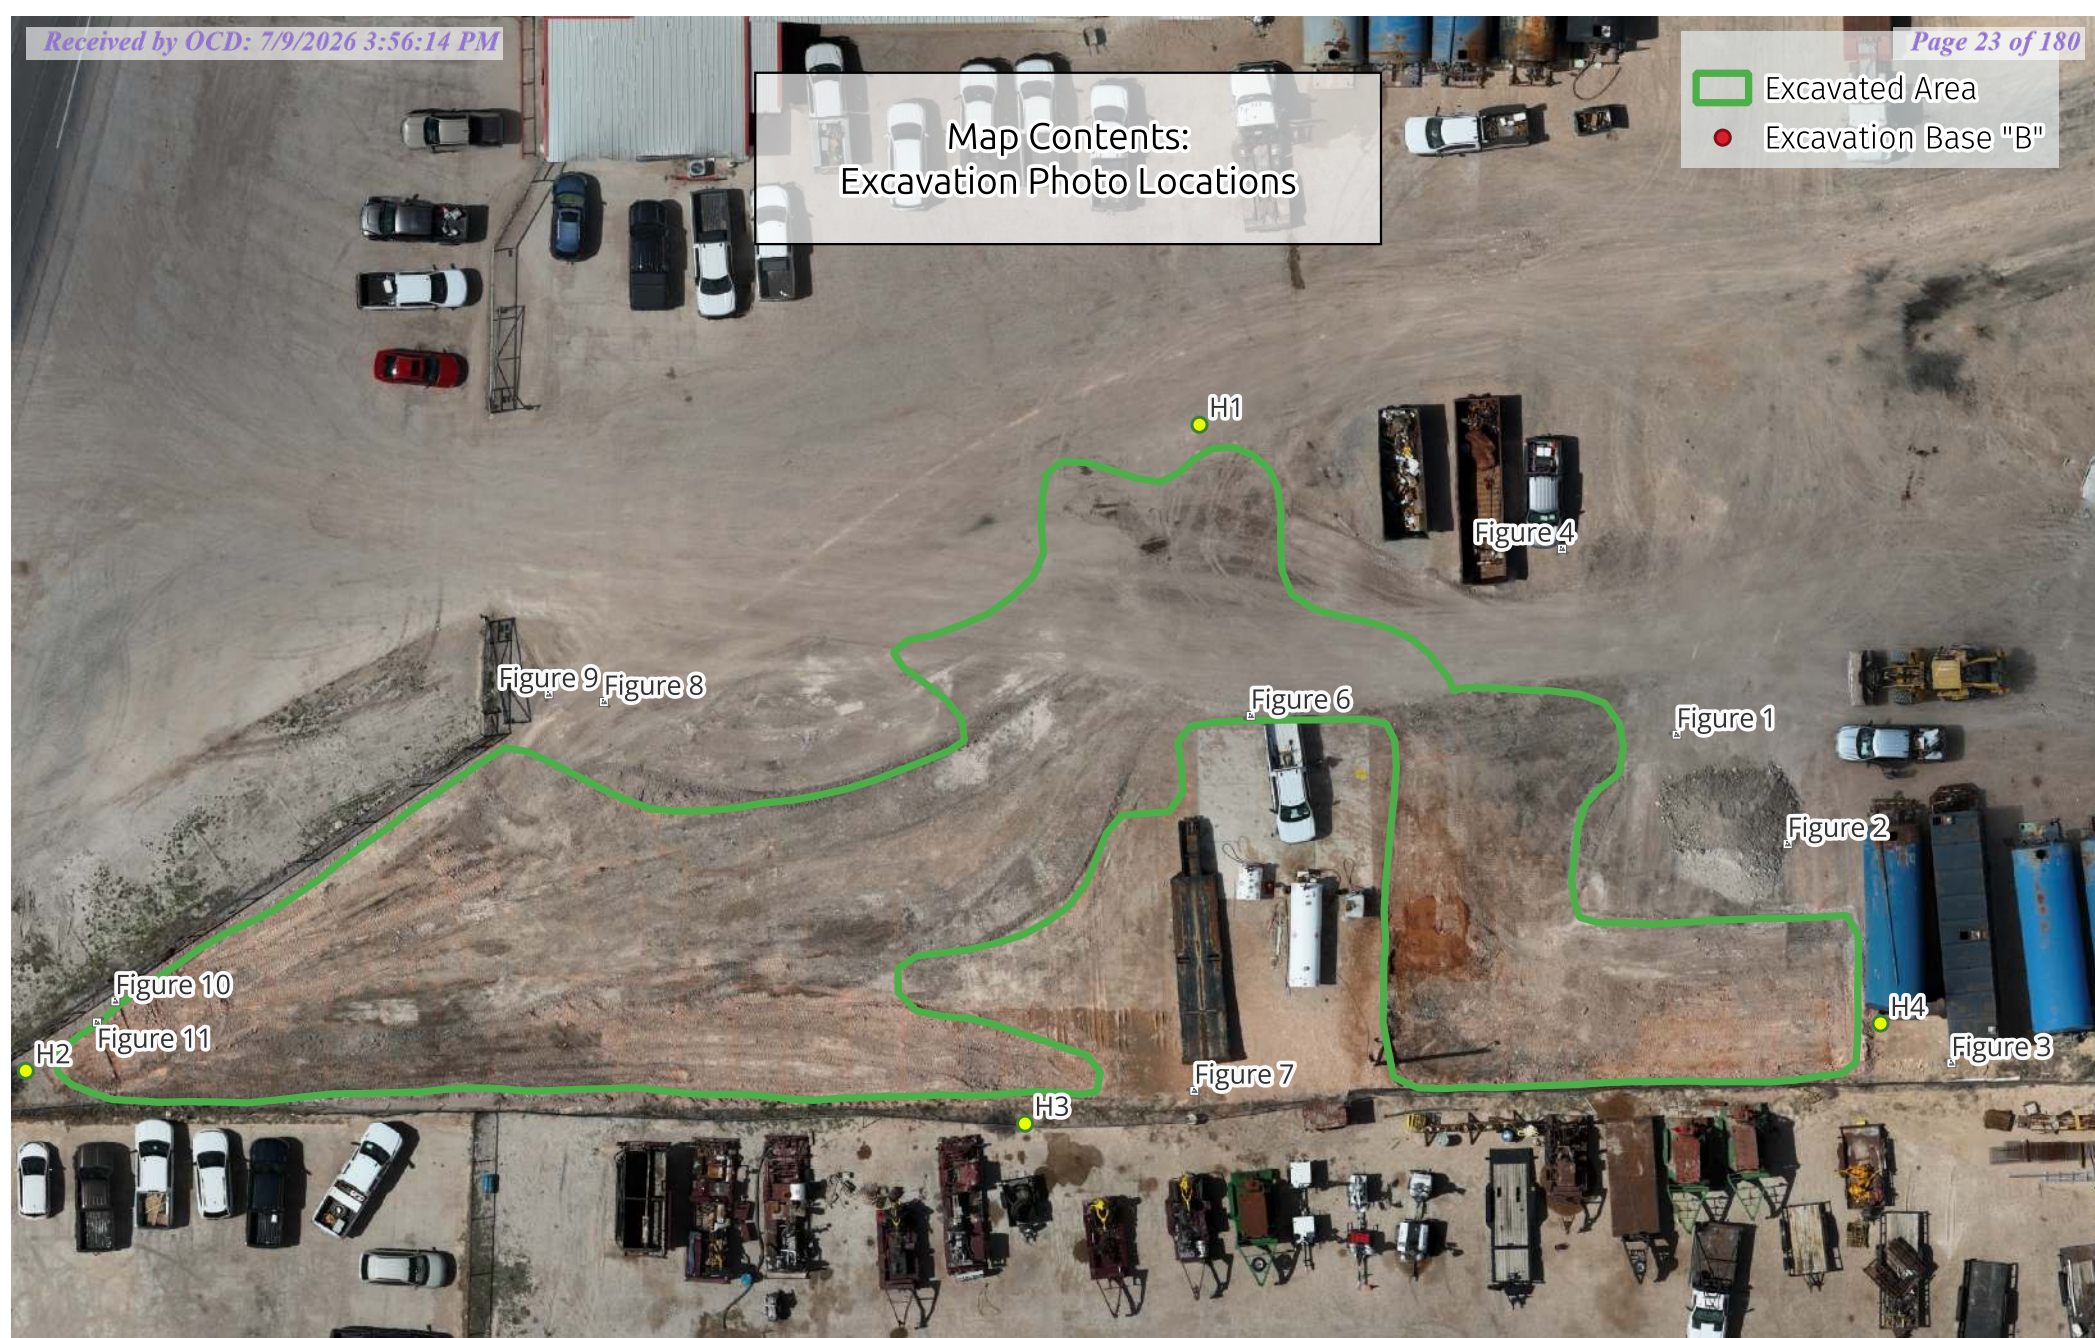
Map Contents:  
Excavation Photo Locations

- Excavated Area
- Excavation Base "B"

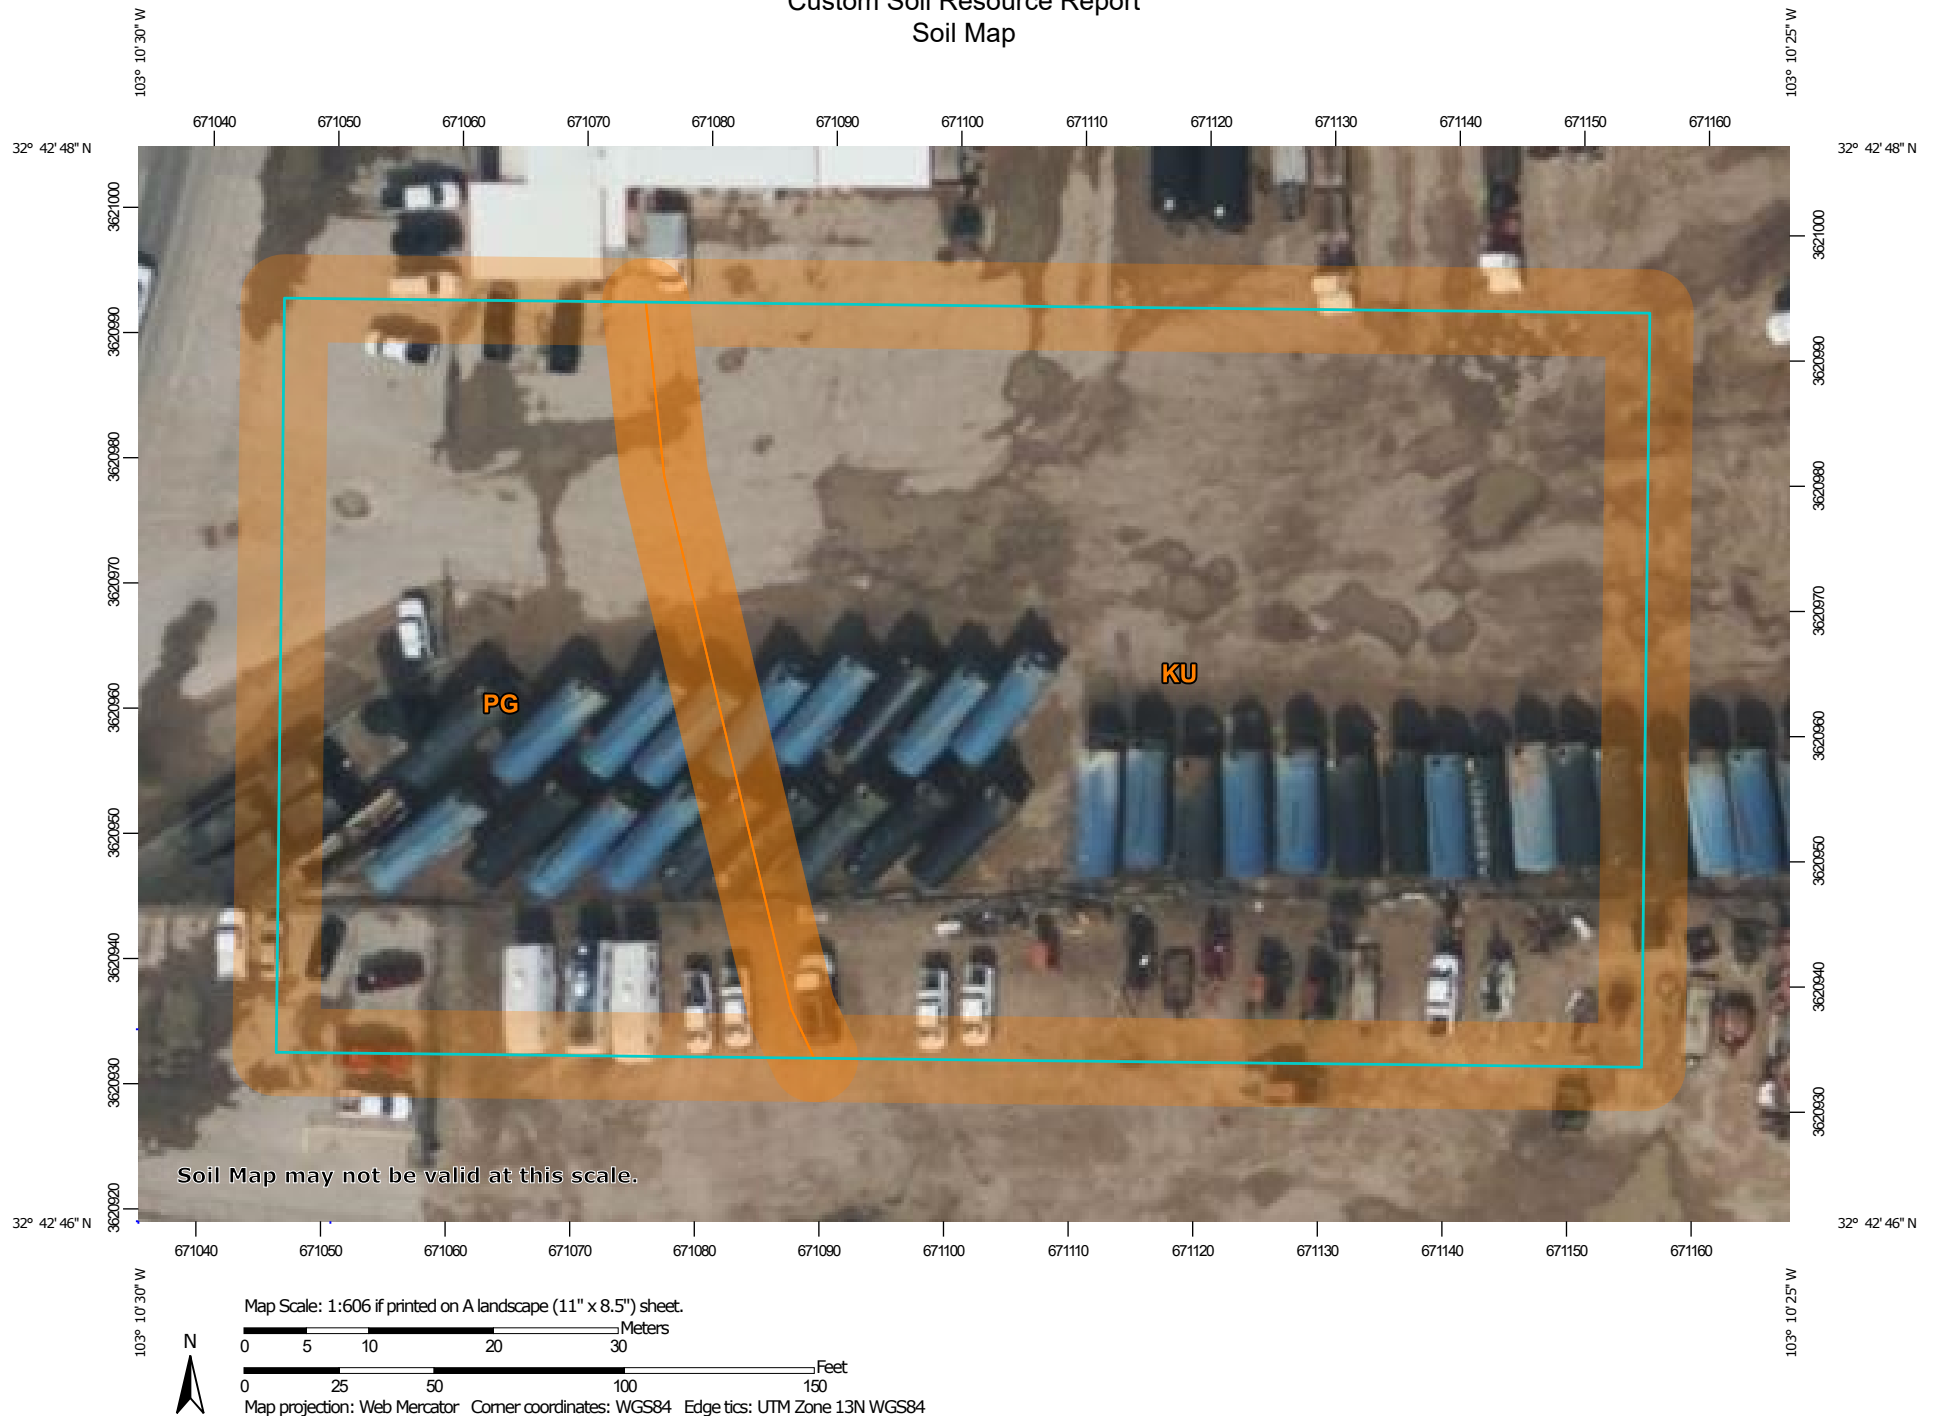
Custom Soil Resource Report  
Soil Map

The soil map section includes the soil map for the defined area of interest, a list of soil map units on the map and extent of each map unit, and cartographic symbols displayed on the map. Also presented are various metadata about data used to produce the map, and a description of each soil map unit.
