**C-141 - CO2 GAS RELEASE ONLY (No Liquids)**  
**EVENT SUMMARY, VARIANCE REQUEST & CLOSURE REQUEST REPORT**

**Facility ID:** fKJ1518128159

Incident  
nAPP2621139354

**Facility Name:** NORTH HOBBS NIB

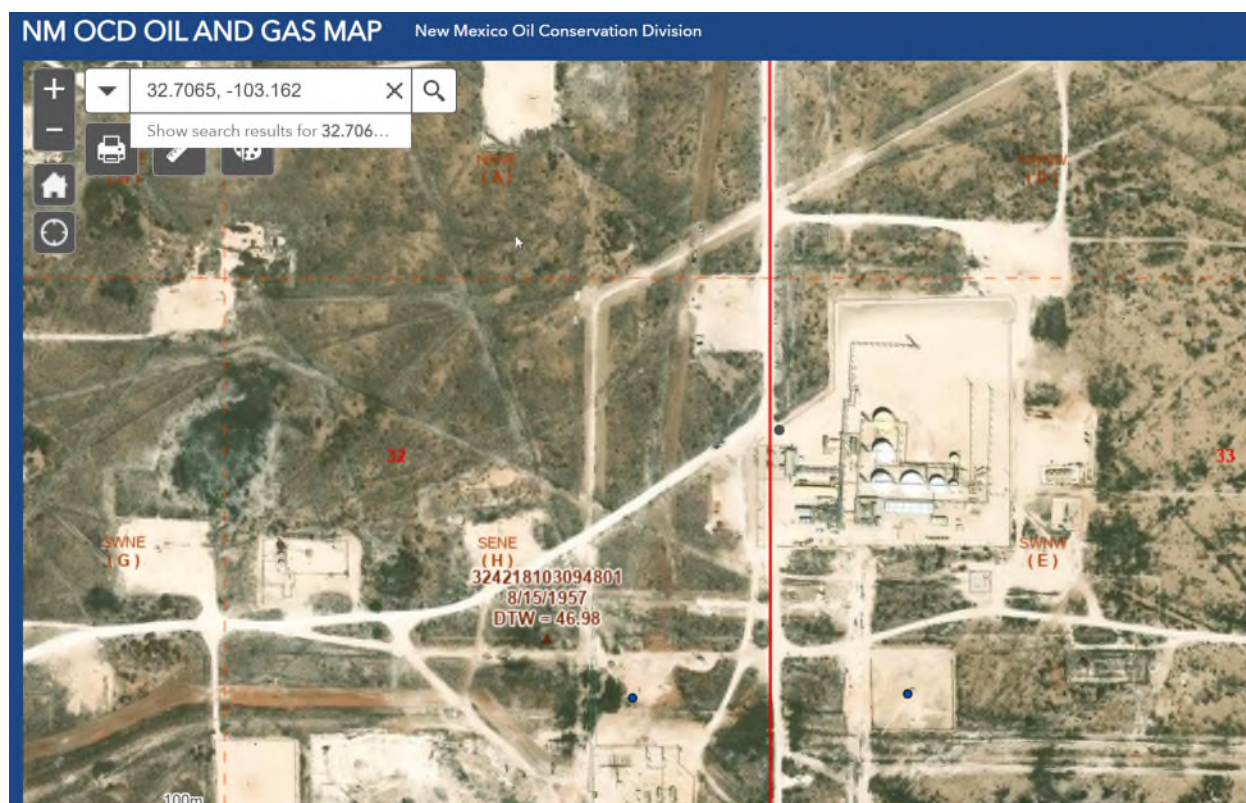
Depth to water: 26-50 feet, USGS
