RE: Groundwater Statement Response and Proposed Groundwater and Background Chloride Investigation  
WPX Energy Permian, LLC  
North Brushy PW Line  
Incident Numbers nAPP2231126594 & nAPP2312845934  
Eddy County, New Mexico

Etech Environmental & Safety Solutions, Inc. (Etech), on behalf of WPX Energy Permian, LLC (WPX Energy), submits this Groundwater Statement Response and Proposed Groundwater and Background Chloride Investigation for two inadvertent releases of produced water at the North Brushy PW Line (Site). The investigation is proposed in response to the New Mexico Oil Conservation Division's (NMOCD's) conditional approval of the Remediation Work Plan (RWP). The RWP and supporting findings can be referenced under submission ID [333444](#).

# **2D Electrical Resistivity Imaging Report North Brushy PW Line Spill Eddy County, New Mexico**

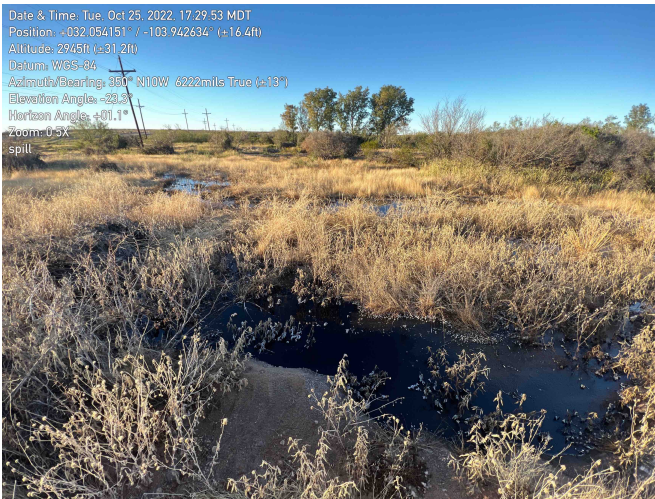
**Photograph 1****Date: 10/25/2022**

Description: Northwestern view during initial spill response activities of Incident nAPP2231126594.

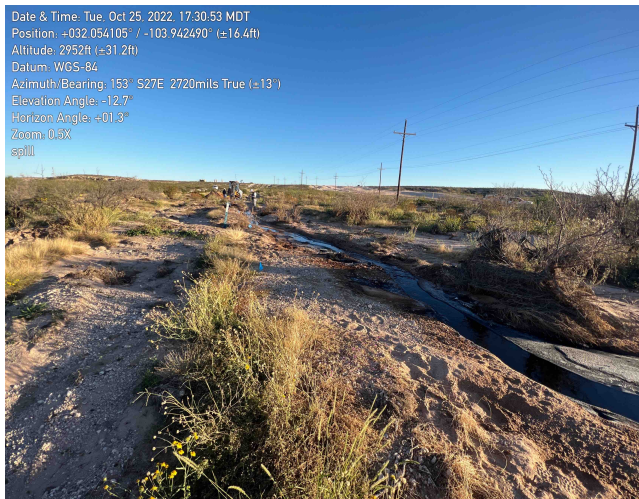
**Photograph 2****Date: 10/25/2022**

Description: Southeastern view during initial spill response activities of Incident nAPP2231126594.

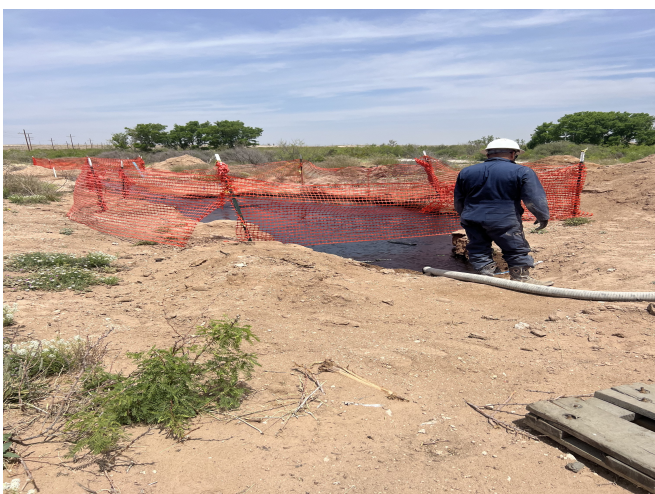
**Photograph 3****Date: 05/03/2023**

Description: Northwestern view during initial spill response activities of Incident nAPP2312845934.

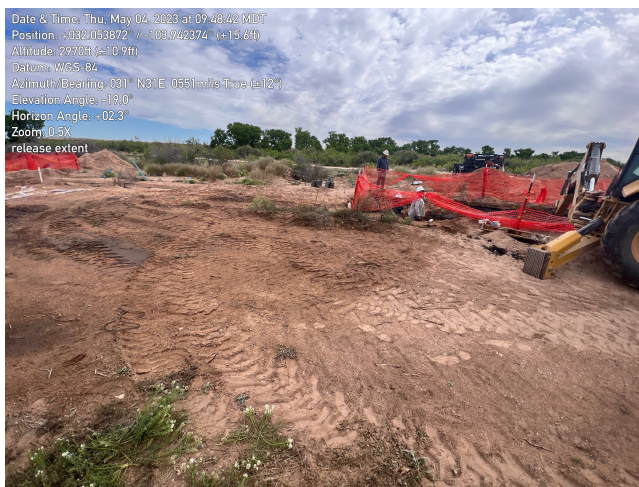
**Photograph 4****Date: 05/04/2023**

Description: Northwestern view during initial spill response activities of Incident nAPP2312845934..

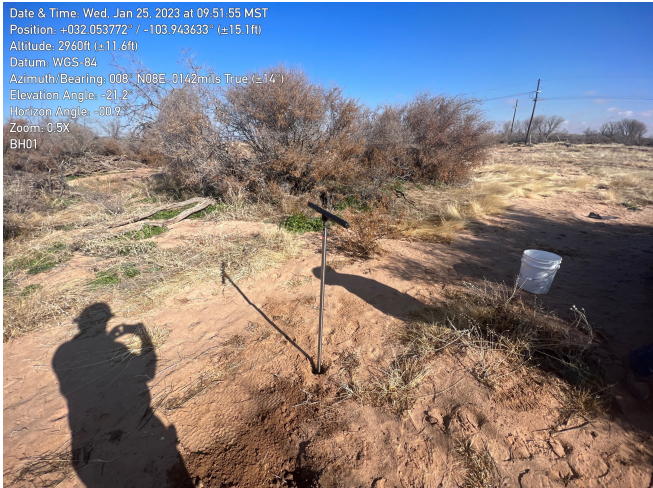
**Photograph 1****Date: 01/25/2023**

Description: Southwester view during delineation activities of BH01..

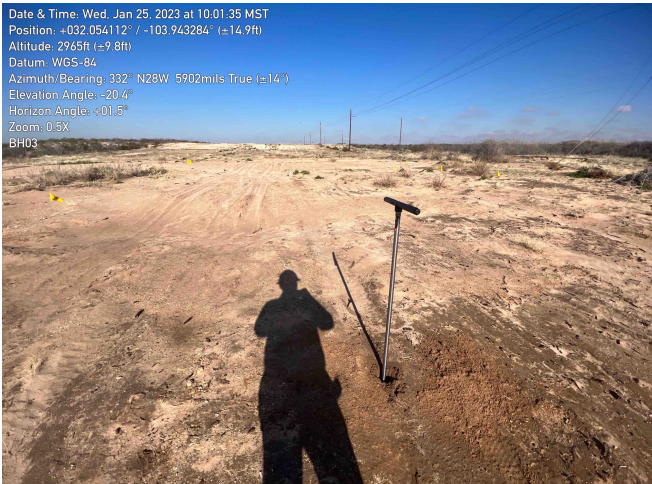
**Photograph 2****Date: 01/25/2023**

Description: Northwestern view during delineation activities of BH03.

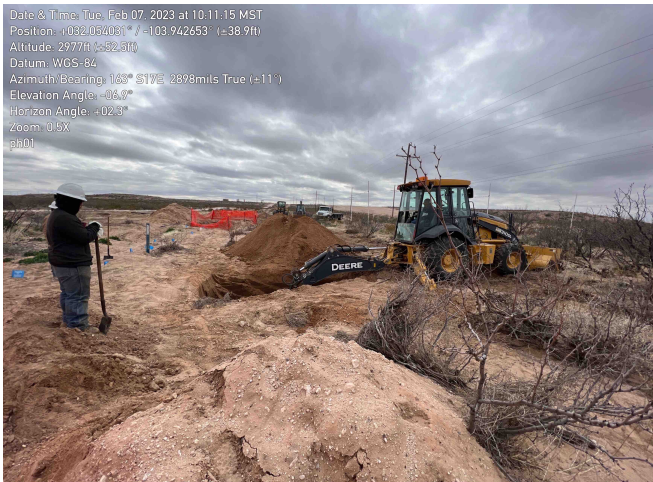
**Photograph 3****Date: 02/07/2023**

Description: Southeastern view during delineation activities of PH01..

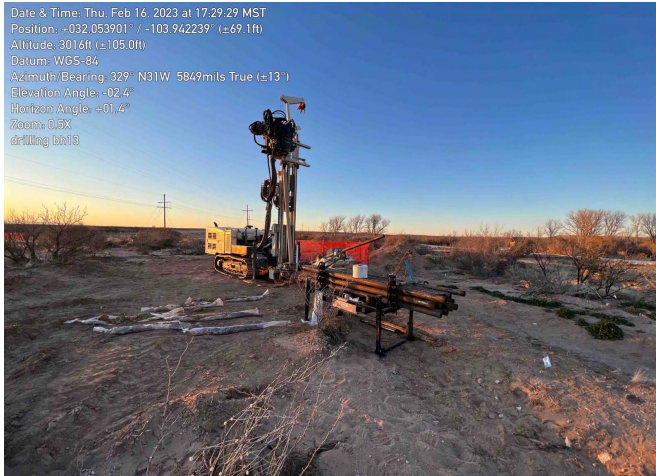
**Photograph 9****Date: 02/16/2023**

Description: Northwestern view during delineation activities of BH01..

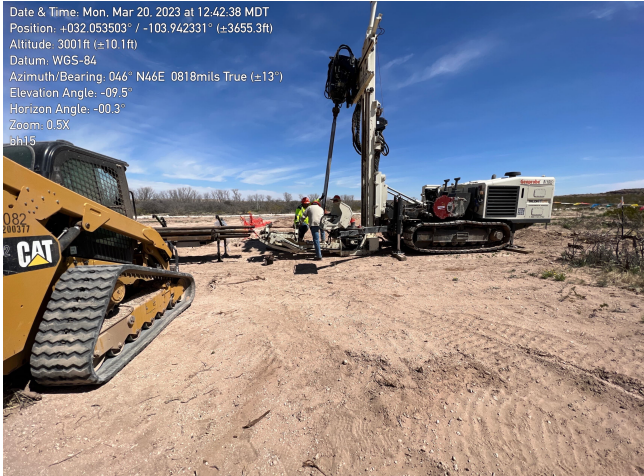
**Photograph 10****Date: 03/20/2023**

Description: Northeastern view during delineation activities of BH15.

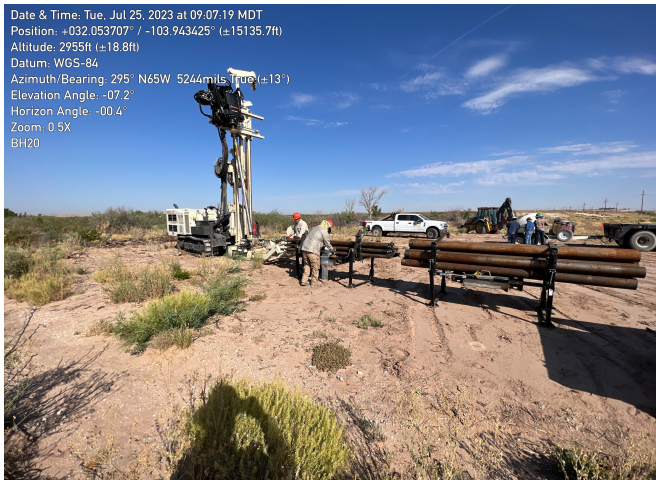
**Photograph 11****Date: 07/25/2023**

Description: Southeastern view during drilling activities of BH20.

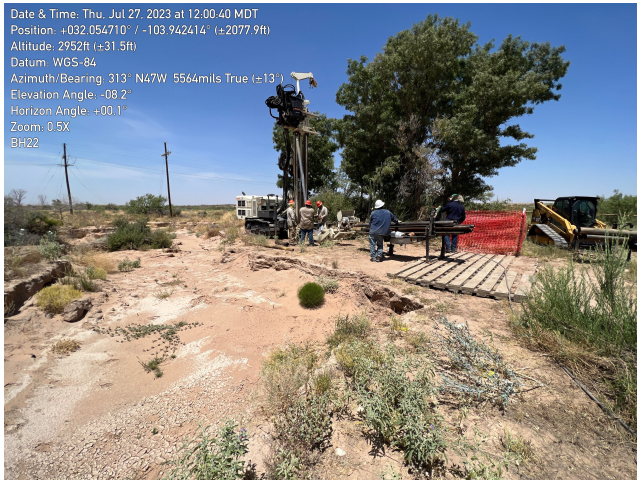
**Photograph 12****Date: 07/27/2023**

Description: Southeastern view during drilling activities of BH22..

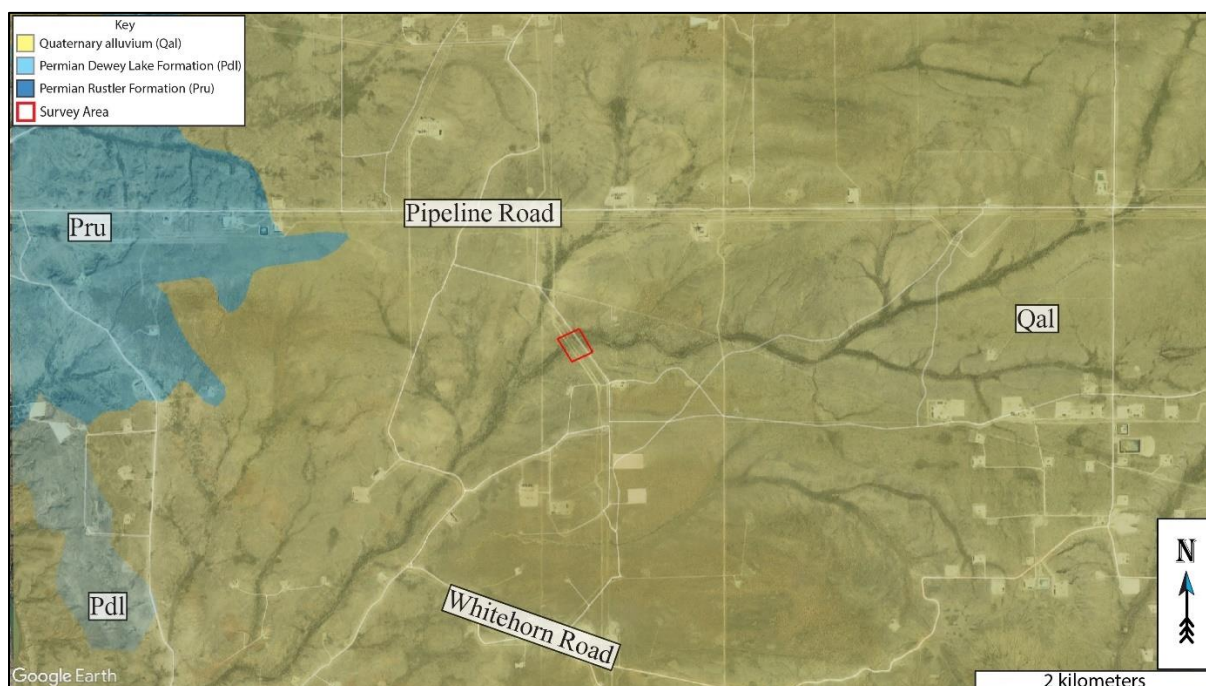
The Dewey Lake Formation is composed of calcite-cemented, hematite-stained quartz sand grains<sup>[8]</sup> and occasional gypsum lenses and can, in favorable conditions, form cavernous porosity within 30 meters of the top of the Rustler<sup>[9]</sup>. The Dewey Lake Formation is also known to be highly fractured near areas of heavy halite dissolution such as Nash Draw (approximately 30 kilometers north), and these fractures can act as hydrologic conduits.

**Figure 3: Geology overview.** Geology map credit: The Digital Geologic Map of New Mexico in ARC/INFO Format<sup>[10]</sup>. Background image credit: Google Earth. Image date: December 21, 2019. Image datum: WGS-84.
