Pit, Below-Grade Tank, or
Proposed Alternative Method Permit or Closure Plan Application

**Hilcorp Energy Company  
San Juan Basin  
Below Grade Tank Closure Report**

**Lease Name: San Juan 32-8 Unit 10**

**API No.: 30-045-10562**

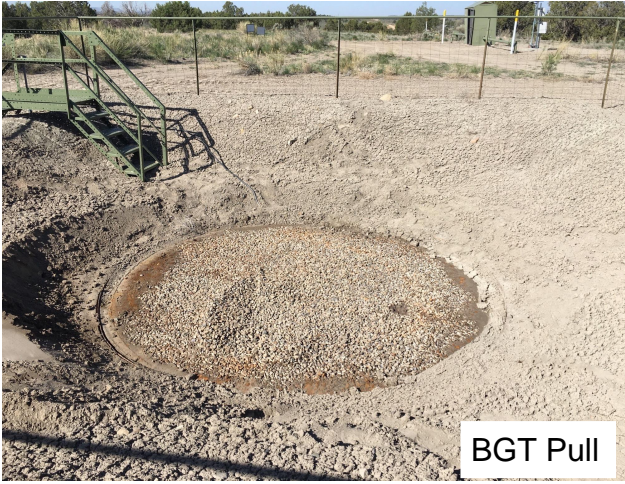
BGT Pull

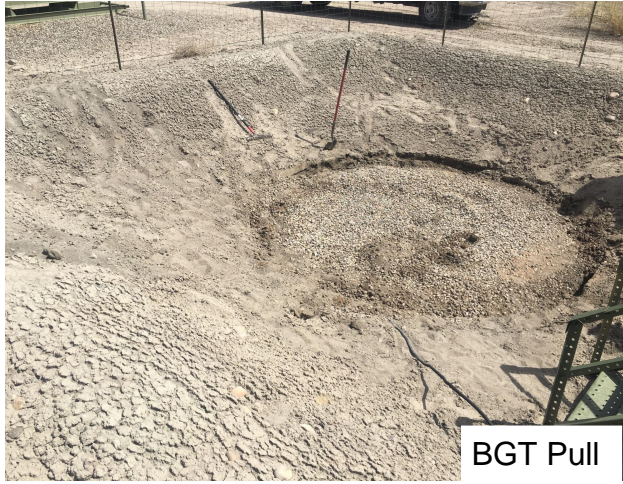
BGT Pull

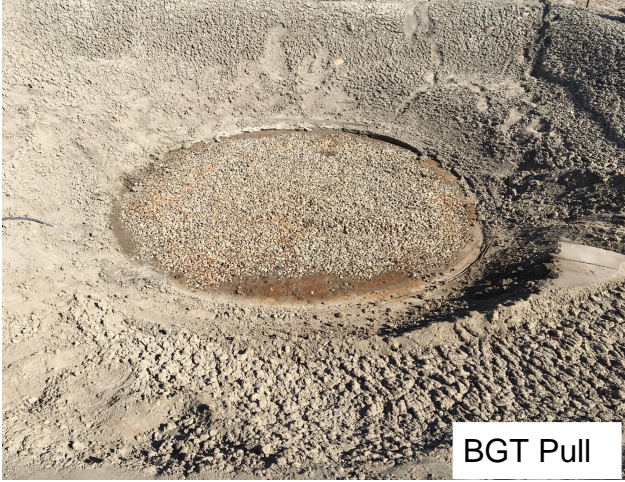
BGT Pull

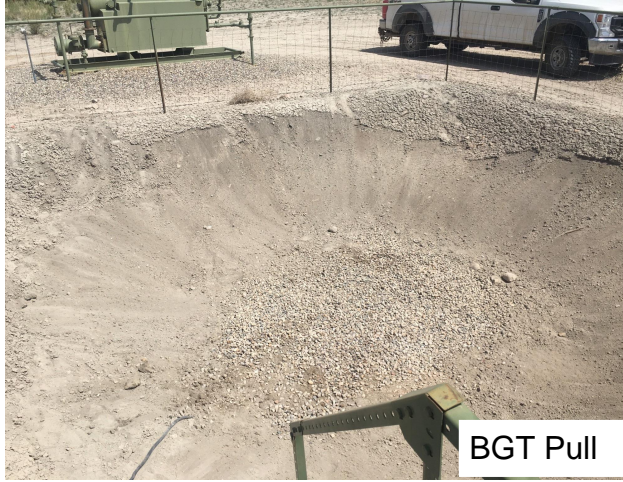
BGT Pull

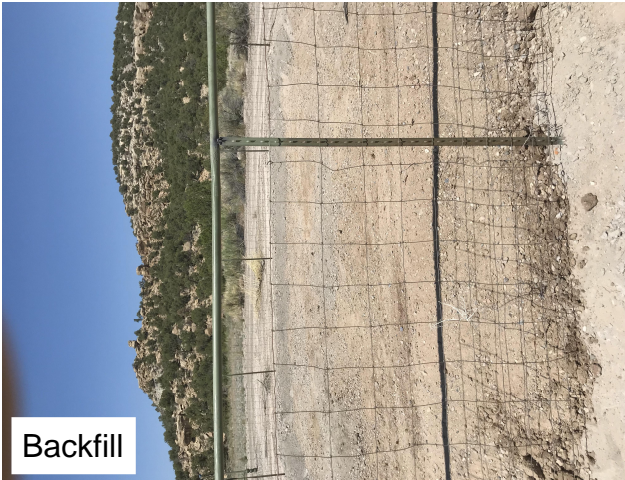
Backfill

**The below-grade tank area passed all requirements of Paragraph (4) of Subsection E of 19.15.17.13 NMAC and was backfilled with compacted, non-waste containing, earthen material.**

**The below-grade tank area was backfilled and more than four feet of cover was achieved and the cover included one foot of suitable material to establish vegetation at the site.**

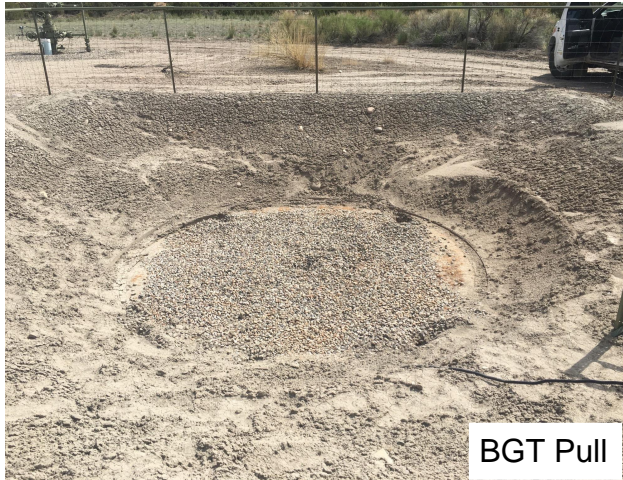
BGT Pull
