**Pit, Closed-Loop System, Below-Grade Tank, or
Proposed Alternative Method Permit or Closure Plan Application**

Cole GC B001 - Tank ID: B
API #: 3004508205
Unit Letter O, Section 15,
T29N, R9W

BP AMERICA PRODUCTION COMPANY
SAN JUAN BASIN, NORTHWEST NEW MEXICO

BELOW-GRADE TANK CLOSURE PLAN

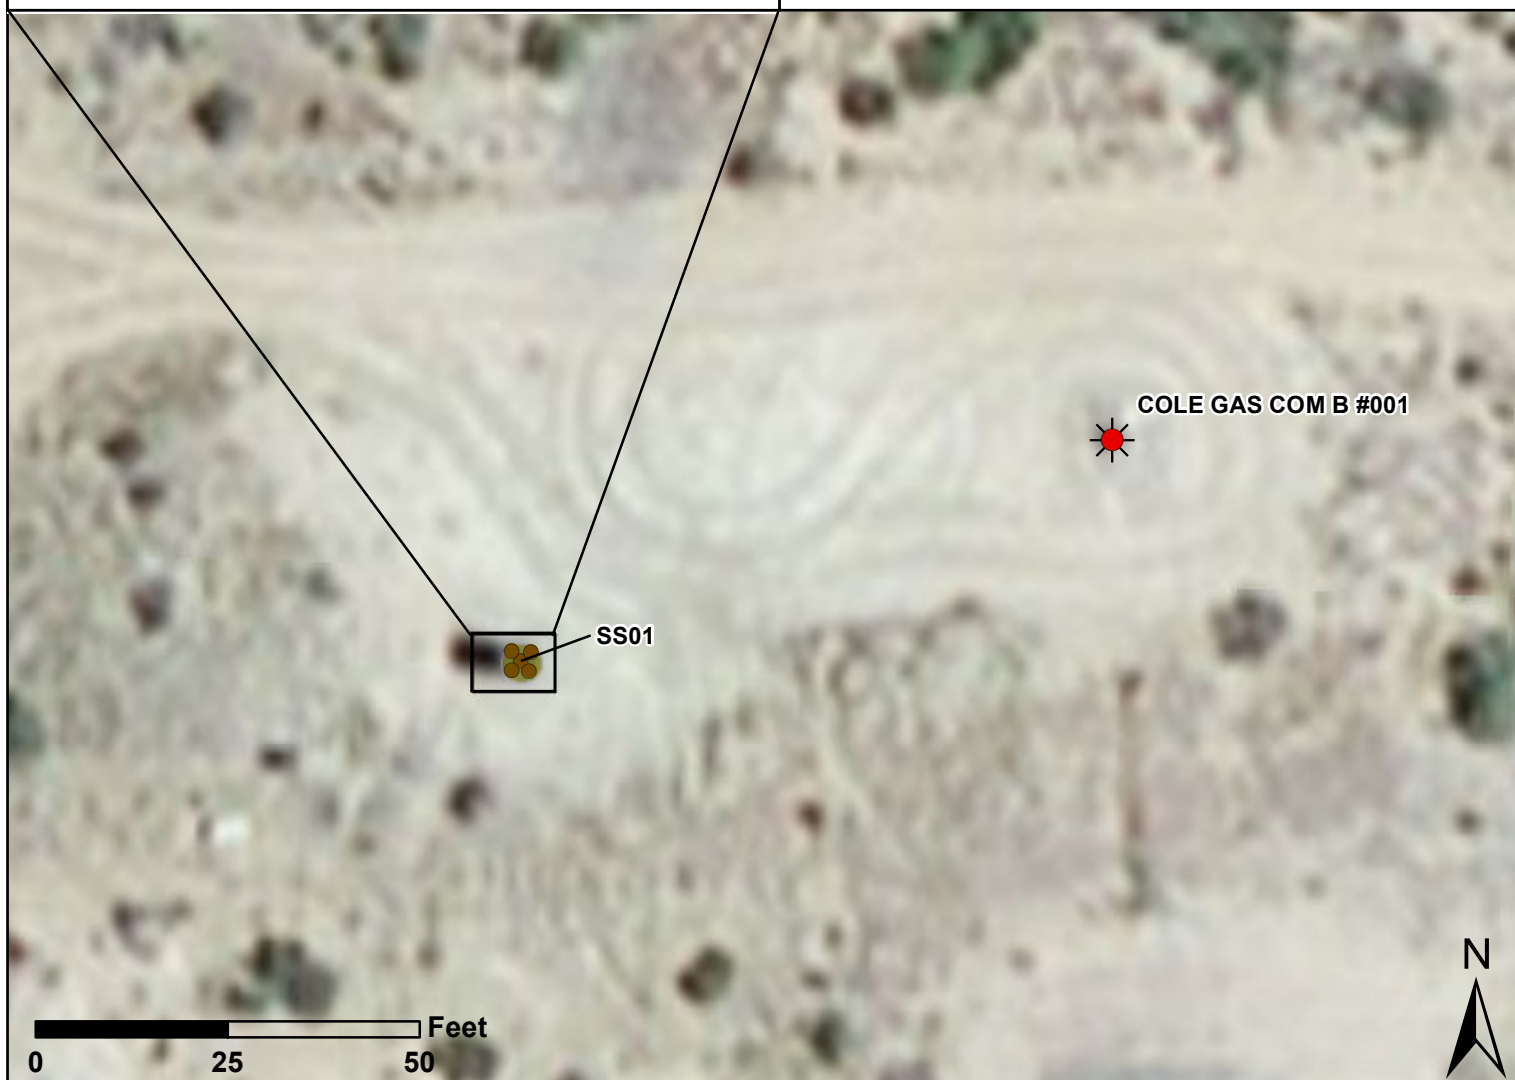
Notes: Sample collected 9/30/2021. SS01 is a five-point composite sample.

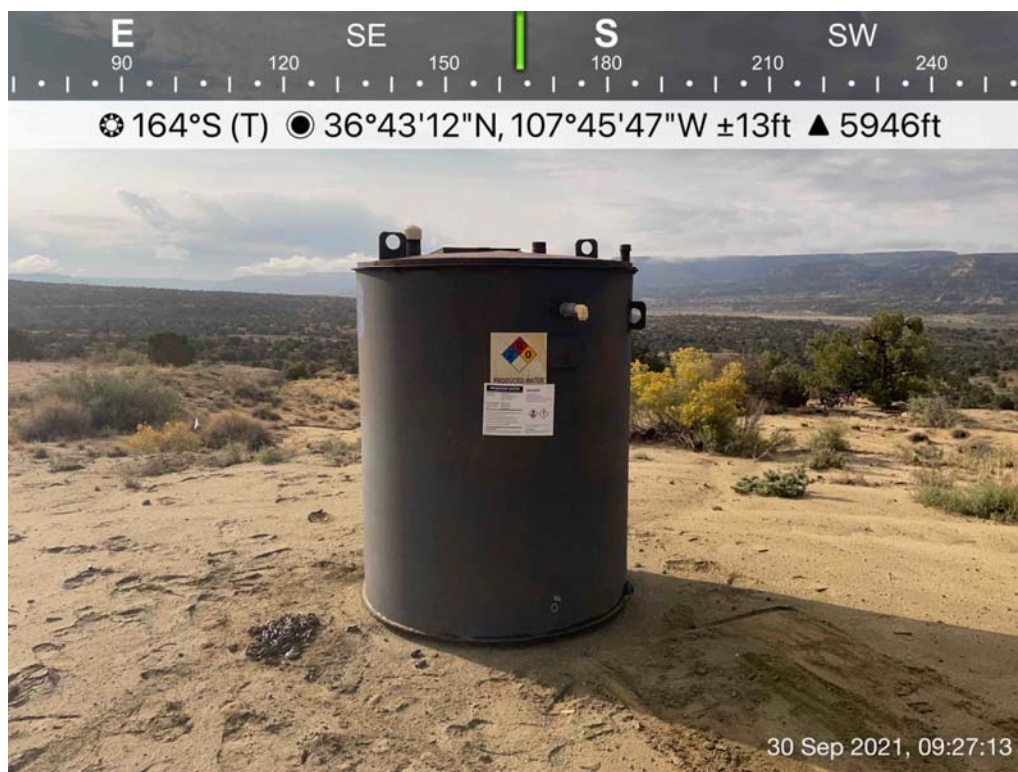
Photo 2: 21 bbls steel tank "B" prior to removal, 9/30/21.

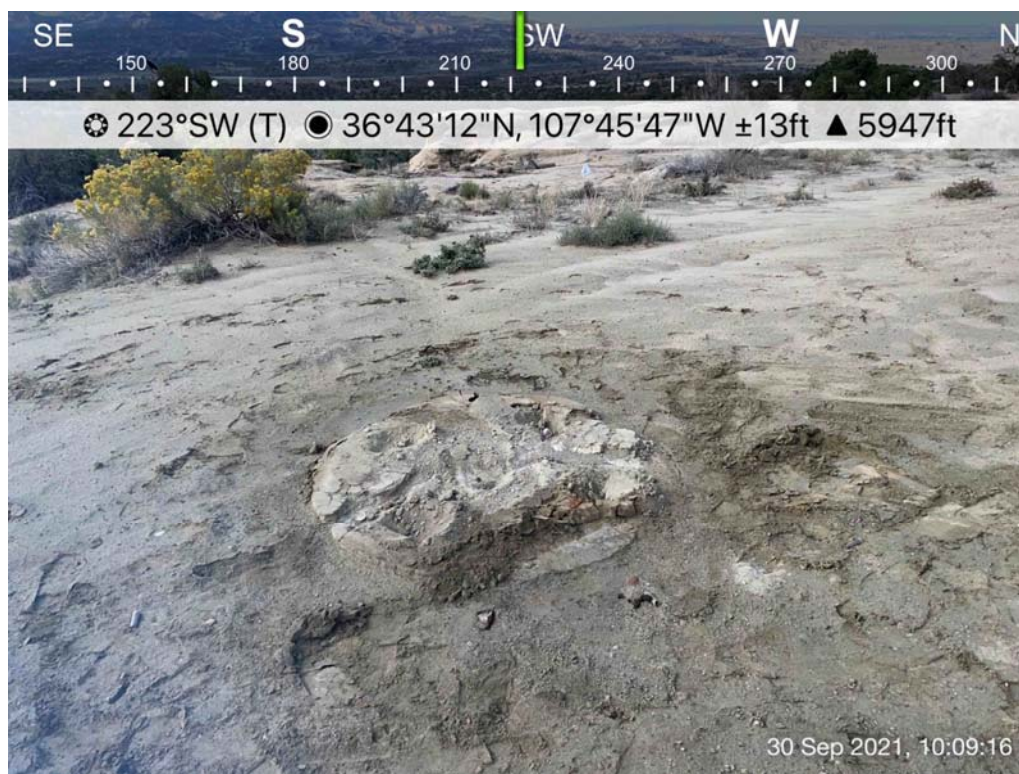
Photo 3: Former location of 21 bbls steel tank "B" following removal, 9/30/21.

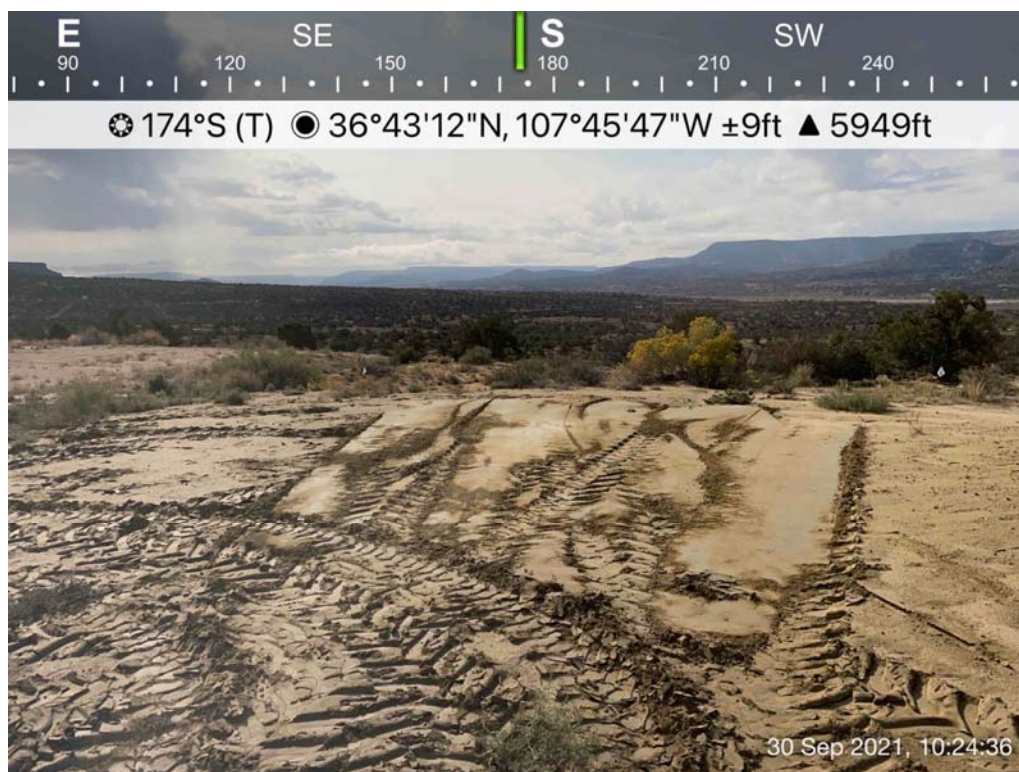
Photo 4: Former location of 21 bbls steel tank "B" following removal and re-grading, 9/30/21.

10. BP shall reclaim the BGT location and all areas associated with the BGT including associated access roads to a safe and stable condition that blends with the surrounding undisturbed area. BP shall substantially restore the impacted surface area to the condition that existed prior to oil and gas operations by placement of the soil cover as provided in Subsection H of 19.15.17.13 NMAC, re-contour the location and associated areas to a contour that approximates the original contour and blends with the surrounding topography and re-vegetate according to Subsection I of 19.15.17.13 NMAC. **Area re-graded following tank removal. Reclamation will be completed within allowable timeframe and will meet standards of NMAC 19.15.17.13.**
