Pit, Below-Grade Tank, or  
Proposed Alternative Method Permit or Closure Plan Application

**Hilcorp Energy Company  
San Juan Basin  
Below Grade Tank Closure Report**

**Lease Name: Huerfanito Unit 81**

**API No.: 30-045-05972**

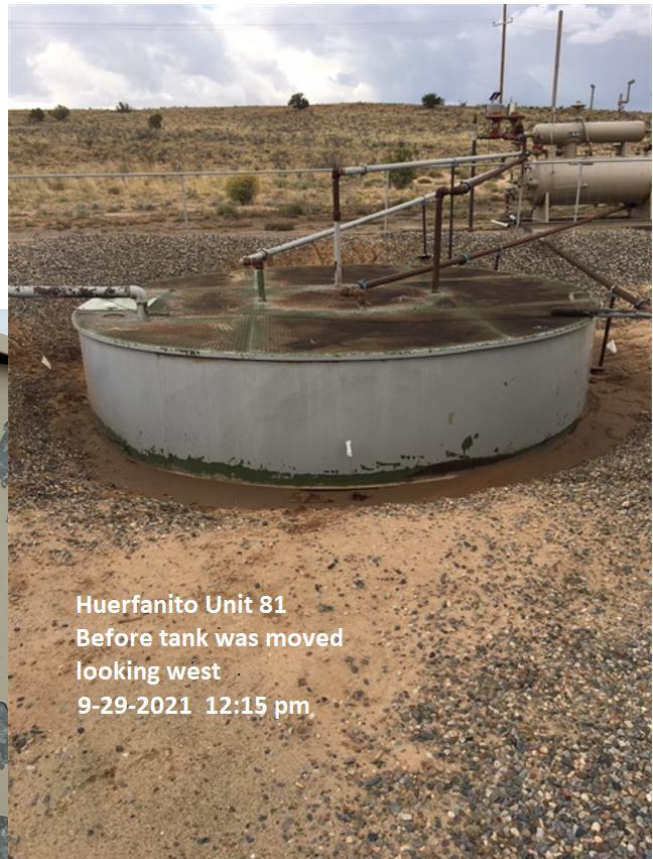
Huerfanito Unit 81  
Before tank was moved  
looking west  
9-29-2021 12:15 pm

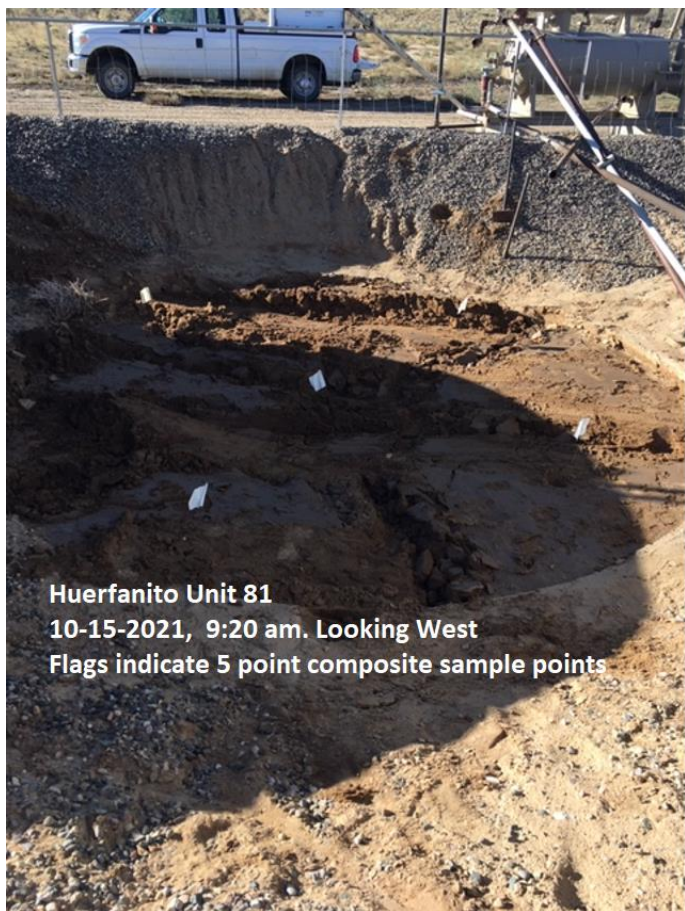
Huerfanito Unit 81  
10-15-2021, 9:20 am. Looking West  
Flags indicate 5 point composite sample points

**A five point composite sample was taken of the below-grade tank using sampling tools and all samples tested per Subsection B of 19.15.17.1 3(B)(1)(b). (Sample results attached). Form C-141 is attached.**

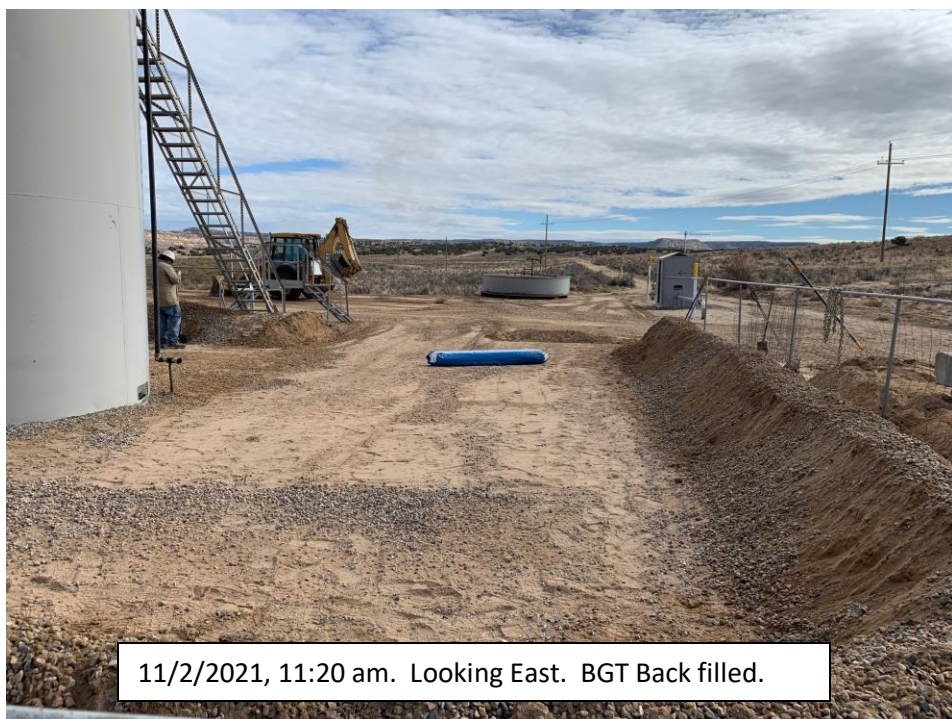
11/2/2021, 11:20 am. Looking East. BGT Back filled.

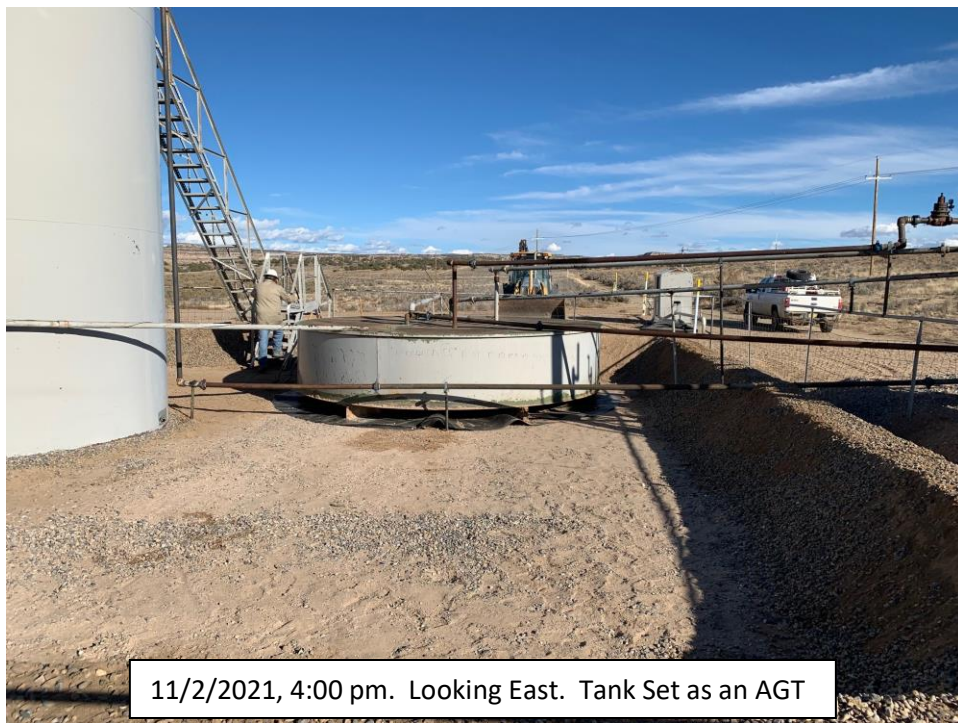
11/2/2021, 4:00 pm. Looking East. Tank Set as an AGT
