Pit, Closed-Loop System, Below-Grade Tank, or
Proposed Alternative Method Permit or Closure Plan Application

1.
Operator: SIMCOE LLC (BP America Production contract operator) OGRID #: 329736
Address: 1199 Main Ave., Suite 101, Durango, CO 81301
Facility or well name: FLORANCE 023B
APPNumber: 3004532143 OCD Permit Number: _____
U/L or Qtr/Qtr O Section 24.0 Township 29.0N Range 09W County: San Juan County
Center of Proposed Design: Latitude 36.70589 Longitude -107.72955 NAD: ☐ 1927 ☒ 1983
Surface Owner: ☒ Federal ☐ State ☐ Private ☐ Tribal Trust or Indian Allotment

BELOW-GRADE TANK CLOSURE PLAN**Florance # 23B – Tank ID: A****API #: 3004532143****Unit Letter O, Section 24, T29N, R9W**

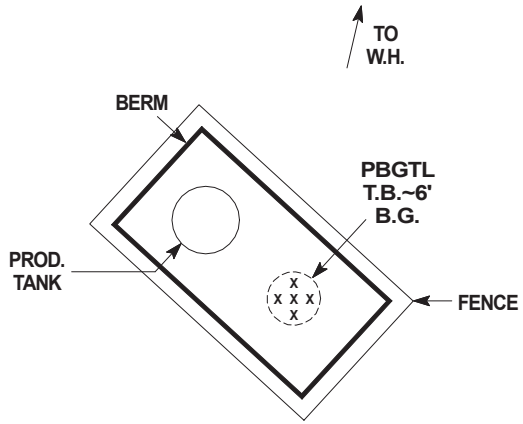
SITE OBSERVATIONS: LOST INTEGRITY OF EQUIPMENT: YES <input checked="" type="checkbox"/> NO EXPLANATION - _____ APPARENT EVIDENCE OF A RELEASE OBSERVED AND/OR OCCURRED: YES <input checked="" type="checkbox"/> NO EXPLANATION: _____ EQUIPMENT SET OVER RECLAIMED AREA: YES <input checked="" type="checkbox"/> NO EXPLANATION - _____ OTHER: BLM REP. PRESENT TO WITNESS CONFIRMATION SAMPLING.		
EXCAVATION DIMENSION ESTIMATION: NA ft. X NA ft. X NA ft. EXCAVATION ESTIMATION (Cubic Yards): NA DEPTH TO GROUNDWATER: >100' NEAREST WATER SOURCE: >1,000' NEAREST SURFACE WATER: >1,000' NMOCD TPH CLOSURE STD: 2,500 ppm		
SITE SKETCH BGT Located : off <input checked="" type="checkbox"/> on site PLOT PLAN circle: attached

NOTES: BGT = BELOW-GRADE TANK; E.D. = EXCAVATION DEPRESSION; B.G. = BELOW GRADE; B = BELOW; T.H. = TEST HOLE; ~ = APPROX.; W.H. = WELL HEAD; T.B. = TANK BOTTOM; PBGTL = PREVIOUS BELOW-GRADE TANK LOCATION; SPD = SAMPLE POINT DESIGNATION; R.W. = RETAINING WALL; NA - NOT APPLICABLE OR NOT AVAILABLE; SW - SINGLE WALL; DW - DOUBLE WALL; SB - SINGLE BOTTOM; DB - DOUBLE BOTTOM.		MISCELL. NOTES PO: 4301191982 AFE #: SIO #: GL #: Permit date(s): 06/10/10 OCD Appr. date(s): 03/09/17 Tank ID: A OVM = Organic Vapor Meter ppm = parts per million BGT Sidewalls Visible: Y / <input checked="" type="checkbox"/> N BGT Sidewalls Visible: Y / <input type="checkbox"/> N BGT Sidewalls Visible: Y / <input type="checkbox"/> N Magnetic declination: 10° E

NOTES: GOOGLE EARTH IMAGERY DATE: 04/06/2019 ONSITE: 07/30/20
