Pit, Below-Grade Tank, or  
Proposed Alternative Method Permit or Closure Plan Application

Hilcorp Energy Company  
San Juan Basin  
Below Grade Tank Closure Report

Lease Name: State Gas Com BI 4

API No.: 3004532287

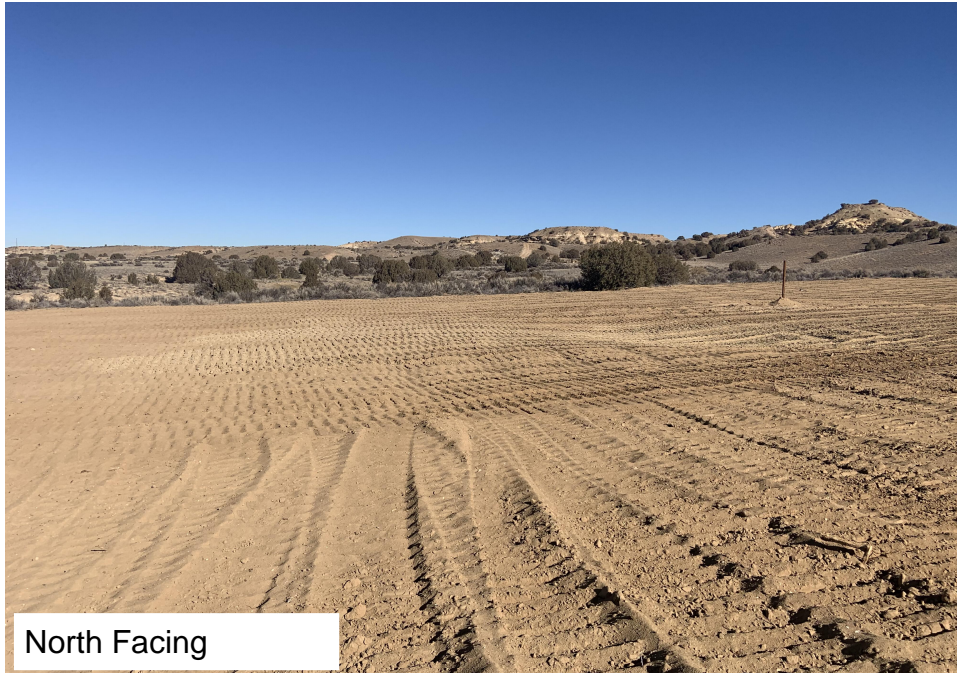
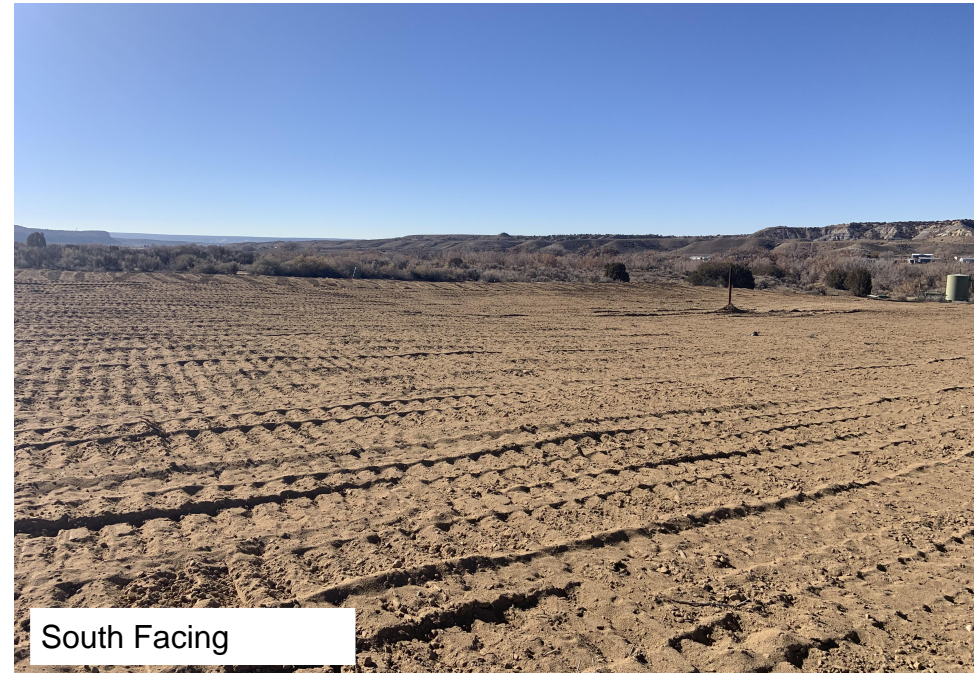
Taken 12/1/2021 @ 10 am

The below-grade tank area passed all requirements of Paragraph (4) of Subsection E of 19.15.17.13 NMAC and was backfilled with compacted, non-waste containing, earthen material.
