Pit, Below-Grade Tank, or
Proposed Alternative Method Permit or Closure Plan Application

Operator: Harvest Four Corners, LLC OGRID #: 37388
Address: 1755 Arroyo Dr., Bloomfield, NM 87413
Facility or well name: Florance #19A
API Number: 30-045-21861 OCD Permit Number: _____
U/L or Qtr/Qtr P Section 3 Township 30N Range 9W County: San Juan
Center of Proposed Design: Latitude _____ Longitude _____ NAD83
Surface Owner: ☒ Federal ☐ State ☐ Private ☐ Tribal Trust or Indian Allotment

Based on BGT laboratory analytical results for benzene, total BTEX, TPH, and chloride at the location of the removed Harvest BGT, the site was backfilled with clean soil obtained from Four Corners Materials. No further work is recommended at the Florance #19A for this Harvest BGT Closure.

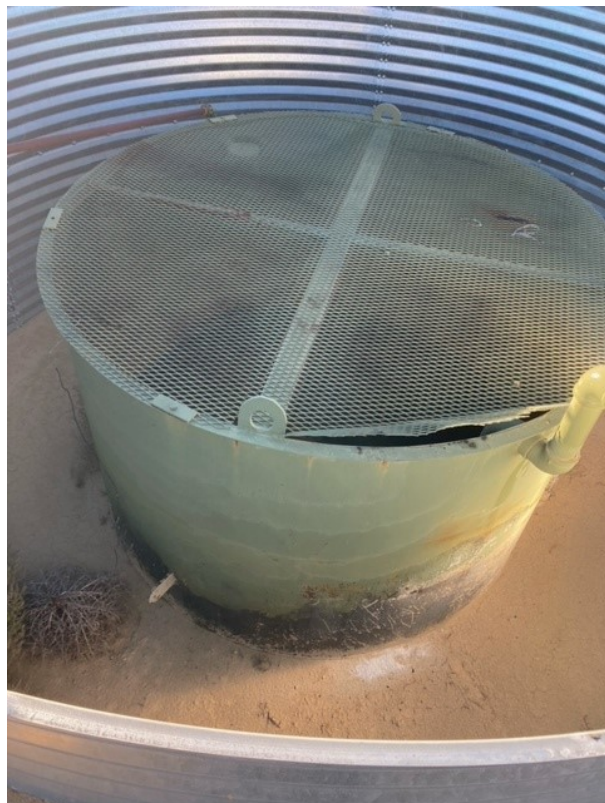
Photo 1: Florance #19A BGT.

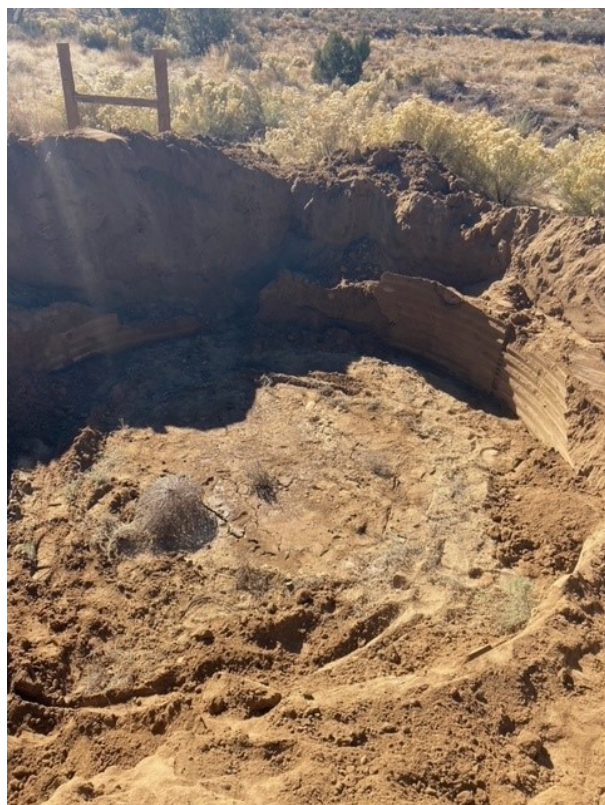
Photo 2: Florance #19A BGT location following removal.

In accordance with standard procedures as outlined in the tank closure plans, Harvest removed any liquids and sludge found within the BGTs within 60 days of their ceasing operations. Liquids and sludge were disposed of only at the NMOCD-approved facilities named in the closure plans. Subsequently, Harvest removed the BGTs. All removed Harvest BGTs are properly disposed of, recycled, or reused in an approved manner. All associated equipment was also removed from the location.

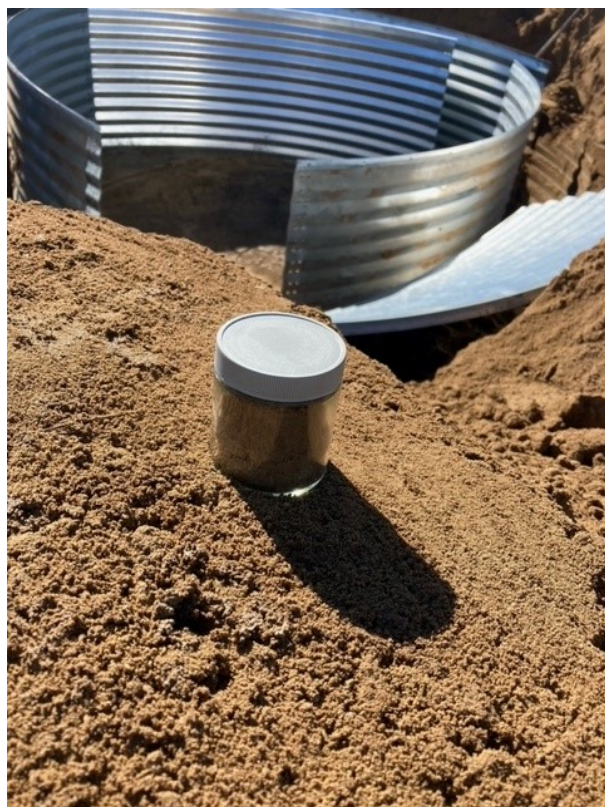
Photo 3: Florance #19A composite soil sample.

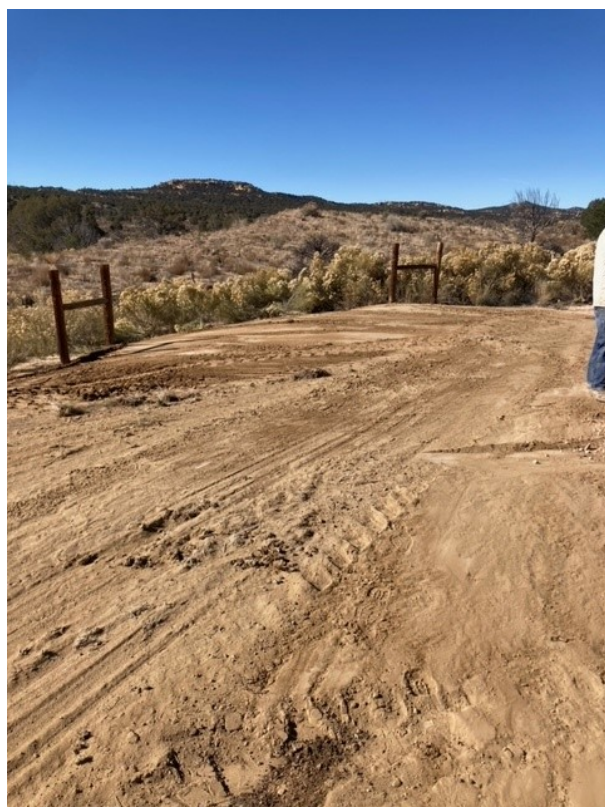
Photo 4: Florance #19A BGT location following backfill.
