Pit, Below-Grade Tank, or
Proposed Alternative Method Permit or Closure Plan Application

Well Name: Smyers Com A LS #002

BELOW-GRADE TANK CLOSURE PLAN

**Smyers Com A LS #002
Photographic Log
Simcoe, LLC**

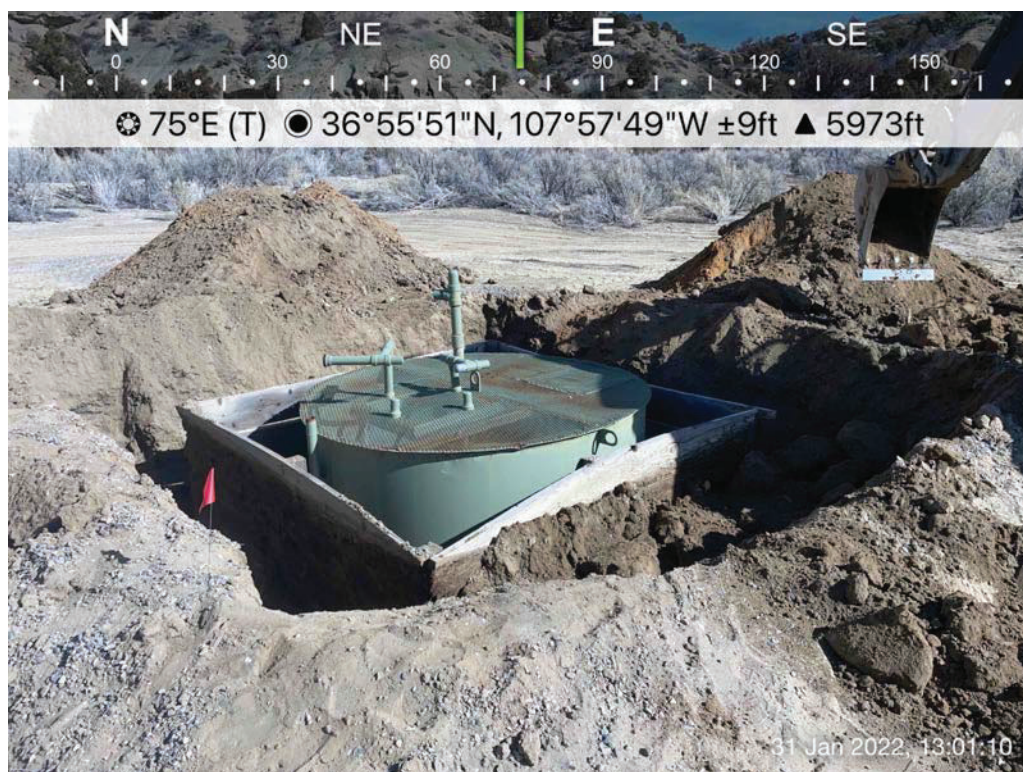
Photo 2: 45 bbls steel tank prior to removal, 1/31/2022.

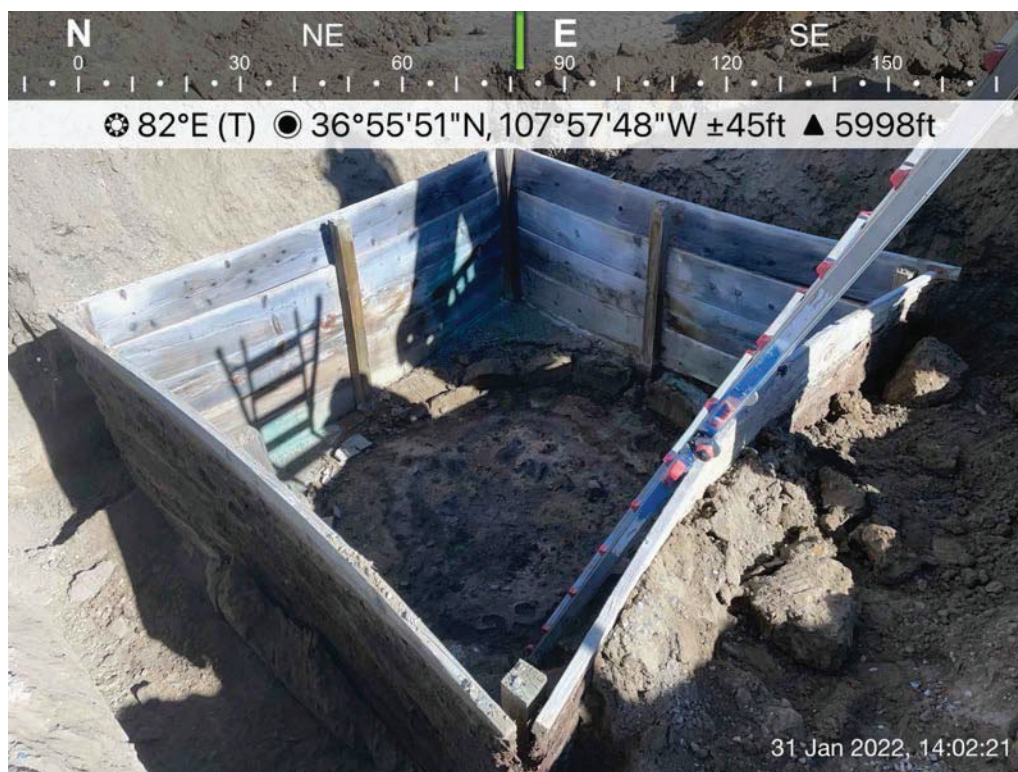
Photo 3: Former location of 45 bbls steel tank following removal, 1/31/2022.

Cause of Release TPH, BTEX, & chloride all non-detect based on laboratory analytical results.
No evidence of a release had occurred.

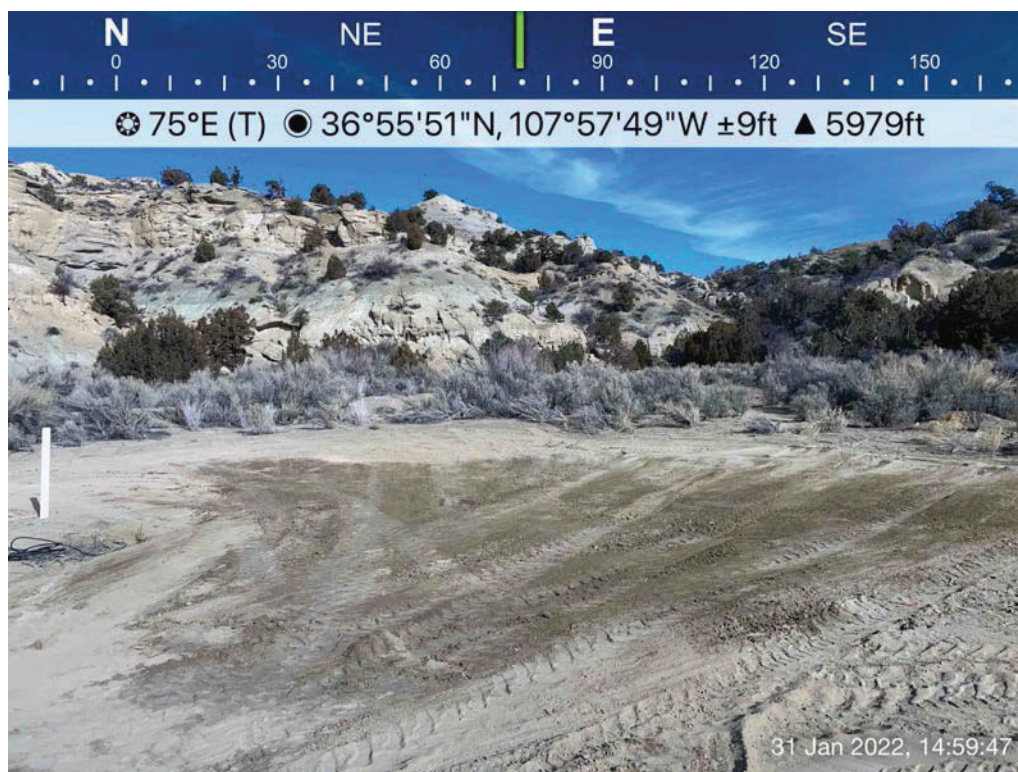
Photo 4: Former location of 45 bbls steel tank following removal and re-grading, 1/31/2022.
