Pit, Below-Grade Tank, or
Proposed Alternative Method Permit or Closure Plan Application

1.
Operator: Simcoe, LLC OGRID #: 329736
Address: 1199 Main Ave., Suite 101, Durango, CO 81301
Facility or well name: Heaton LS #003A
API Number: 30-045-29292 OCD Permit Number: _____
U/L or Qtr/Qtr F Section 32 Township 31N Range 11W County: San Juan
Center of Proposed Design: Latitude 36.85835276 Longitude -108.016875 NAD83
Surface Owner: ☐ Federal ☐ State ☒ Private ☐ Tribal Trust or Indian Allotment

BELOW-GRADE TANK CLOSURE PLAN

**Heaton LS #003A
Photographic Log
Simcoe, LLC**

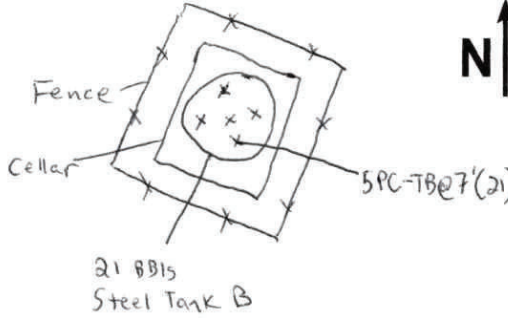
SITE SKETCH BGT Located: off / <u>on</u> site PLOT PLAN circle: <u>attached</u>

SOIL DESCRIPTION: SOIL COLOR: <u>Brown</u> COHESION (ALL OTHERS): <u>NON COHESIVE</u> / SLIGHTLY COHESIVE / COHESIVE / HIGHLY COHESIVE CONSISTENCY (NON COHESIVE SOILS): <u>LOOSE</u> / FIRM / DENSE / VERY DENSE MOISTURE: <u>DRY</u> / SLIGHTLY MOIST / <u>WET</u> / SATURATED / SUPER SATURATED SAMPLE TYPE: <u>GRAB</u> / <u>COMPOSITE</u> # OF PTS. <u>5</u> DISCOLORATION/STAINING OBSERVED: YES / <u>NO</u> EXPLANATION: _____	SOIL TYPE: <u>SAND</u> / SILTY SAND / SILT / SILTY CLAY / CLAY / GRAVEL / OTHER <u>sand w/ gravel</u> PLASTICITY (CLAYS): NON PLASTIC / SLIGHTLY PLASTIC / COHESIVE / MEDIUM PLASTIC / HIGHLY PLASTIC DENSITY (COHESIVE CLAYS & SILTS): <u>SOFT</u> / FIRM / STIFF / VERY STIFF / HARD HC ODOR DETECTED: YES / <u>NO</u> EXPLANATION: _____ ANY AREAS DISPLAYING WETNESS: YES / <u>NO</u> EXPLANATION: _____
--	--

SITE OBSERVATIONS: APPARENT EVIDENCE OF A RELEASE OBSERVED AND/OR OCCURRED: YES / <u>NO</u> EXPLANATION: _____ EQUIPMENT SET OVER RECLAIMED AREA: YES / <u>NO</u> EXPLANATION: _____ OTHER: _____	LOST INTEGRITY OF EQUIPMENT: YES / <u>NO</u> EXPLANATION: _____
---	---

EXCAVATION DIMENSION ESTIMATION: <u>NA</u> ft. X <u>NA</u> ft. X <u>NA</u> ft. DEPTH TO GROUNDWATER: <u>50-100 ft</u> NEAREST WATER SOURCE: <u>>100 ft</u> NEAREST SURFACE WATER: <u>>100 ft</u>	EXCAVATION ESTIMATION (Cubic Yards): <u>NA</u> NMOC DTPH CLOSURE STD: <u>2,500 ppm</u>
---	---

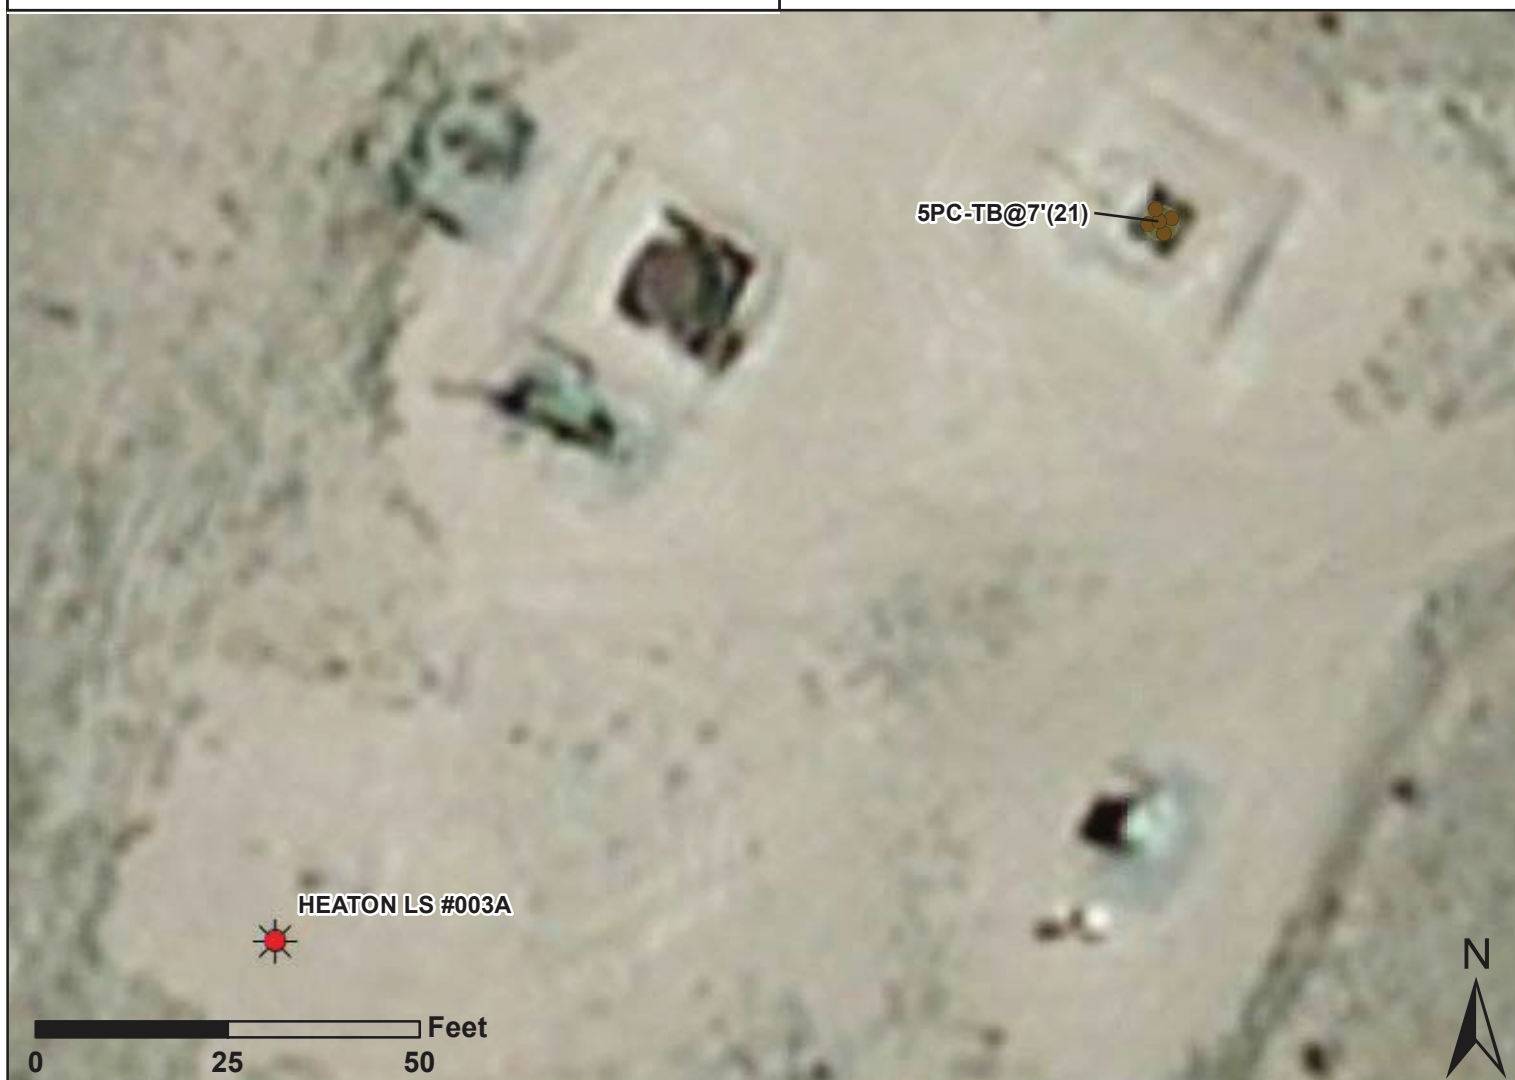
Notes: Sample collected 1/31/2022. Sample 5PC-TB@7'(21) is a five-point composite sample.

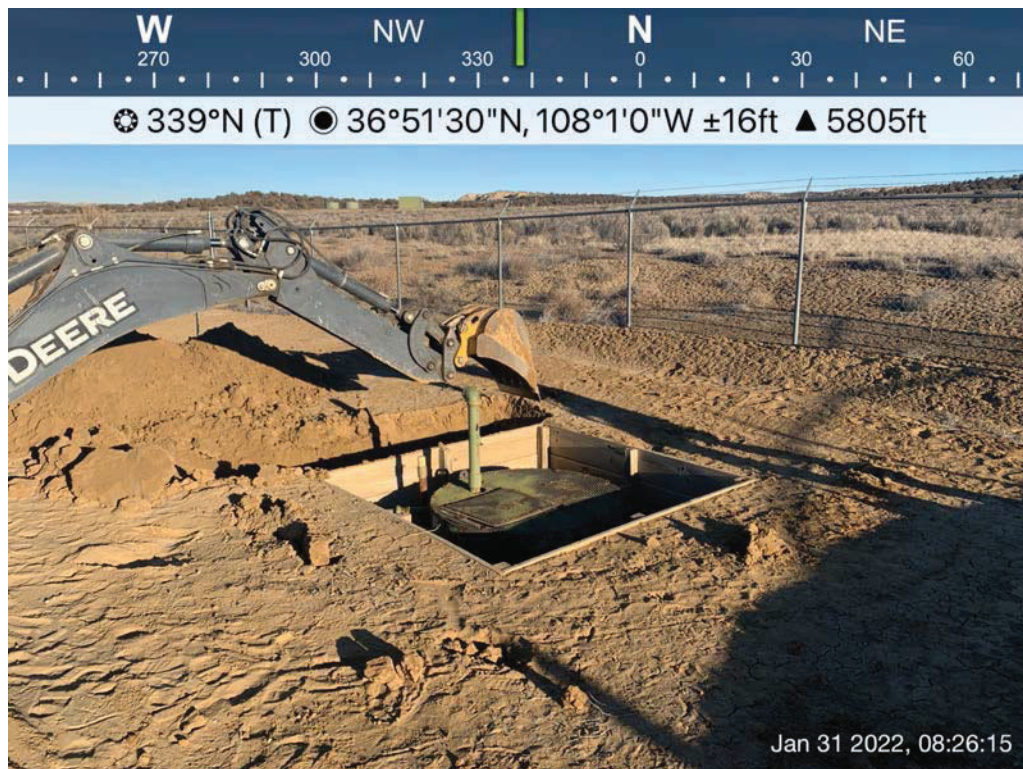
Photo 2: 21 bbls steel tank "B" prior to removal, 1/31/2022.

The BGT was transported for reuse.

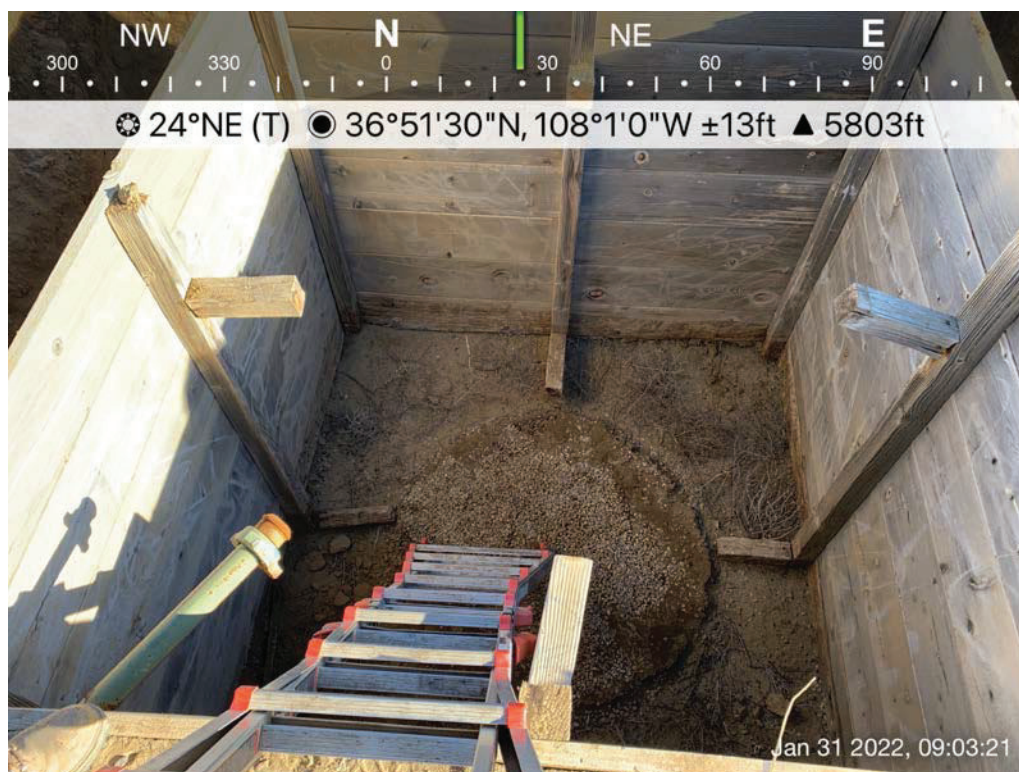
Photo 3: Former location of 21 bbls steel tank "B" following removal, 1/31/2022.

Cause of Release TPH, BTEX, & chloride all non-detect based on laboratory analytical results.
No evidence of a release had occurred.

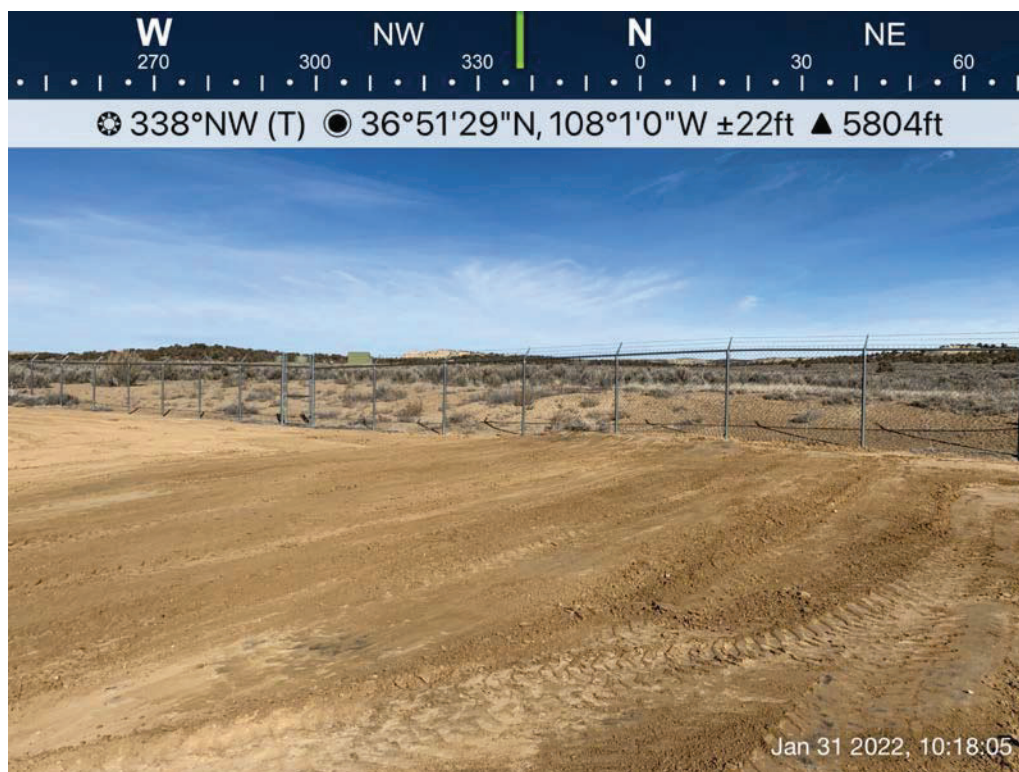
Photo 4: Former location of 21 bbls steel tank "B" following removal and regrading, 1/31/2022.

10. Simcoe, LLC shall reclaim the BGT location, and all areas associated with the BGT including associated access roads to a safe and stable condition that blends with the surrounding undisturbed area. Simcoe, LLC shall substantially restore the impacted surface area to the condition that existed prior to oil and gas operations by placement of the soil cover as provided in Subsection H of 19.15.17.13 NMAC, re-contour the location and associated areas to a contour that approximates the original contour and blends with the surrounding topography and re-vegetate according to Subsection I of 19.15.17.13 NMAC. 11. The
