Pit, Below-Grade Tank, or
Proposed Alternative Method Permit or Closure Plan Application

1.
Operator: Simcoe, LLC OGRID #: 329736
Address: 1199 Main Ave., Suite 101, Durango, CO 81301
Facility or well name: NORTHEAST BLANCO UNIT #046
API Number: 30-045-10076 OCD Permit Number: _____
U/L or Qtr/Qtr N Section 33 Township 31N Range 7W County: San Juan
Center of Proposed Design: Latitude 36.85248278 Longitude -107.5808604 NAD83
Surface Owner: ☒ Federal ☐ State ☐ Private ☐ Tribal Trust or Indian Allotment

Northeast Blanco Unit #046
Photographic Log
Simcoe, LLC

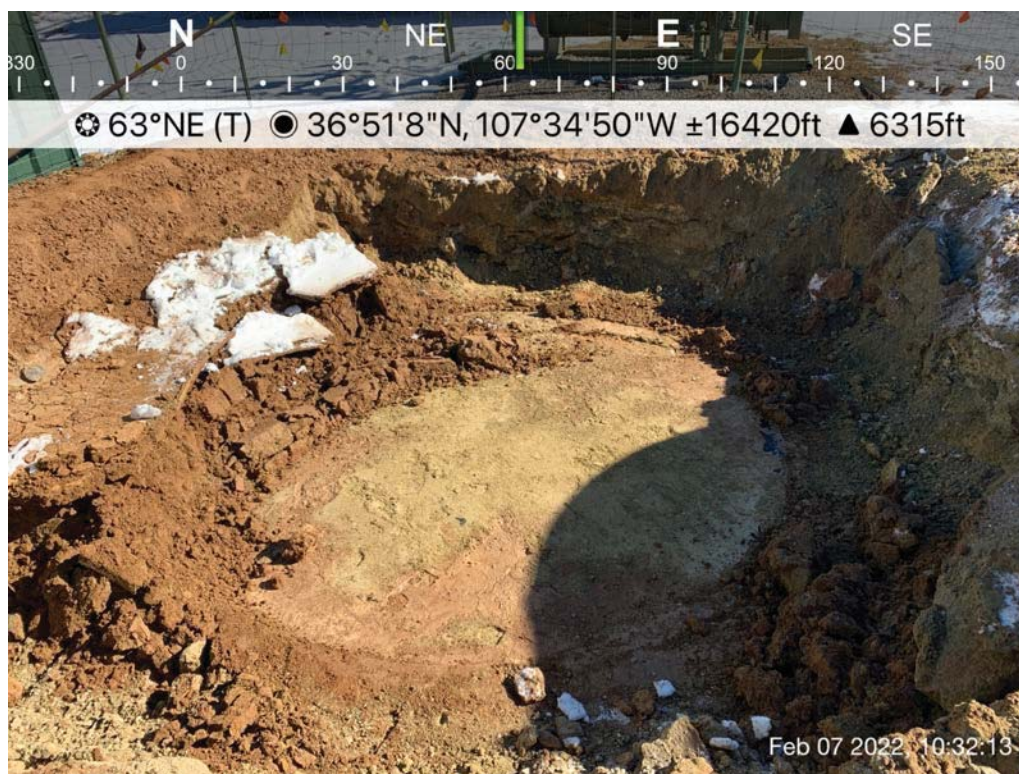
No evidence of a release. The BGT was replaced.

Cause of Release TPH, BTEX, & chloride all non-detect based on laboratory analytical results.
No evidence of a release had occurred.

Photo 3: Former location of 40 bbls steel tank following removal, 2/7/2022.

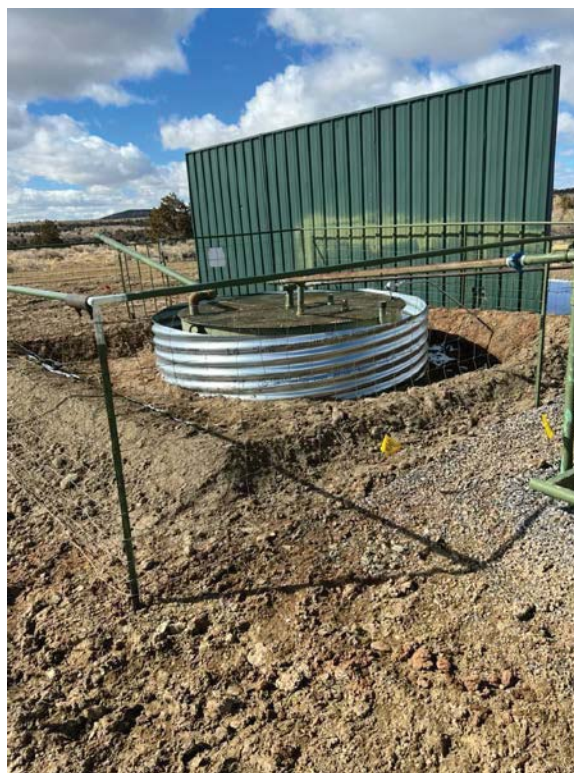
Photo 4: Replaced BGT, 2/18/2022.

The BGT was replaced and equipment remained on site.
