Pit, Below-Grade Tank, or
Proposed Alternative Method Permit or Closure Plan Application

1.
Operator: Simcoe, LLC OGRID #: 329736
Address: 1199 Main Ave., Suite 101, Durango, CO 81301
Facility or well name: NORTHEAST BLANCO UNIT #045
API Number: 30-045-60187 OCD Permit Number: _____
U/L or Qtr/Qtr A Section 5 Township 30N Range 7W County: San Juan
Center of Proposed Design: Latitude 36.84700089 Longitude -107.5895648 NAD83
Surface Owner: ☒ Federal ☐ State ☐ Private ☐ Tribal Trust or Indian Allotment

Procedure Description: On 2/3/2022 beginning at 9 am the 45 bbl bgt on the subject location will be replaced per NMAC 19.15.17.13 regulations. The current tank will be closed per the regulations and a new 45 bbl BGT with liner placed into the same location. Attached aerial demonstrates the location of the BGT.

Northeast Blanco Unit #045
Photographic Log
Simcoe, LLC

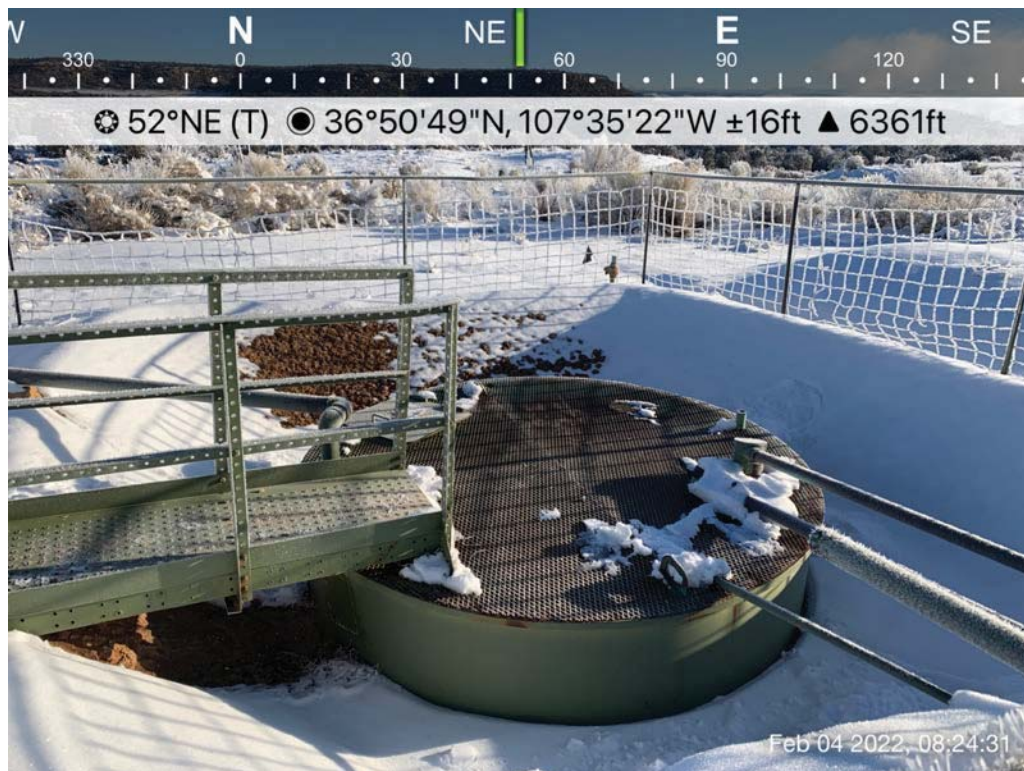
Photo 2: 45 bbls steel tank prior to removal, 2/4/2022.

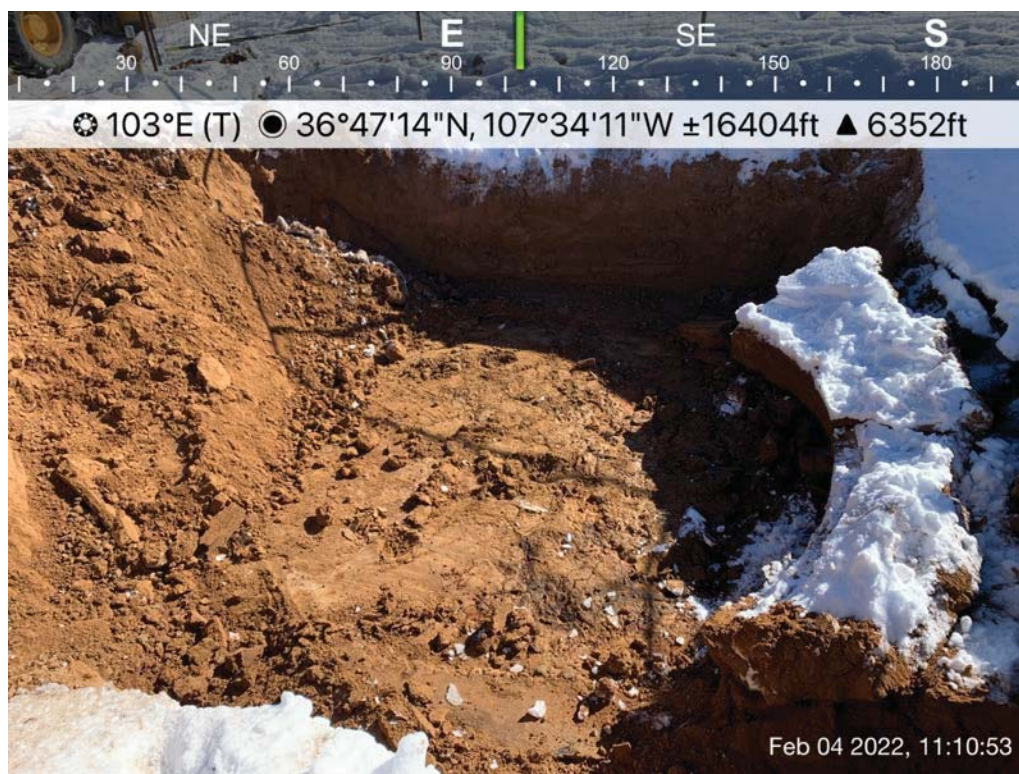
Photo 3: Former location of 45 bbls steel tank following removal, 2/4/2022.

No evidence of a release. The BGT was replaced.

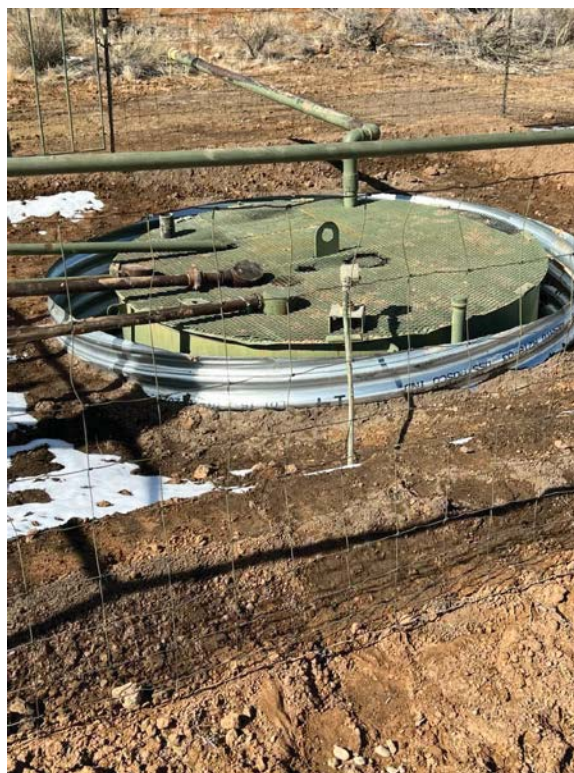
Photo 4: Replaced BGT, 2/18/2022.
