Pit, Below-Grade Tank, or
Proposed Alternative Method Permit or Closure Plan Application

Operator: Hilcorp Energy Company OGRID #: 372171
Address: 382 Road 3100 Aztec, NM 87410
Facility or well name: Byrd Frost 1 – BGT #2
API Number: 30-045-25533 OCD Permit Number: _____
U/L or Qtr/Qtr D Section 16 Township 26N Range 8W County: San Juan
Center of Proposed Design: Latitude 36.491844 Longitude -107.693171 NAD83
Surface Owner: ☐ Federal ☒ State ☐ Private ☐ Tribal Trust or Indian Allotment

Hilcorp Energy Company
San Juan Basin: New Mexico Assets
Below Grade Tank Closure Report

Lease Name: Byrd Frost 1 – BGT #2
API No.: 30-045-25533

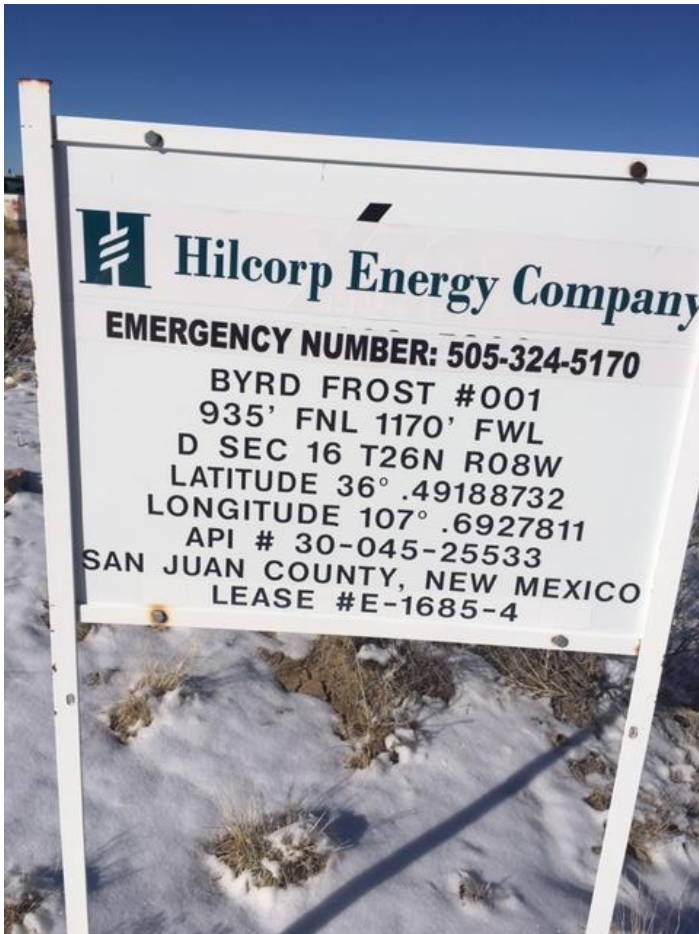
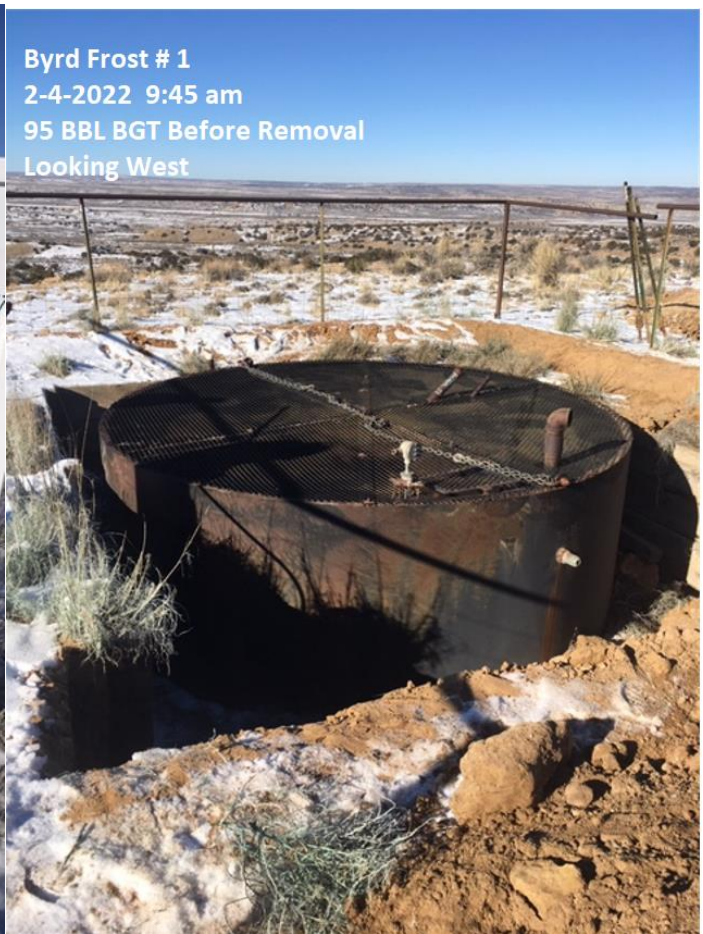
Byrd Frost # 1
2-4-2022 9:45 am
95 BBL BGT Before Removal
Looking West

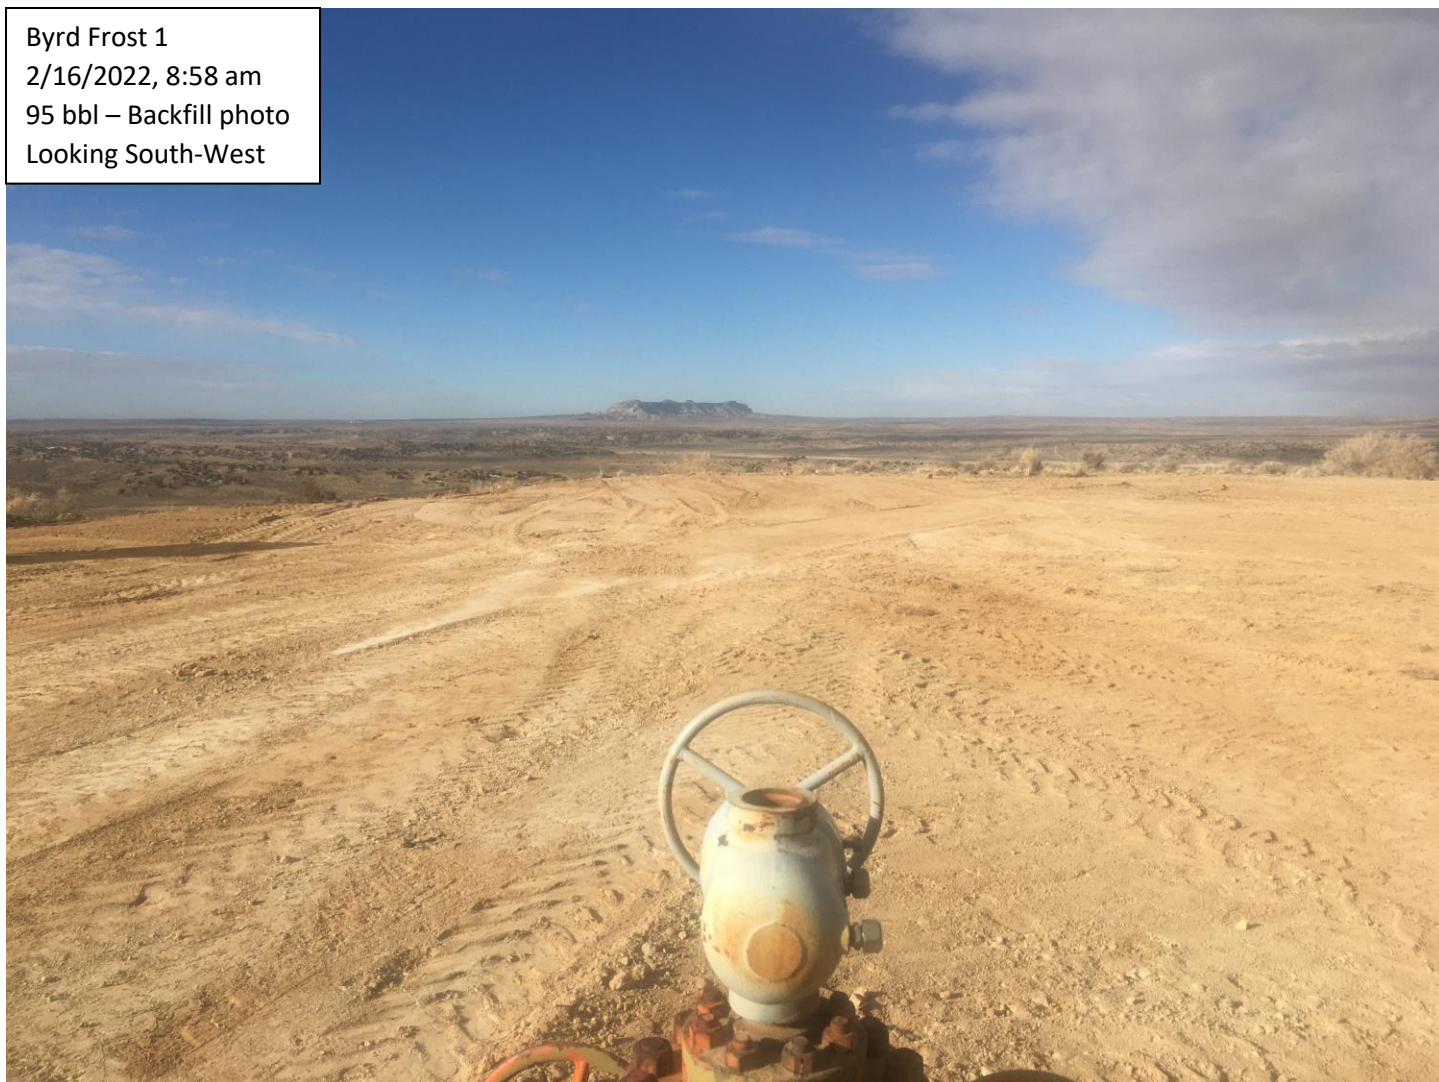
Byrd Frost 1
2/16/2022, 8:58 am
95 bbl – Backfill photo
Looking South-West

The former BGT area is required for production activities and reseeding will be completed upon plug and abandonment, per the procedure noted above.
