Proposed Alternative Method Permit or Closure Plan Application

i. Operator: Harvest Four Corners, LLC OGRID #: 37388		
Address: 1775 Arroyo Drive, Bloomfield, NM 87413		
Facility or well name:		
API Number: 30004523644 OCD Permit Number:		
U/L or Qtr/Qtr Section _1 Township31N Range12W County: San Juan		
Center of Proposed Design: Latitude36.930139 Longitude108.041364 NAD83		
Surface Owner: Federal State Private Tribal Trust or Indian Allotment

4.
Below-grade tank: Subsection I of 19.15.17.11 NMAC
Volume: 45 bbl Type of fluid: Produced water – dehydrator fluids or other produced liquids (RCRA exempt)
Tank Construction material: Steel Fiberglass
Secondary containment with leak detection Visible sidewalls, liner, 6-inch lift and automatic overflow shut-off
☐ Visible sidewalls and liner ☐ Visible sidewalls only ☐ Other TANK BURIES 20%-NO LIJER
Liner type: Thicknessmil

Williams BGT Locations

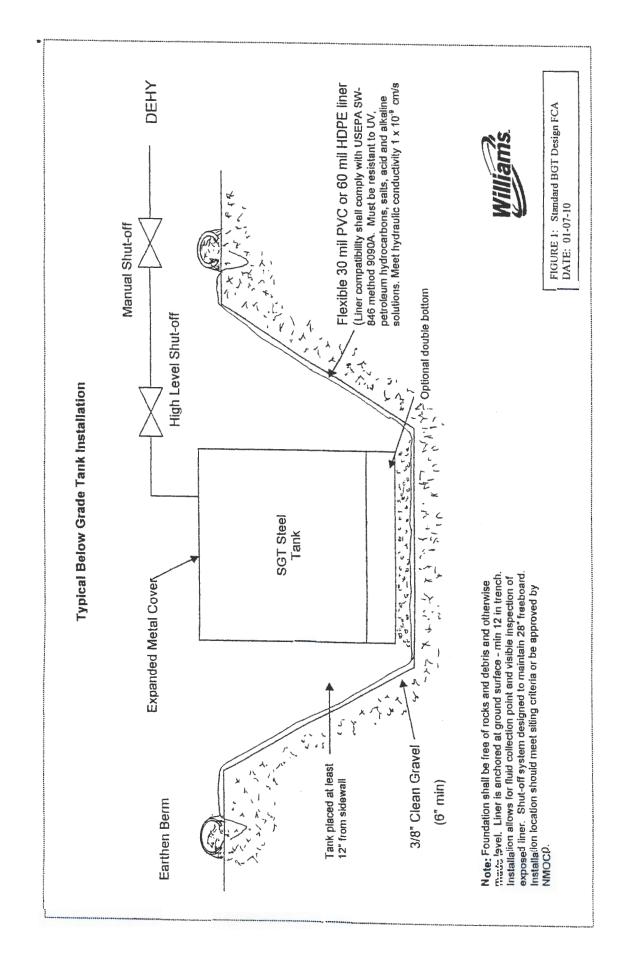
- 14. An existing single walled tank (installed prior to June 16, 2008) which has completely open sidewalls for visible inspection and which may or may not have a geomembrane liner, need not meet the above design and construction standards unless and until integrity fails, or there is a change of Operator, or the tank or facility is sold. The tank will then be closed pursuant to the Closure Plan or be retrofitted in accordance with the design drawing (see Figure 1) or NMOCD approved medification.

Any modifications to, or retrofitting of existing tanks shall necessitate that all of the aforementioned design elements be included and as provided in the design drawing (see Figure 1). If modifications cannot reasonably include the same design standards for new tanks, the existing tank shall be retired and removed from service. In this event, the Williams Closure Plan for Below Grade Tanks shall be implemented.

- Ensure that any BGT modification, replacement, or retrofit conforms with current and applicable design and construction specifications (see Design and Construction Plan Figure 1).

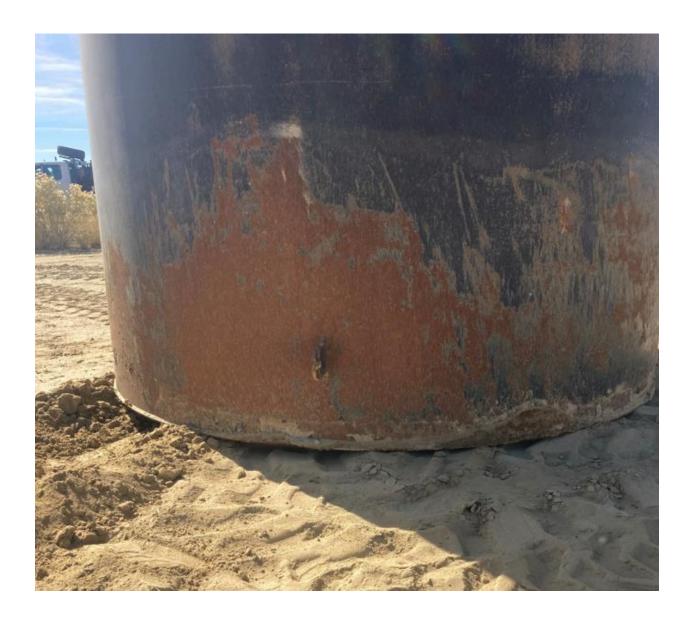
Remedi	ation Excavation and		
Site Name	Ducken ber	19 3 E		
Excavation D	imensions (feet)			
	Length	8' o"_V	/idthO	Dept
Excavation Di	iagram and Samp	le Locations n extents, visual observation	ns, sample locations, nor	th arrow, etc.)
1 2 4

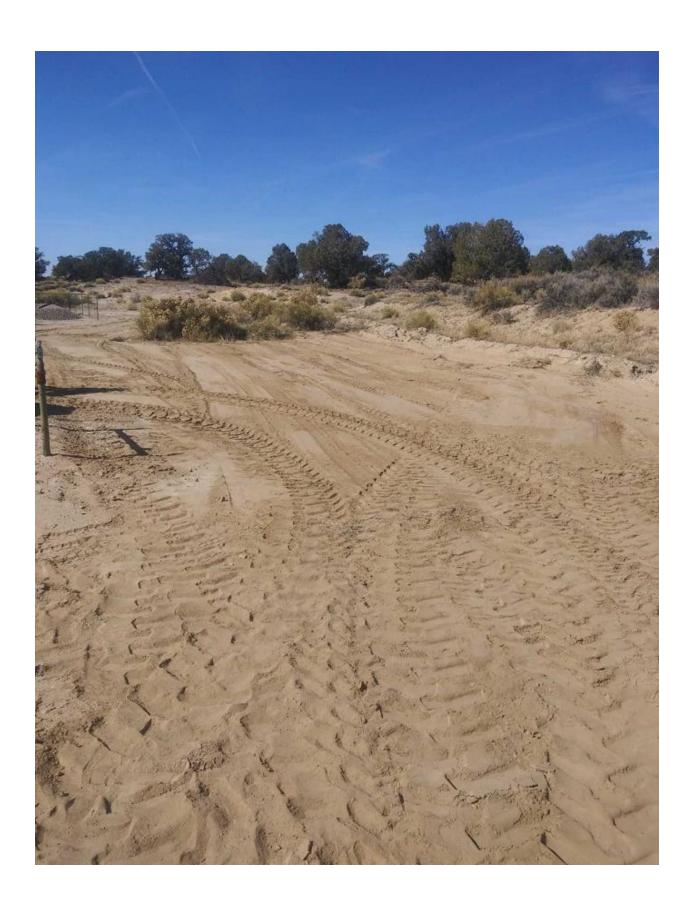
-	(0)	2 "#3		
1	- /-		1	
	-	The same of the sa		
		410		
		410		₩.
		#5 /		
		#5 /		will be a second of the second
		#5 /		
	0 +9	#5 /		
Sample Inform		#5 /		
Sample Inform	nation			
OCD Witness S				
OCD Witness S Agency(s) Rep	nation Sampling Yes or resentative(s)	Type	Location	
OCD Witness S	nation Sampling Yes or resentative(s)	Type (Composite, Grab)	(Floor, Sidewall)	Commen
OCD Witness S Agency(s) Rep	nation Sampling Yes or resentative(s)	Type		Commen
OCD Witness S Agency(s) Rep	nation Sampling Yes or resentative(s)	Type (Composite, Grab)	(Floor, Sidewall)	Commen
OCD Witness S Agency(s) Rep	nation Sampling Yes or resentative(s)	Type (Composite, Grab)	(Floor, Sidewall)	Commen
OCD Witness S Agency(s) Rep	nation Sampling Yes or resentative(s)	Type (Composite, Grab)	(Floor, Sidewall)	Commen
OCD Witness S Agency(s) Rep	nation Sampling Yes or resentative(s)	Type (Composite, Grab)	(Floor, Sidewall)	Commen
