Pit, Below-Grade Tank, or
Proposed Alternative Method Permit or Closure Plan Application

Legacy BGT
Closure
Report

1.
Operator: Simcoe, LLC OGRID #: 329736
Address: 1199 Main Ave., Suite 101, Durango, CO 81301
Facility or well name: NORTHEAST BLANCO UNIT #054A
API Number: 30-045-25093 OCD Permit Number: _____
U/L or Qtr/Qtr O Section 33 Township 31 Range 7 County: San Juan
Center of Proposed Design: Latitude 36.85148099 Longitude -107.5745741 NAD83
Surface Owner: ☒ Federal ☐ State ☐ Private ☐ Tribal Trust or Indian Allotment

Northeast Blanco Unit #054A
Photographic Log
Simcoe, LLC

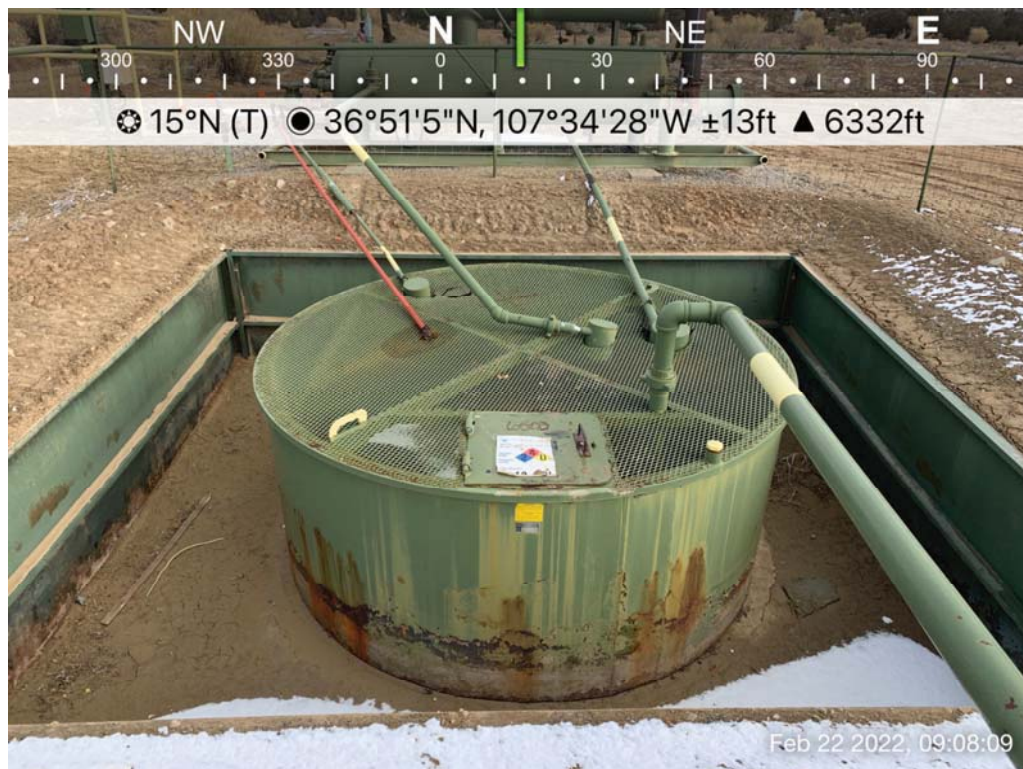
Photo 2: 40 bbls steel tank prior to removal, 2/22/2022.

The BGT was replaced and equipment remained on site.

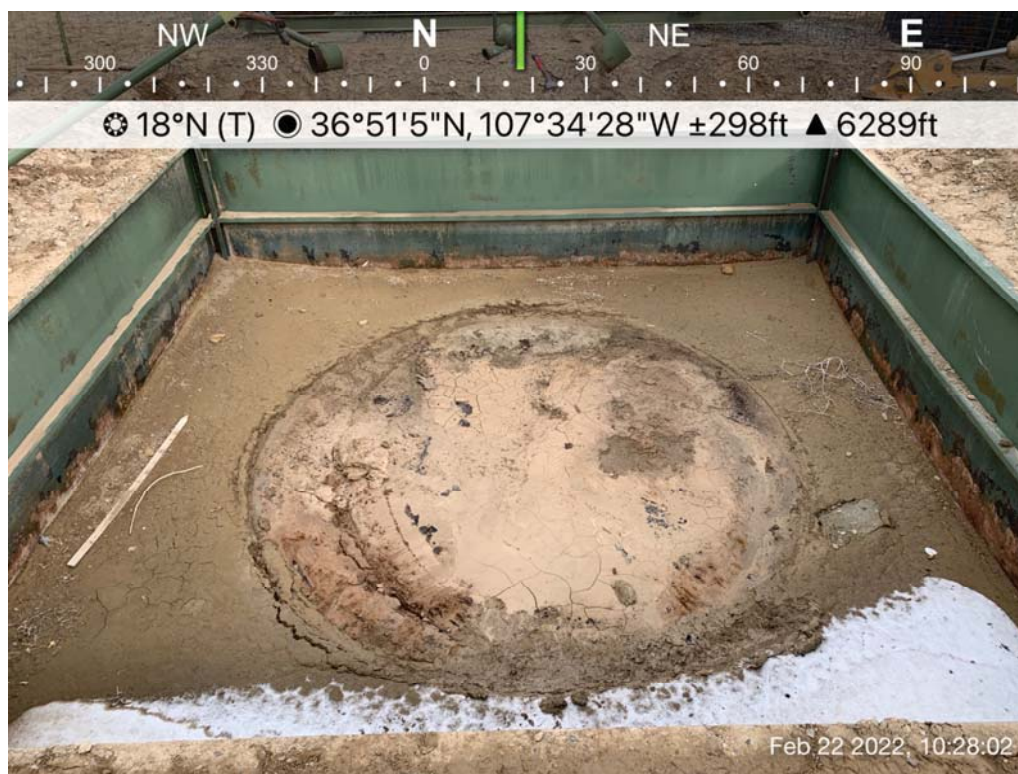
No evidence of a release. The BGT was replaced.

Photo 3: Former location of 40 bbls steel tank following removal, 2/22/2022.

The BGT was replaced. No reclamation to be done at this time as former BGT location is located on well pad within area needed for production operations or subsequent drilling.

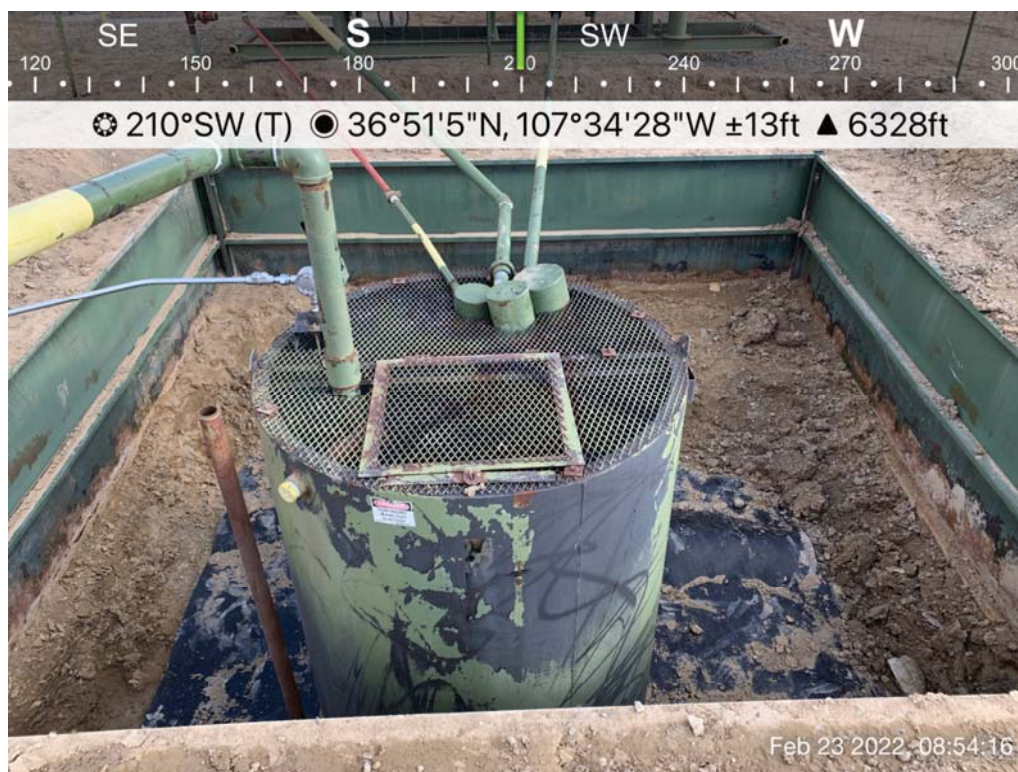
Photo 4: Replaced BGT with liner, 2/23/2022.
