Pit, Below-Grade Tank, or
Proposed Alternative Method Permit or Closure Plan Application

1.
Operator: Simcoe, LLC OGRID #: 329736
Address: 1199 Main Ave., Suite 101, Durango, CO 81301
Facility or well name: EPNG Com J LS #011
API Number: 30-045-21375 OCD Permit Number: _____
U/L or Qtr/Qtr K Section 32 Township 31N Range 10W County: San Juan
Center of Proposed Design: Latitude 36.8529601 Longitude -107.9100361 NAD83
Surface Owner: ☐ Federal ☒ State ☐ Private ☐ Tribal Trust or Indian Allotment

SIMCOE, LLC
SAN JUAN BASIN, NORTHWEST NEW MEXICO

BELOW-GRADE TANK CLOSURE PLAN

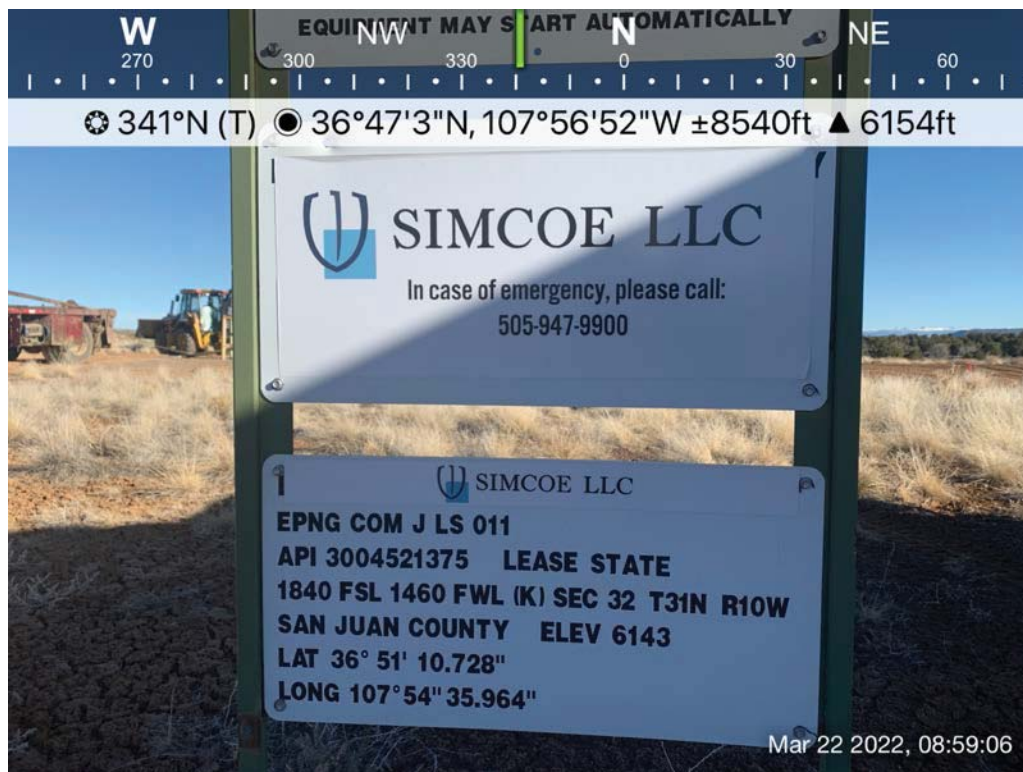
Photo 1: EPNG Com J LS #011 well sign, 3/22/2022.

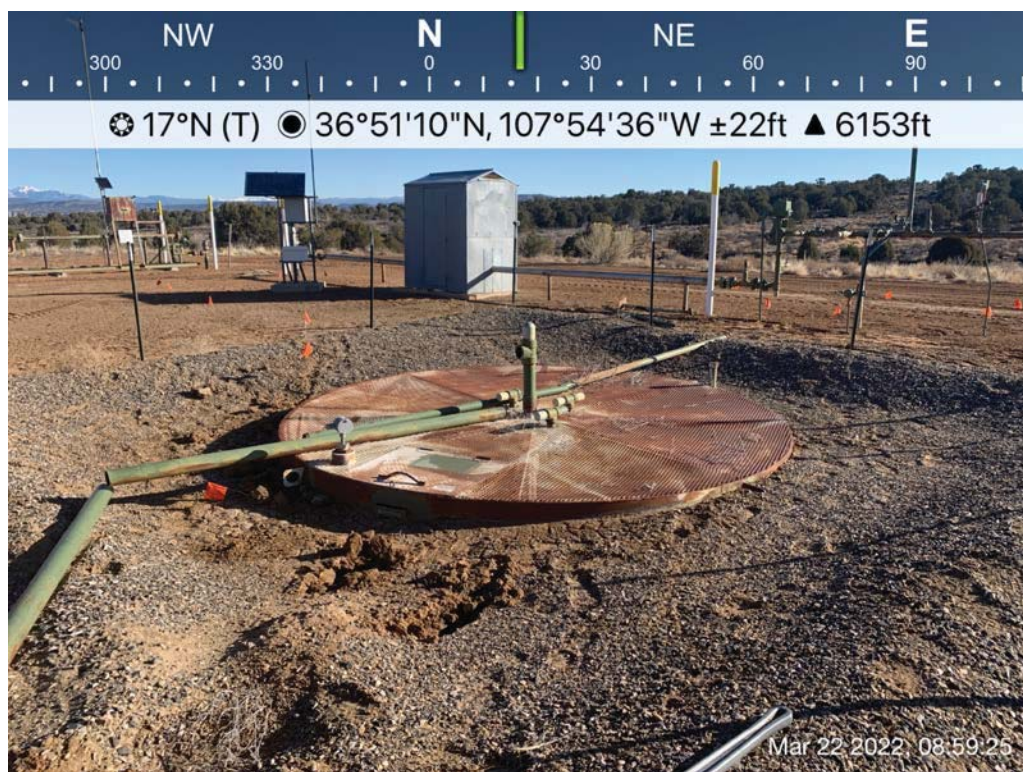
Photo 2: 95 bbls steel tank prior to removal, 3/22/2022.

The BGT was transported for reuse.

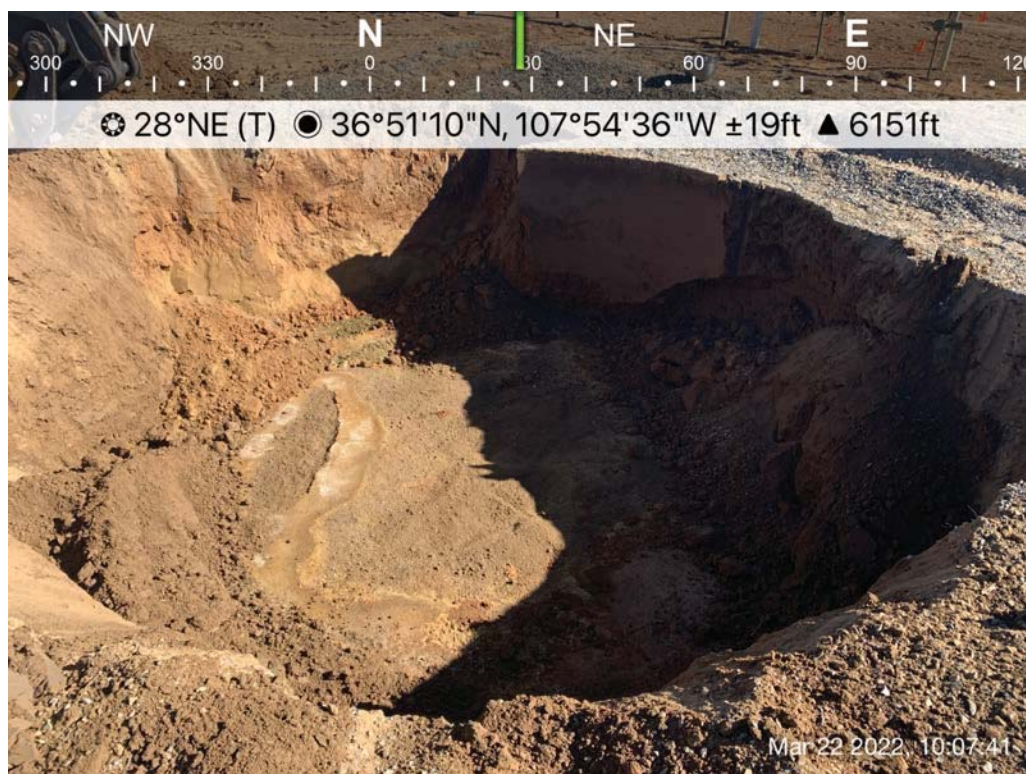
Photo 3: Former location of BGT following removal, 3/22/2022.

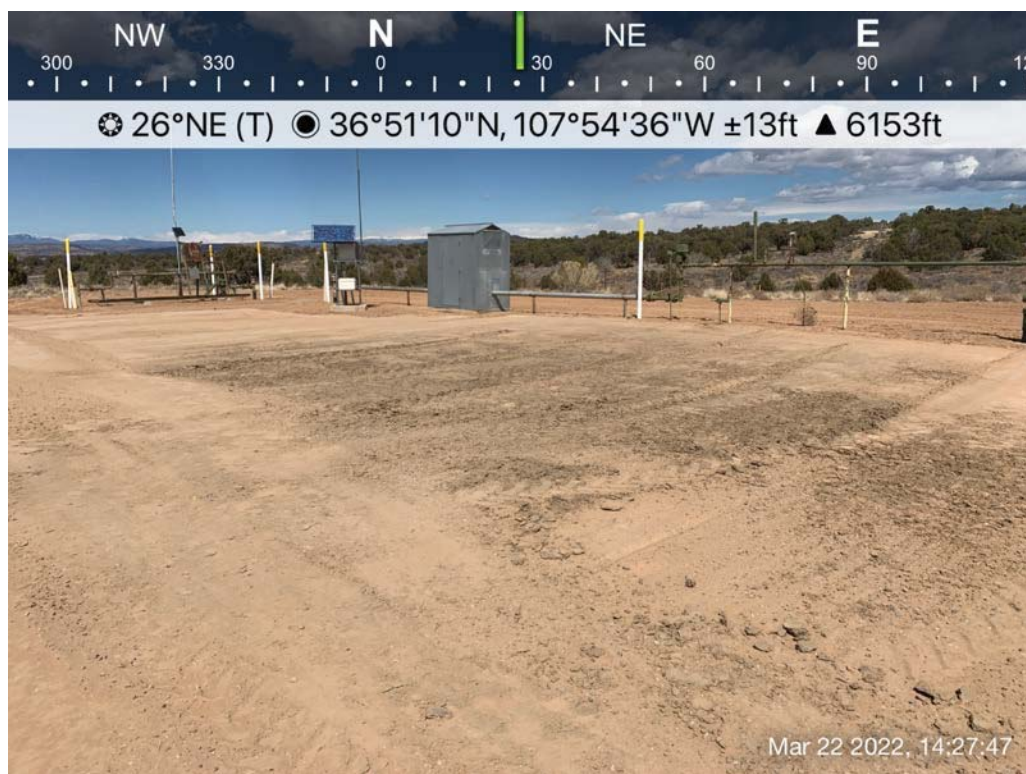
Photo 4: Former location BGT following removal and re-grading, 3/22/2022.

10. Simcoe, LLC shall reclaim the BGT location, and all areas associated with the BGT including associated access roads to a safe and stable condition that blends with the surrounding undisturbed area. Simcoe, LLC shall substantially restore the impacted surface area to the condition that existed prior to oil and gas operations by placement of the soil cover as provided in Subsection H of 19.15.17.13 NMAC, re-contour the location and associated areas to a contour that approximates the original contour and blends
