Pit, Below-Grade Tank, or  
Proposed Alternative Method Permit or Closure Plan Application

1.  
Operator: Simcoe, LLC OGRID #: 329736  
Address: 1199 Main Ave., Suite 101, Durango, CO 81301  
Facility or well name: Day #005M  
API Number: 30-045-30901 OCD Permit Number: \_\_\_\_\_  
U/L or Qtr/Qtr G Section 18 Township 29N Range 8W County: San Juan  
Center of Proposed Design: Latitude 36.72571201 Longitude -107.7118712 NAD83  
Surface Owner: ☒ Federal ☐ State ☐ Private ☐ Tribal Trust or Indian Allotment

**Closure Report (required within 60 days of closure completion):** 19.15.17.13 NMAC

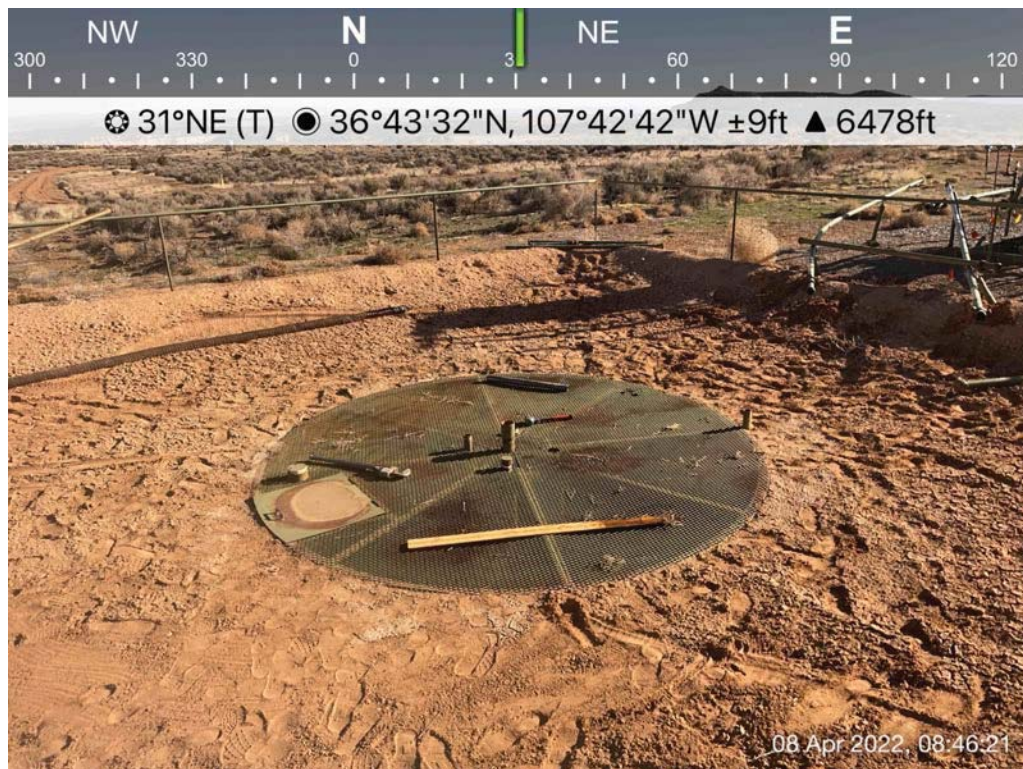
Photo 2: 95 bbls steel tank prior to removal, 4/8/2022.

With regards to the captioned subject well and requirements of the NMOCD Pit Rule 19.15.17.13, this letter is notification that SIMCOE LLC is planning to close a 95 bbl BGT that will be replaced with a 95 bbl at the above well site. We anticipate this work to start on or around April 8, 2022 at 9:30 AM.

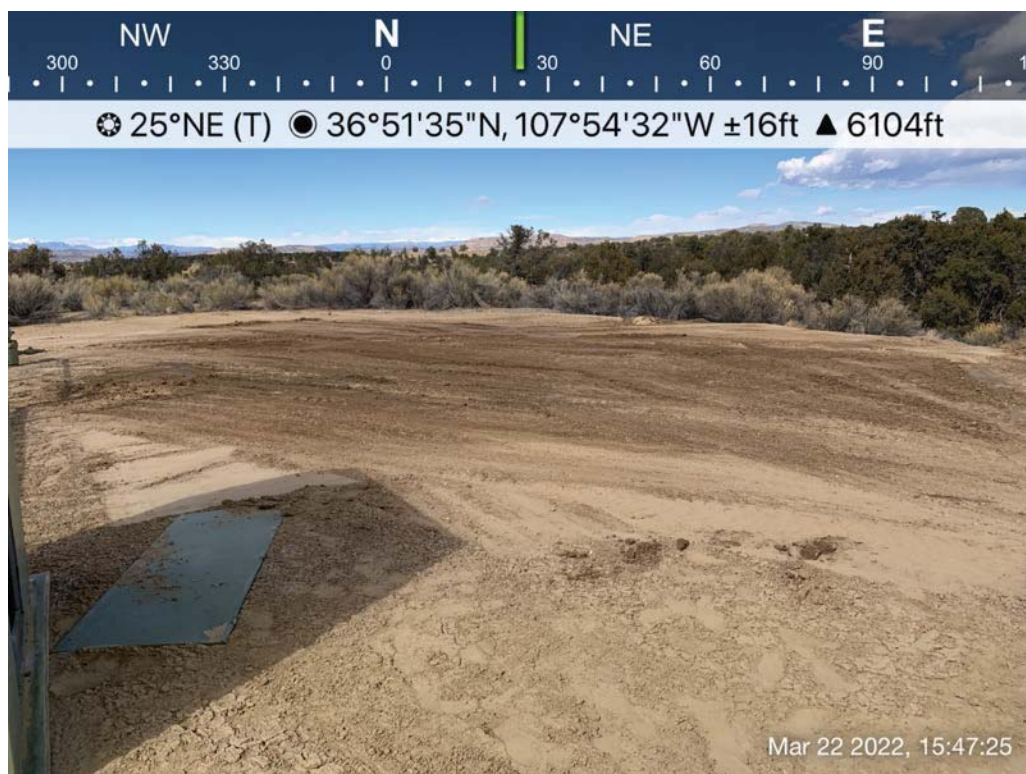
**No evidence of a release. The BGT was replaced.**

Photo 4: Former location of BGT following removal, 4/8/2022.

**The BGT was replaced. No reclamation to be done at this time as former BGT location is located on well pad within area needed for production operations or subsequent drilling.**

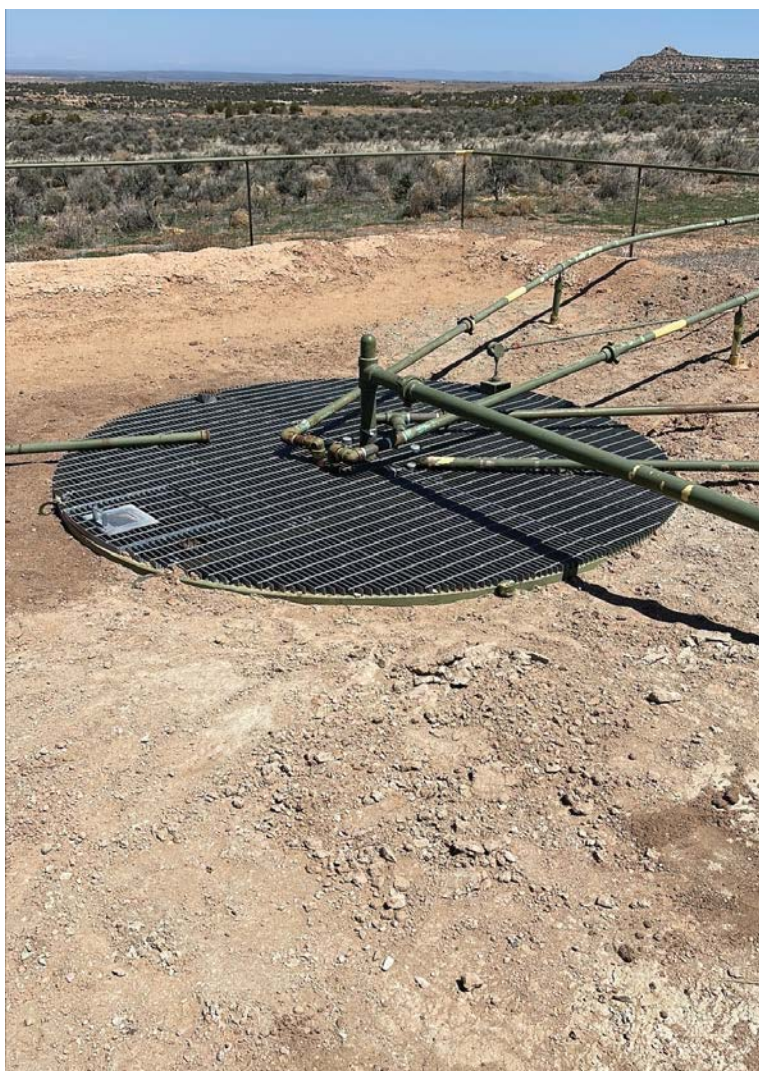
Photo 5: Replaced BGT, 4/8/2022.

**The BGT was replaced and equipment remained on site.**
