Pit, Below-Grade Tank, or  
Proposed Alternative Method Permit or Closure Plan Application

1.  
Operator: Simcoe, LLC OGRID #: 329736  
Address: 1199 Main Ave., Suite 101, Durango, CO 81301  
Facility or well name: NEBU #239  
API Number: 30-045-33213 OCD Permit Number: \_\_\_\_\_  
U/L or Qtr/Qtr N Section 7 Township 31N Range 6W County: San Juan  
Center of Proposed Design: Latitude 36.91023138 Longitude -107.5074671 NAD83  
Surface Owner: ☒ Federal ☐ State ☐ Private ☐ Tribal Trust or Indian Allotment

Northeast Blanco Unit 239 API# 30-045-33213 BGT Closure map 36.910236, -107.507479 Scheduled for closure on 4/6/2022 @ 9:30 AM

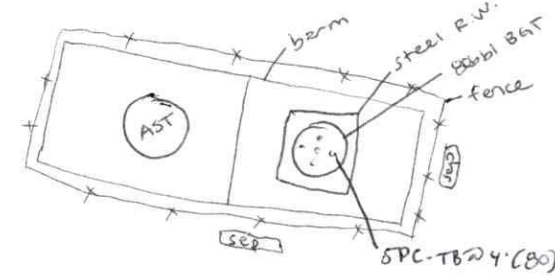
| <b>SITE SKETCH</b><br>BGT Located: off / <u>on</u> site<br>PLOT PLAN circle: <u>attached</u> | |

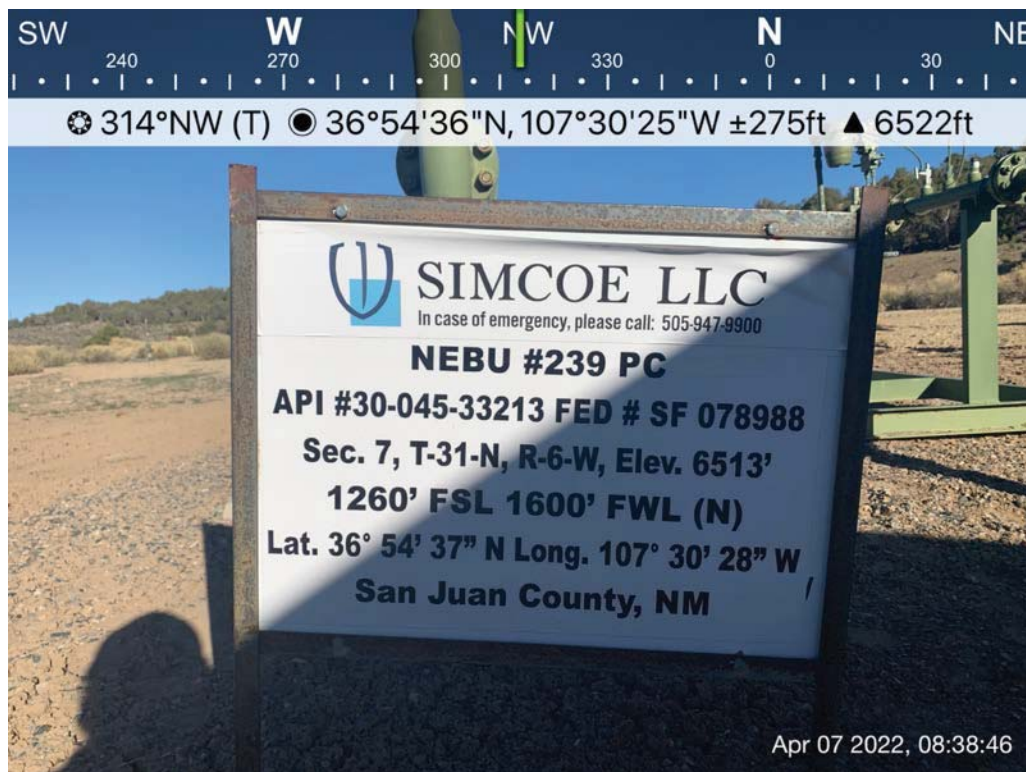
Photo 1: NEBU #239 well sign, 4/7/2022.

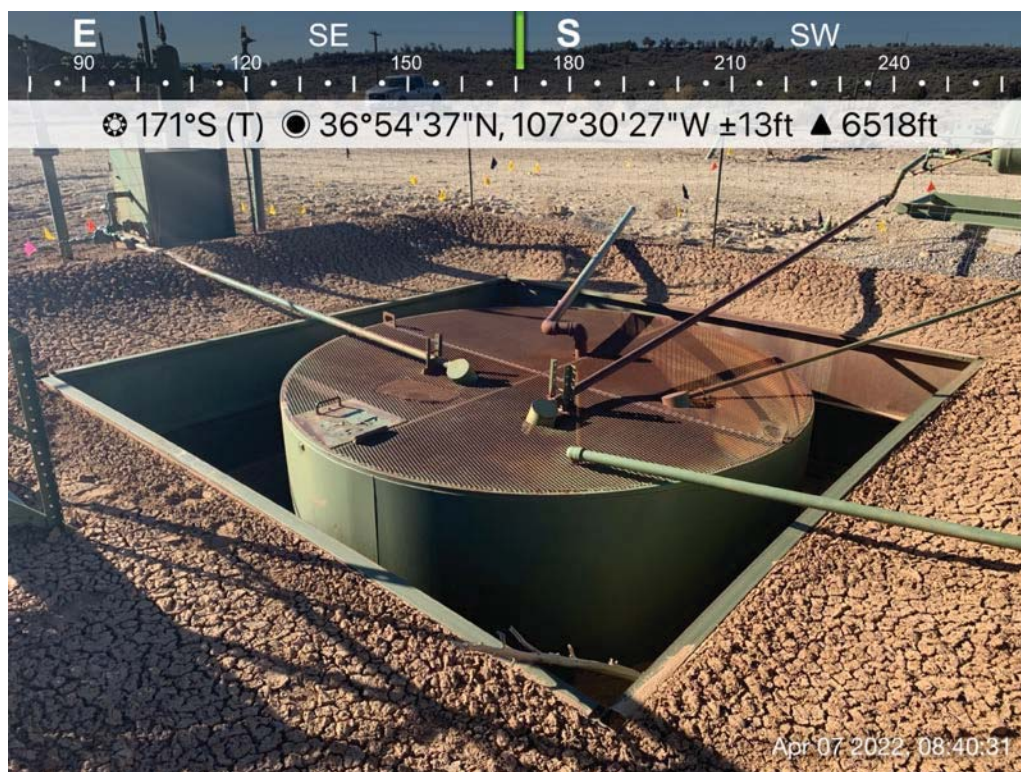
Photo 2: 80 bbls steel tank prior to removal, 4/7/2022.

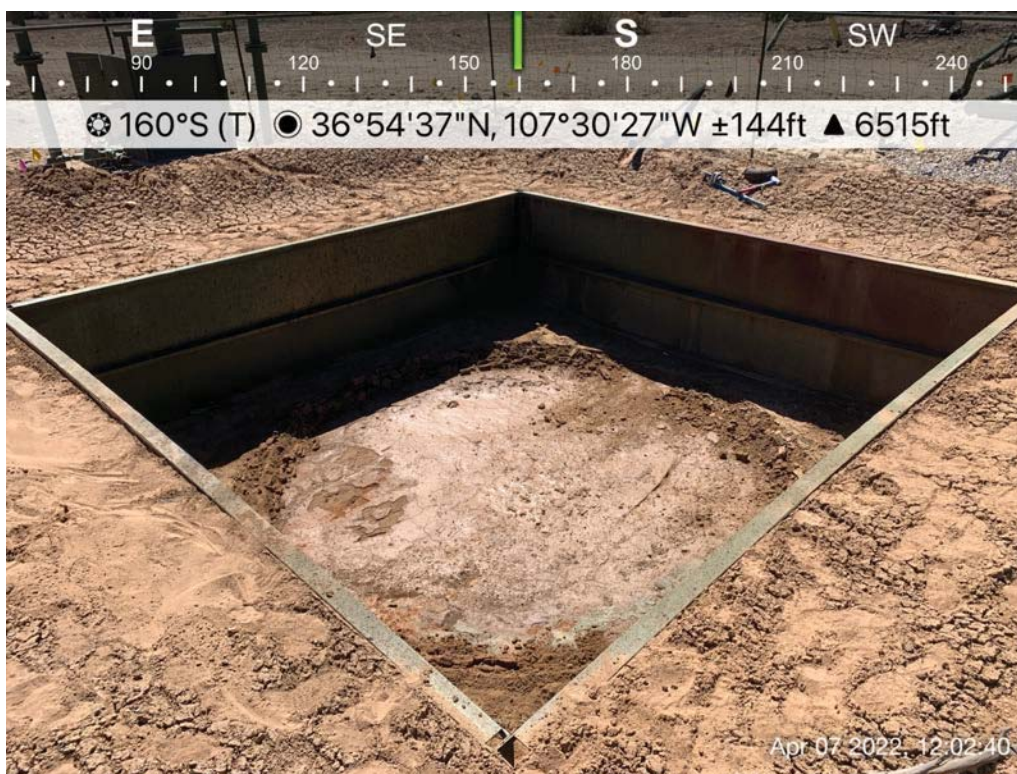
Cause of Release TPH, BTEX, and chloride non-detect based on laboratory analytical results.  
No evidence that a release has occurred.

Photo 3: Former location of BGT following removal, 4/7/2022.

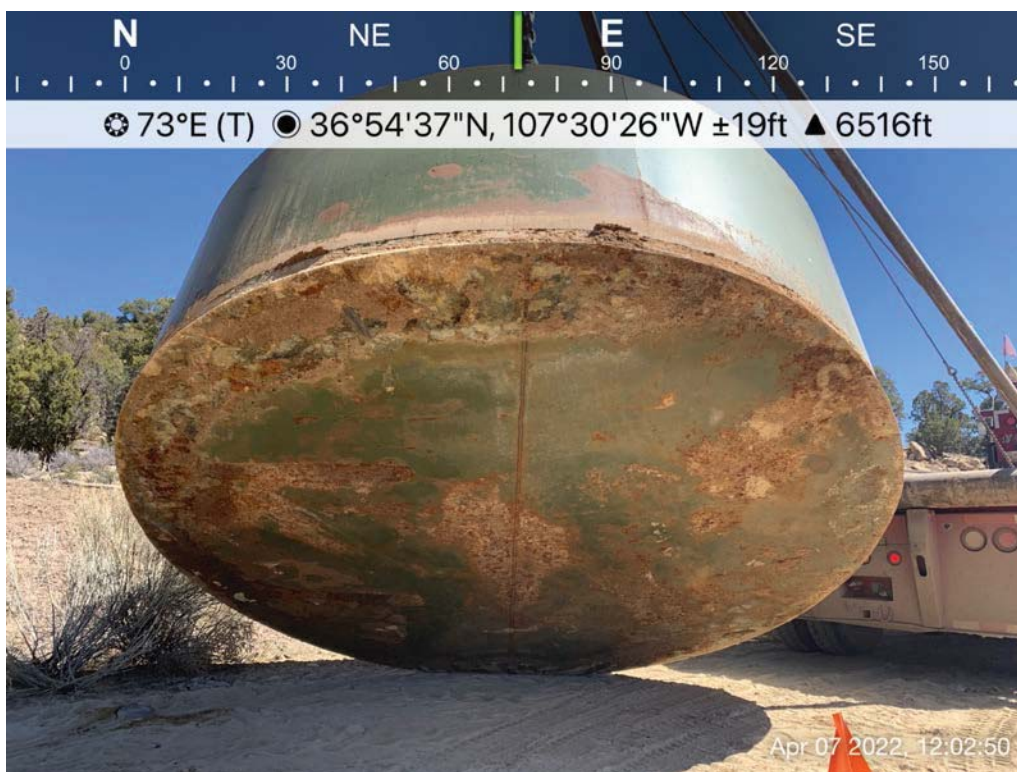
**No evidence of a release. The BGT was replaced.**

Photo 4: Bottom of BGT following removal, 4/7/2022.

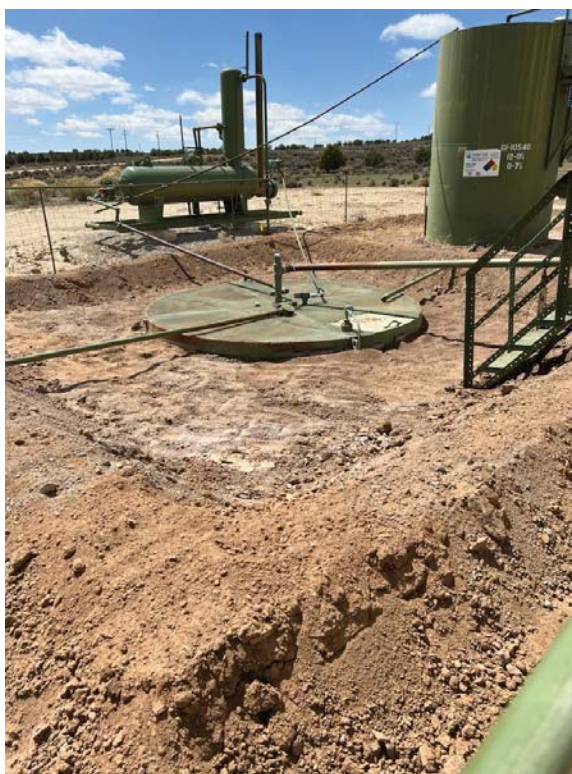
Photo 5: BGT following replacement, 4/7/2022.

**The BGT was replaced and equipment remained on site.**
