Pit, Below-Grade Tank, or
Proposed Alternative Method Permit or Closure Plan Application

Hilcorp Energy Company
San Juan Basin
Below Grade Tank Closure Report

Lease Name: Federal C 4

API No.: 30-045-33692

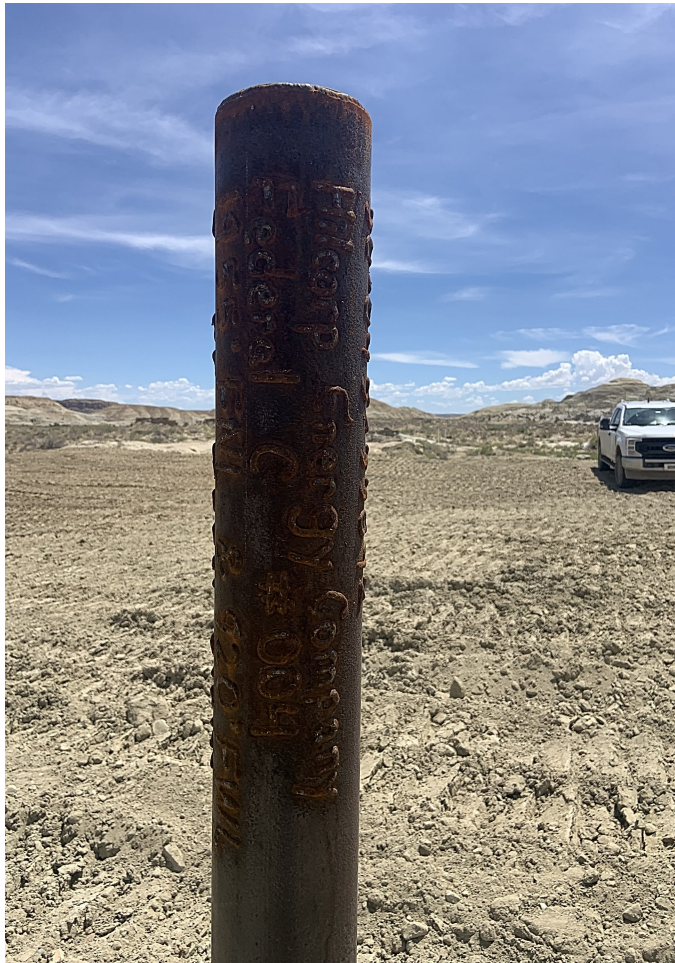
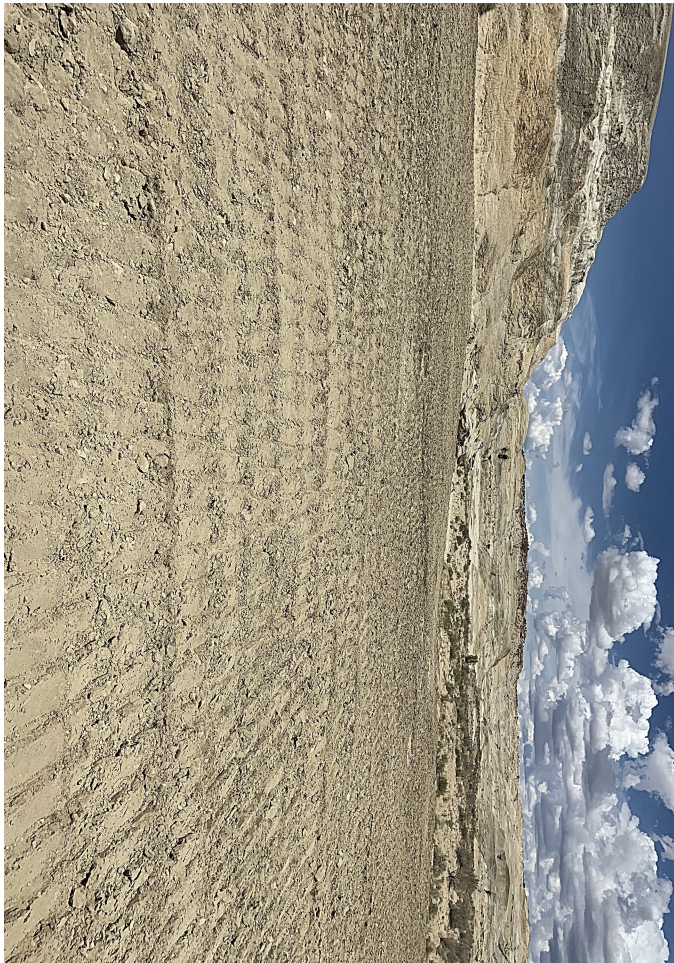
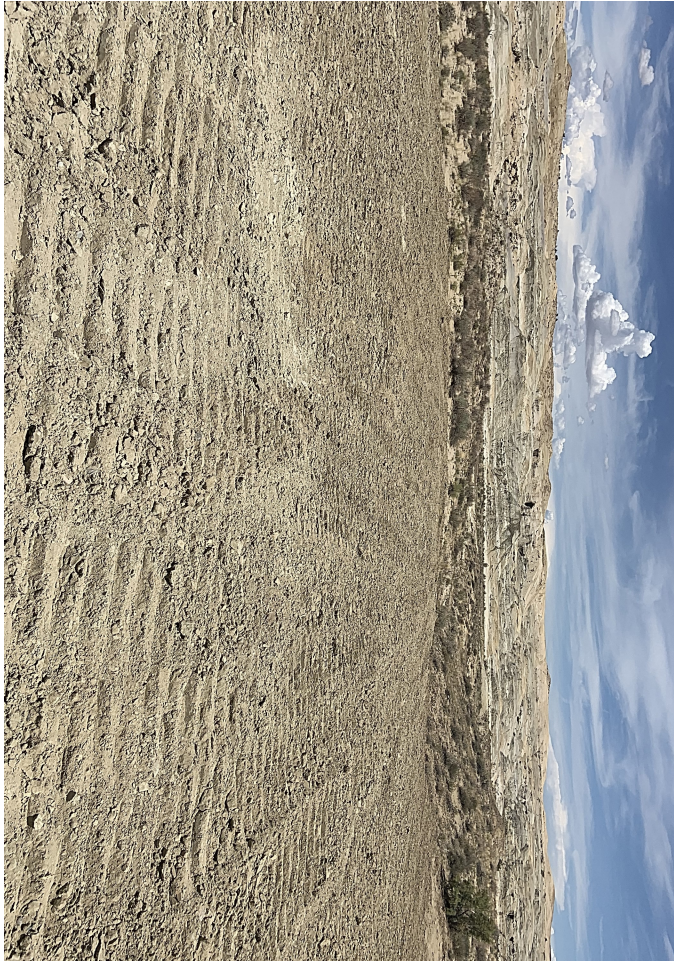
Post BGT Closure Photos

The below-grade tank area passed all requirements of Paragraph (4) of Subsection E of 19.15.17.13 NMAC and was backfilled with compacted, non-waste containing, earthen material.
