Pit, Below-Grade Tank, or
Proposed Alternative Method Permit or Closure Plan Application

Hilcorp Energy Company
San Juan Basin
Below Grade Tank Closure Report

Lease Name: Federal Gas Com 1

API No.: 30-045-07196

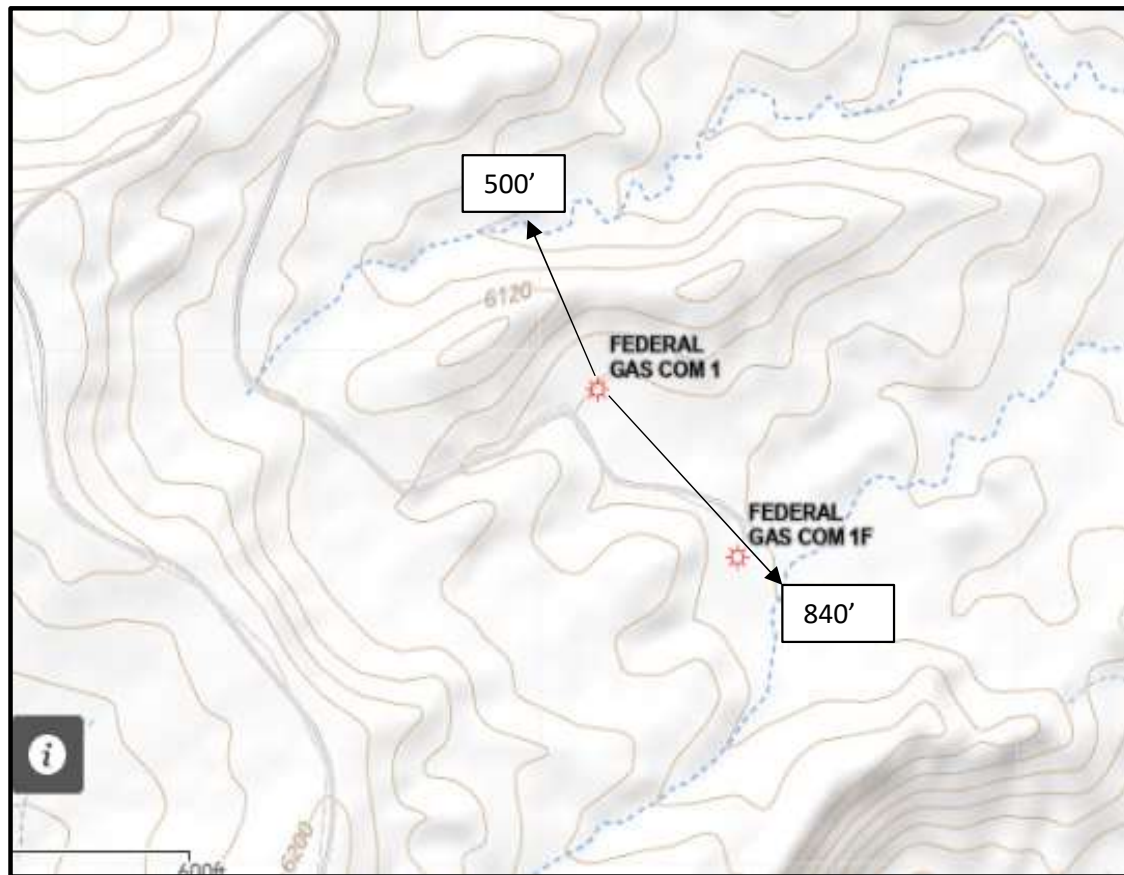
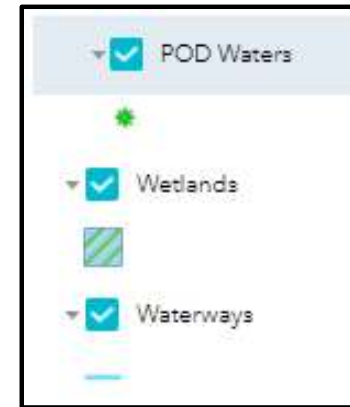
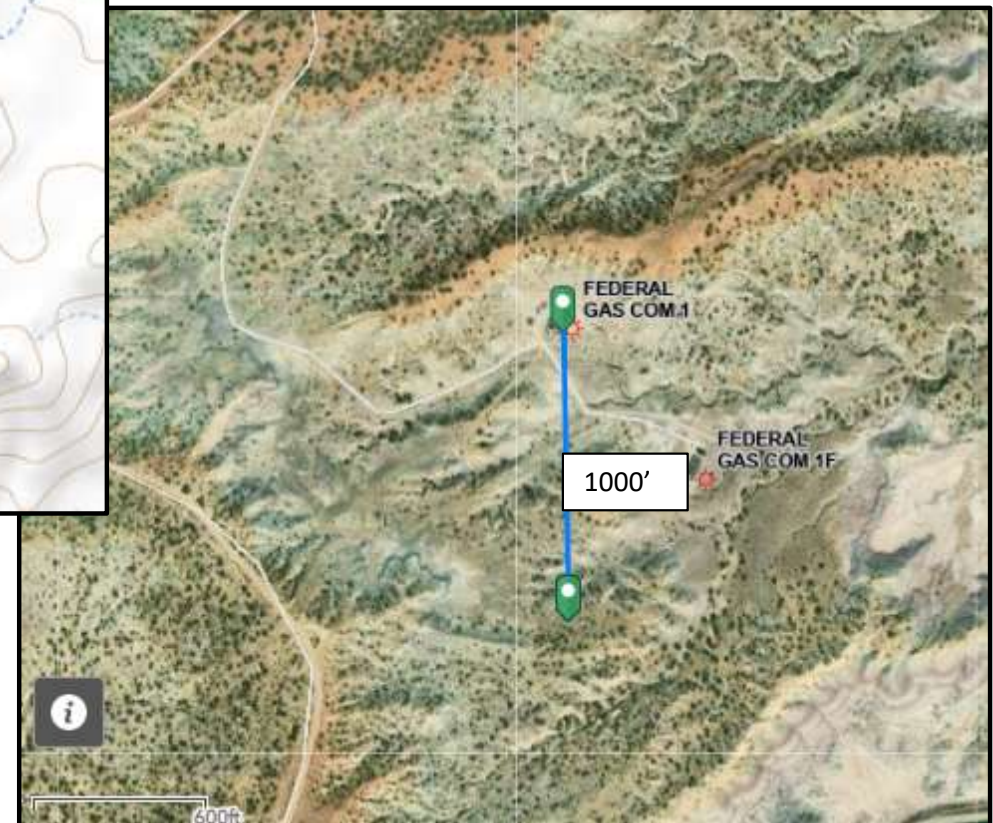
NMAC 19.15.29 Siting Criteria for Closure Standards

The pit will be located on a relatively flat mesa top at an elevation of approximately 6064 feet. It will be approximately 3131 feet from the Kutz Canyon tributary system and 3.60 miles east of Kutz Wash. Groundwater is expected to be shallow within Kutz Wash. However, the significant distance between the Canyon and the site, as well as an elevation difference of over 300 feet suggests groundwater is greater than 100 feet at the proposed site.

BGT is not shown to be within:

- 300 ft of any continuously flowing watercourse or any other significant water course.
- 200 feet of any lakebed, sinkhole or playa lake
- 300 feet of any occupied permanent residence
- 500 feet of a spring or private, domestic fresh water well.
- 1000 feet of any fresh water well
- 300 feet of a wetland
- Incorporated municipal boundaries
- Overlying a subsurface mine
- An unstable area
- A 100-year floodplain

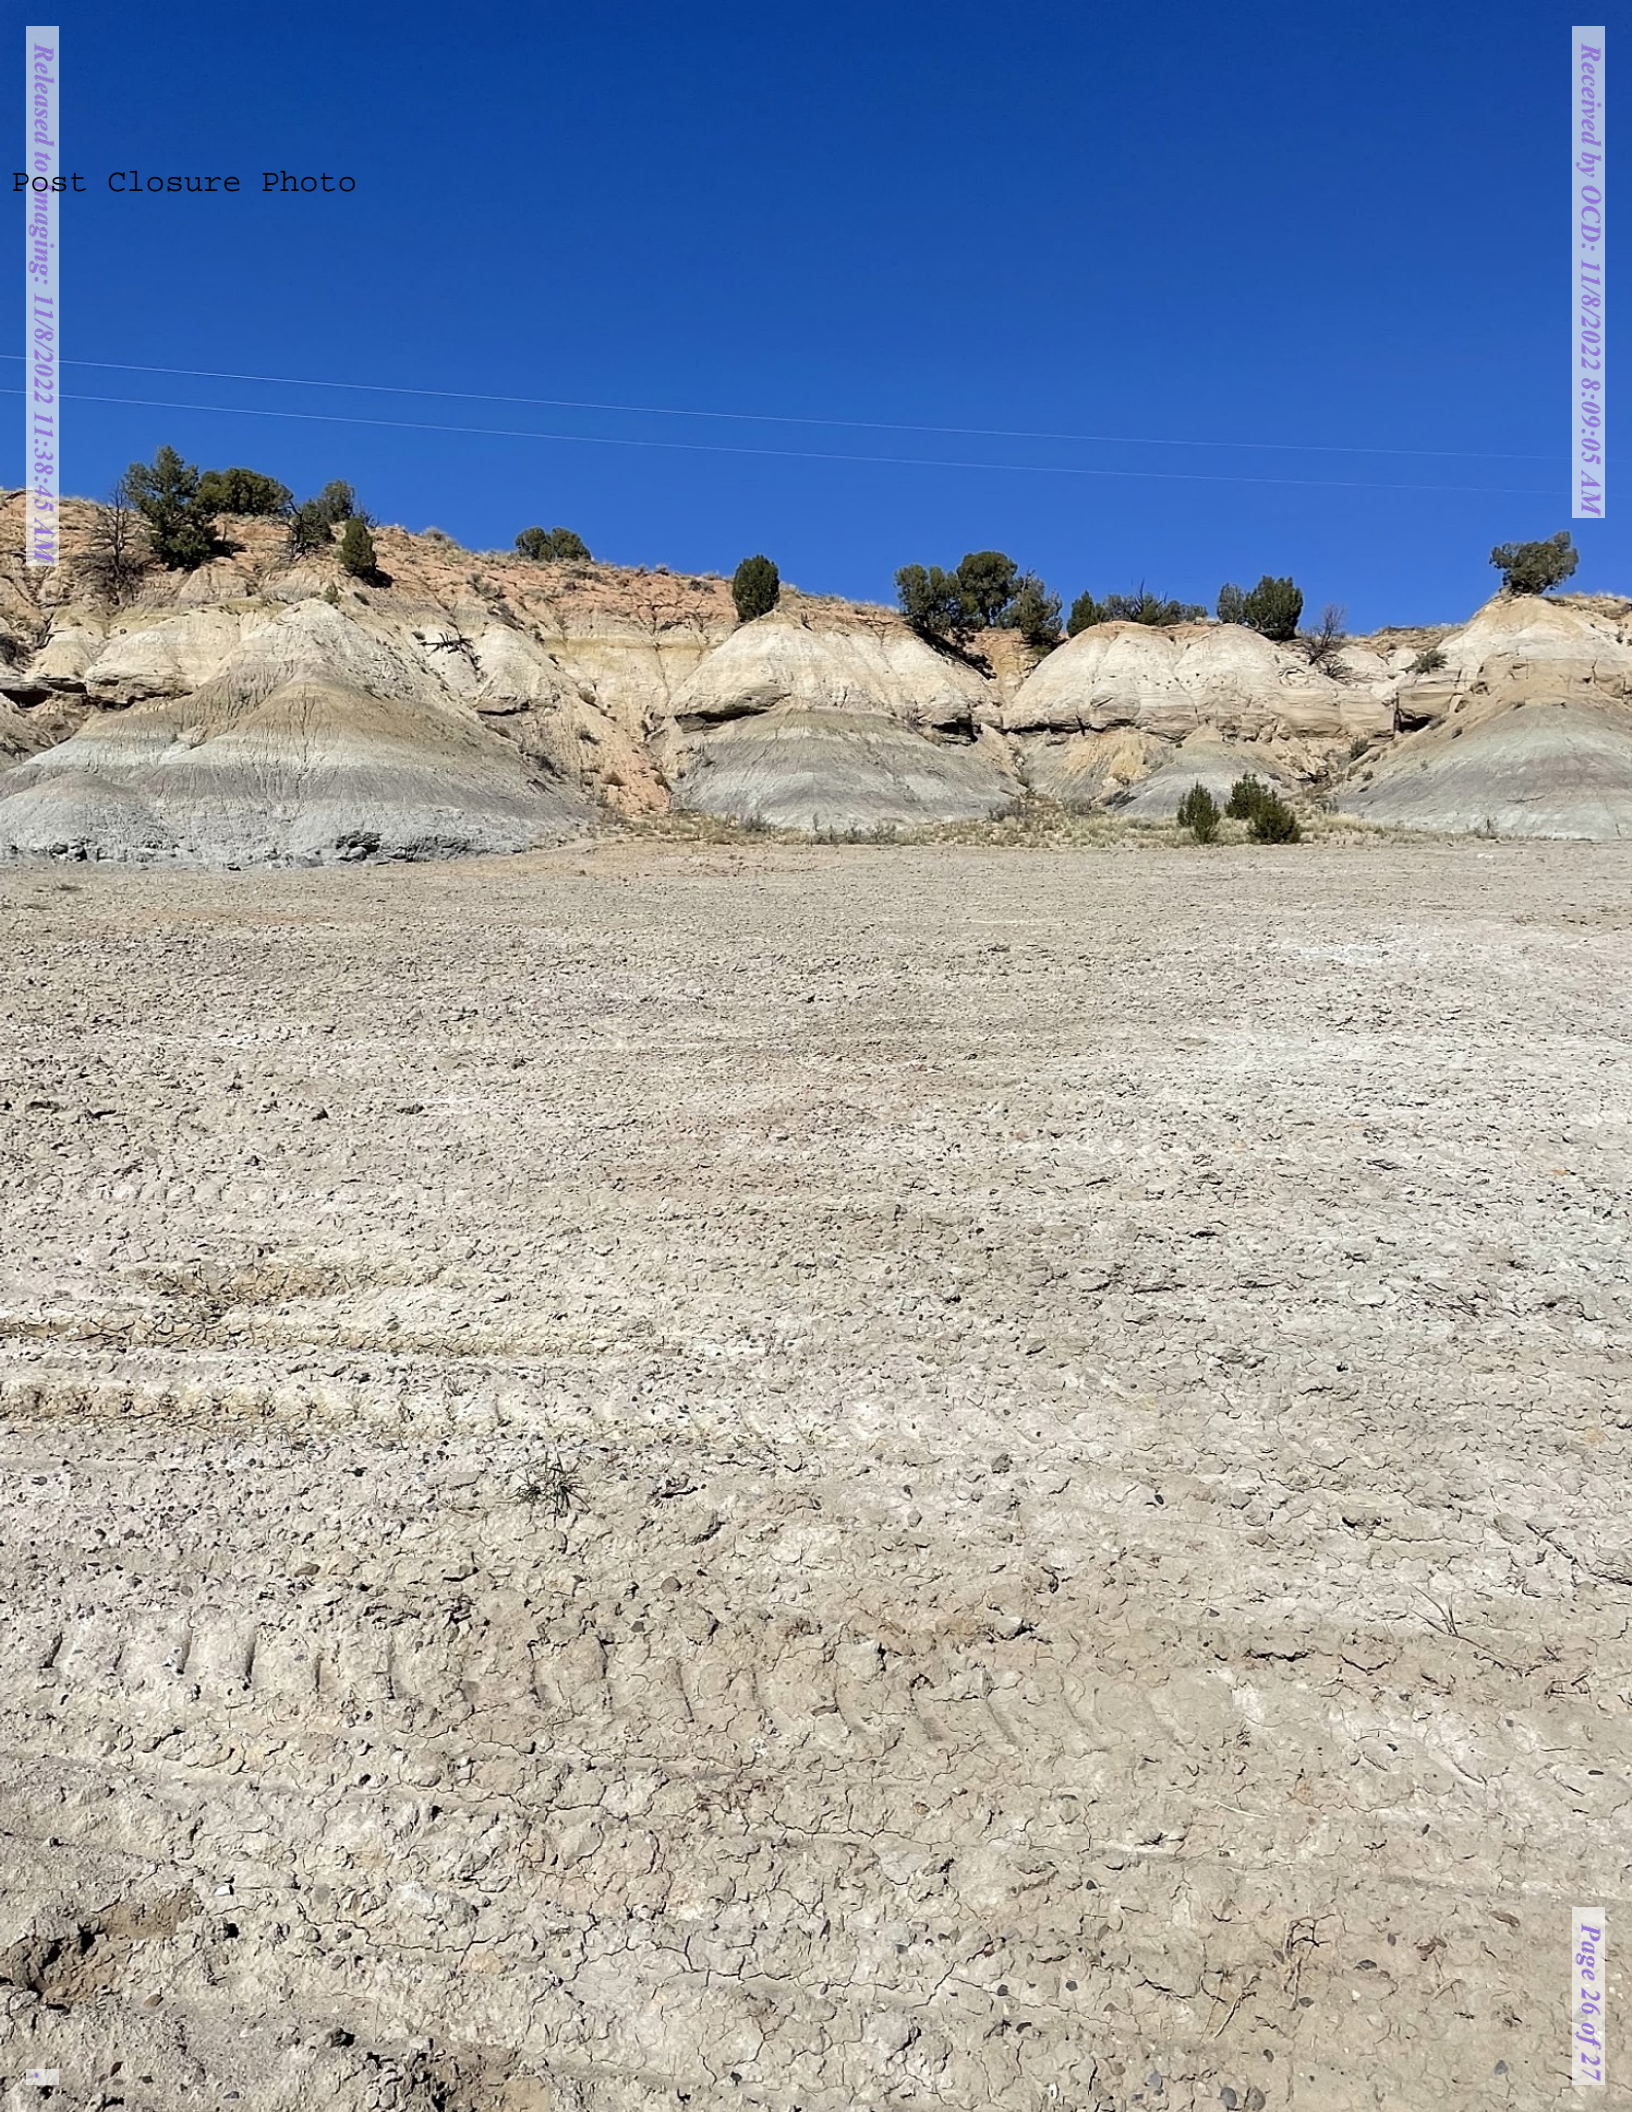
Post Closure Photo

The below-grade tank area passed all requirements of Paragraph (4) of Subsection E of 19.15.17.13 NMAC and was backfilled with compacted, non-waste containing, earthen material.
