Pit, Below-Grade Tank, or
Proposed Alternative Method Permit or Closure Plan Application

Hilcorp Energy Company
San Juan Basin
Below Grade Tank Closure Report

Lease Name: Schwerdtfeger 5 1

API No.: 30-045-27819

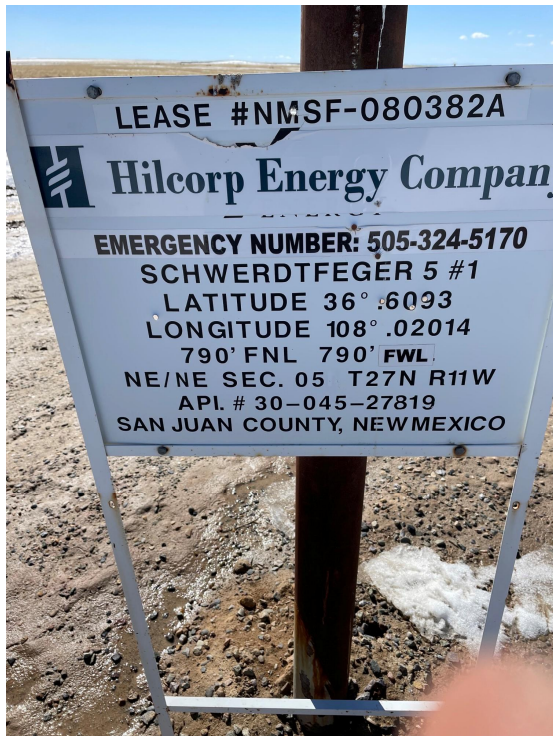
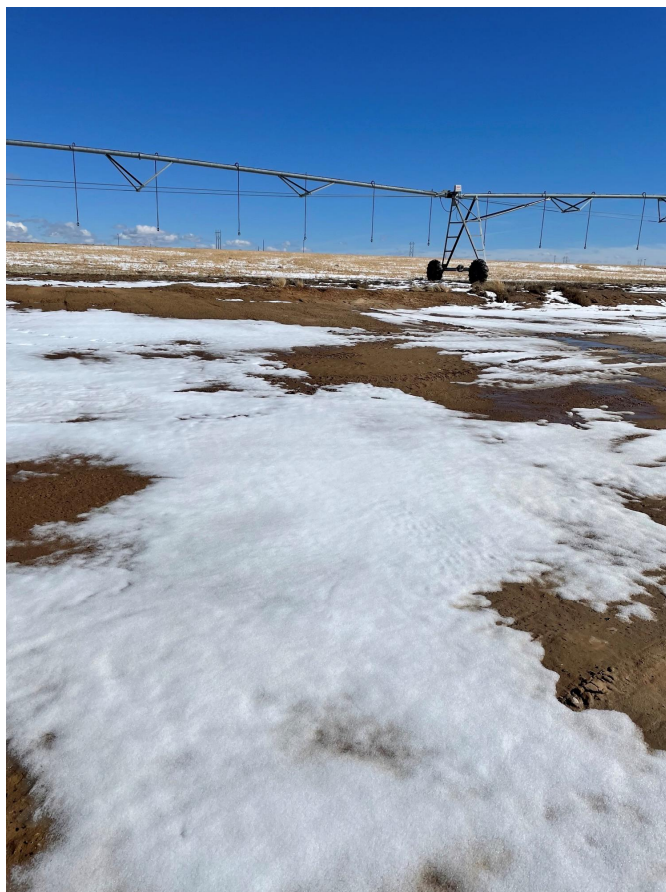
Post Closure Photos

The below-grade tank area passed all requirements of Paragraph (4) of Subsection E of 19.15.17.13 NMAC and was backfilled with compacted, non-waste containing, earthen material.
