Pit, Below-Grade Tank, or
Proposed Alternative Method Permit or Closure Plan Application

**Hilcorp Energy Company
San Juan Basin
Below Grade Tank Closure Report**

Lease Name: State Com A 2

API No.: 30-045-07401

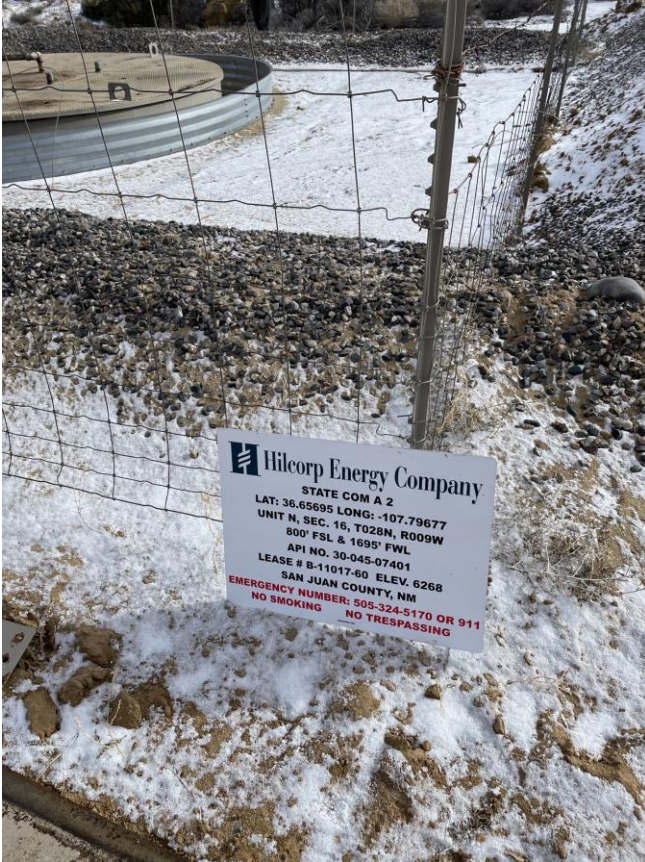
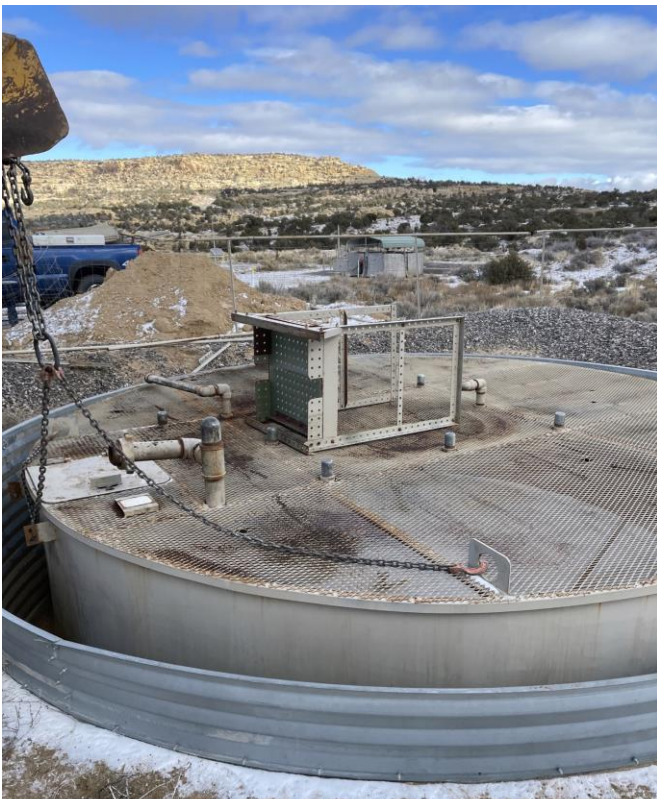
12/14/22, 11:00 am. BGT Before Removal

The below-grade tank was disposed of in a division-approved manner.

All on-site equipment associated with the below-grade tank was removed.

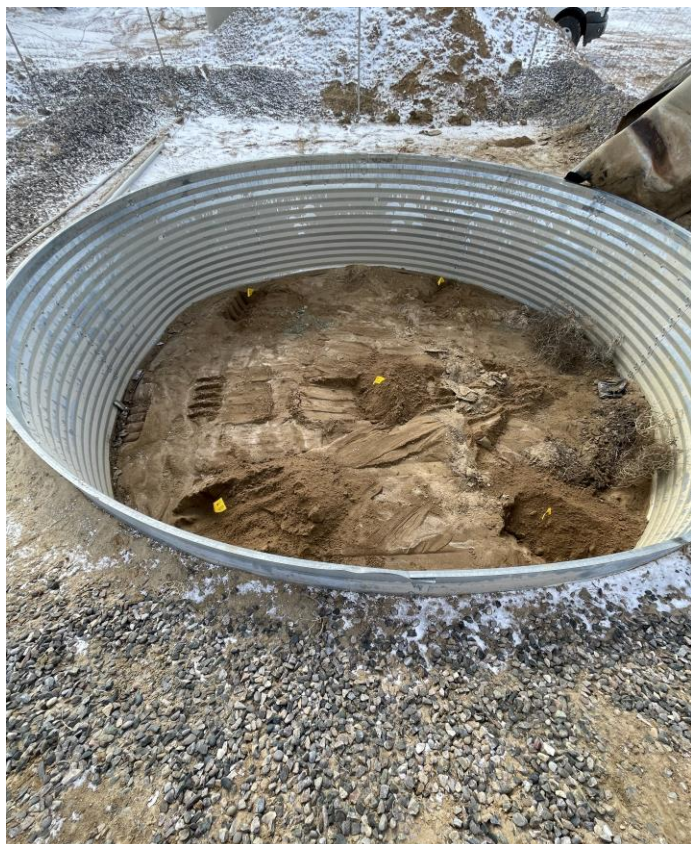
12/14/22, 11:30 am. BGT Soil Samples Taken

A five point composite sample was taken of the below-grade tank using sampling tools and all samples tested per Subsection B of 19.15.17.1 3(B)(1)(b). (Sample results attached). Form C-141 is attached.

A release was not determined for the above referenced well.

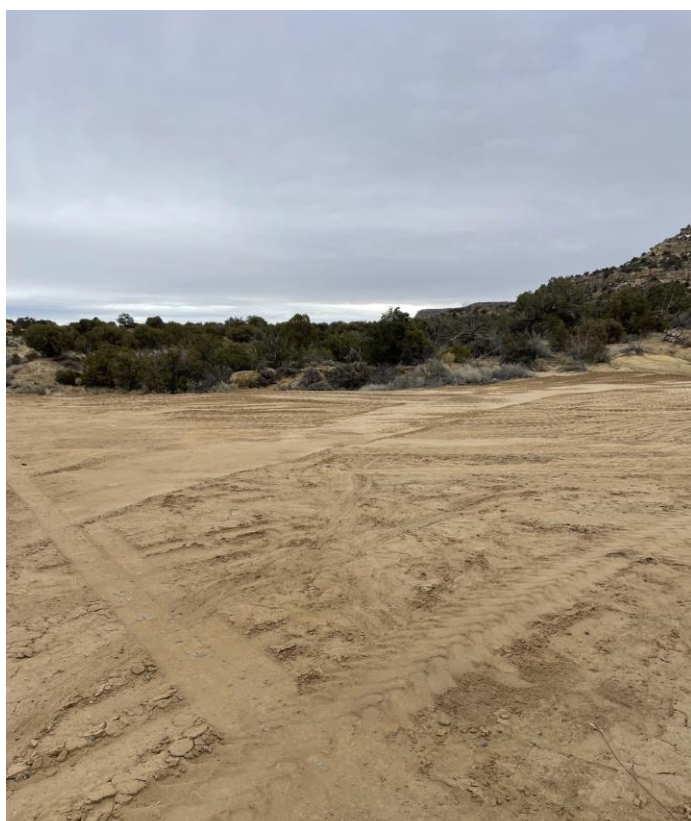
3/10/23, 2:15 pm. Backfill Photo Facing East of Marker.

The below-grade tank area passed all requirements of Paragraph (4) of Subsection E of 19.15.17.13 NMAC and was backfilled with compacted, non-waste containing, earthen material.
