Pit, Below-Grade Tank, or  
Proposed Alternative Method Permit or Closure Plan Application

Hilcorp Energy Company  
San Juan Basin  
Below Grade Tank Closure Report

Lease Name: Huerfano Unit Com 97

API No.: 30-045-05861

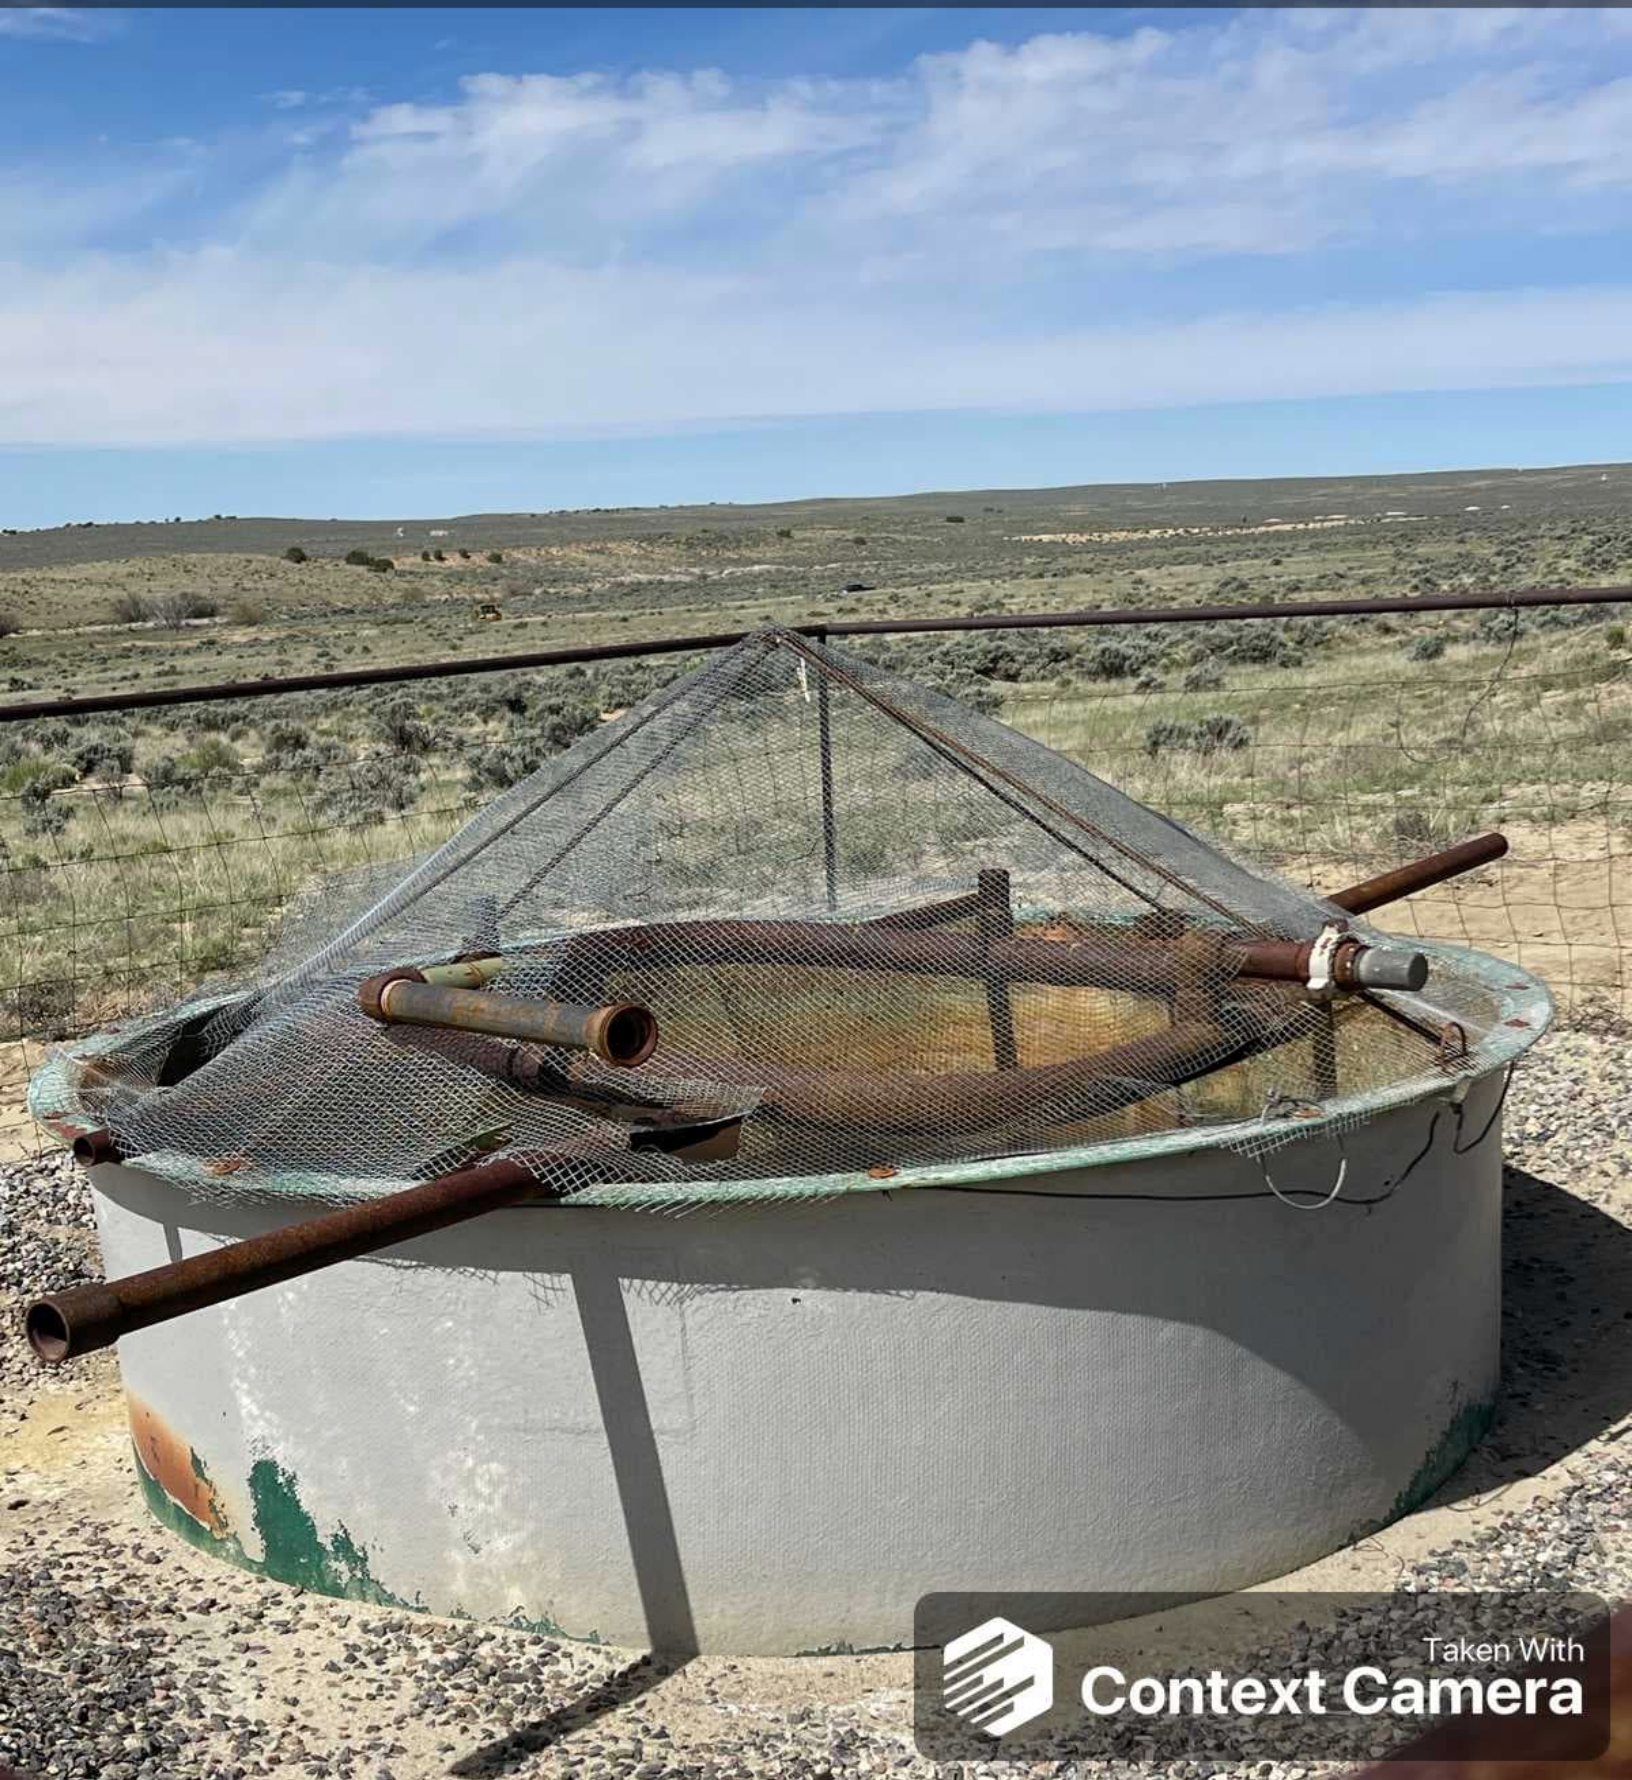
Huerfano Unit  
Com 97

36.49086°N  
107.79724°W

The below-grade tank area passed all requirements of Paragraph (4) of Subsection E of 19.15.17.13 NMAC and was backfilled with compacted, non-waste containing, earthen material.

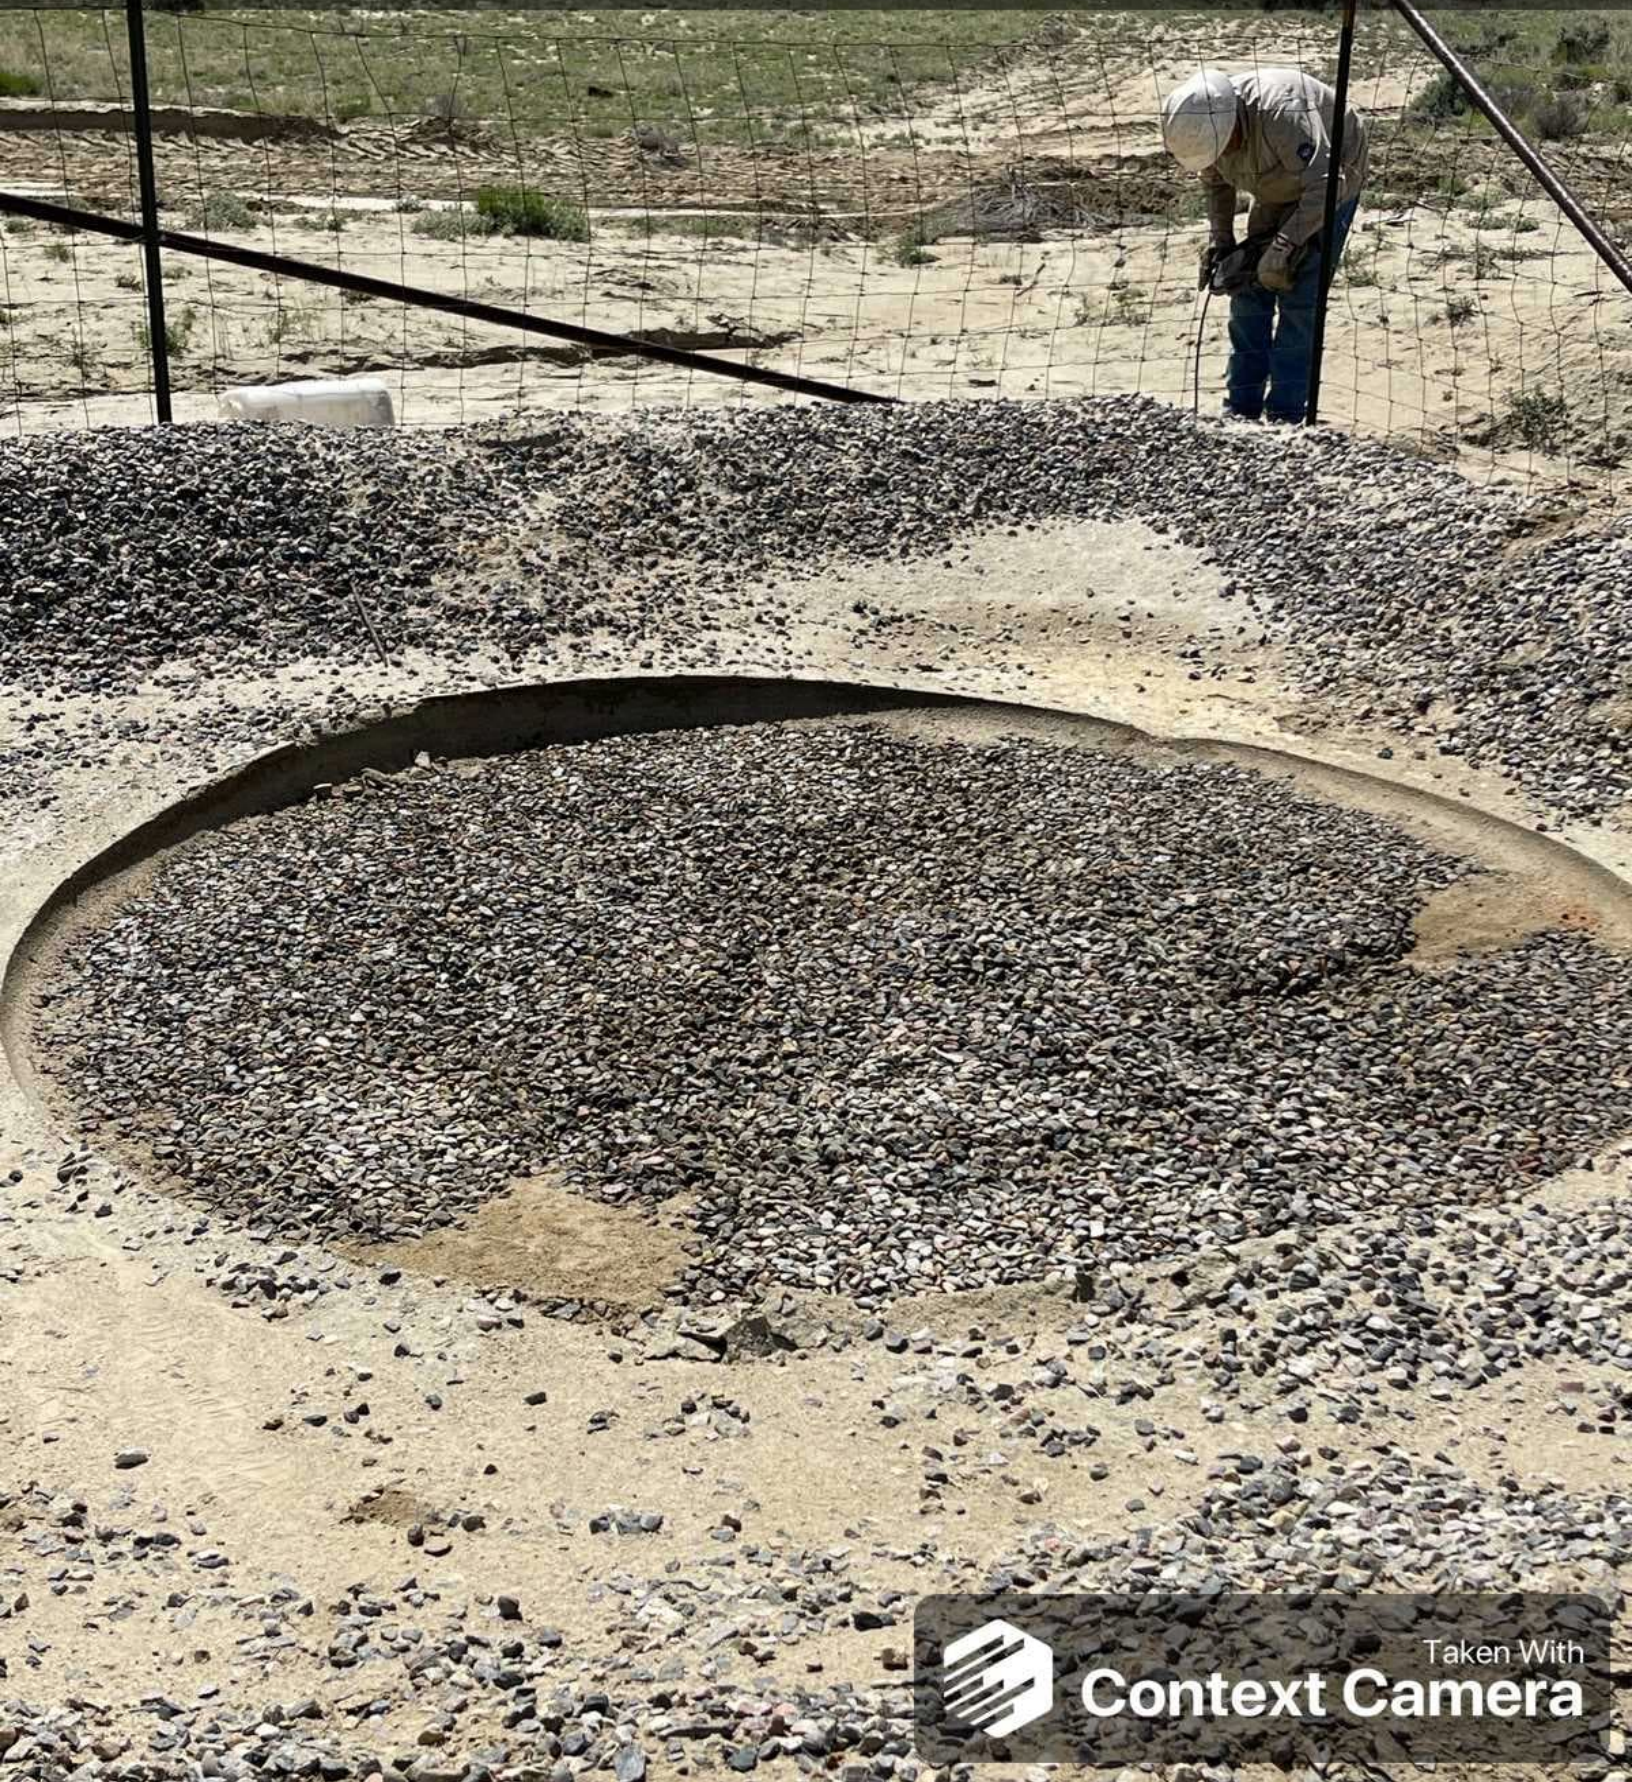
Huerfano Unit  
Com 07

36.49087°N  
107.79731°W

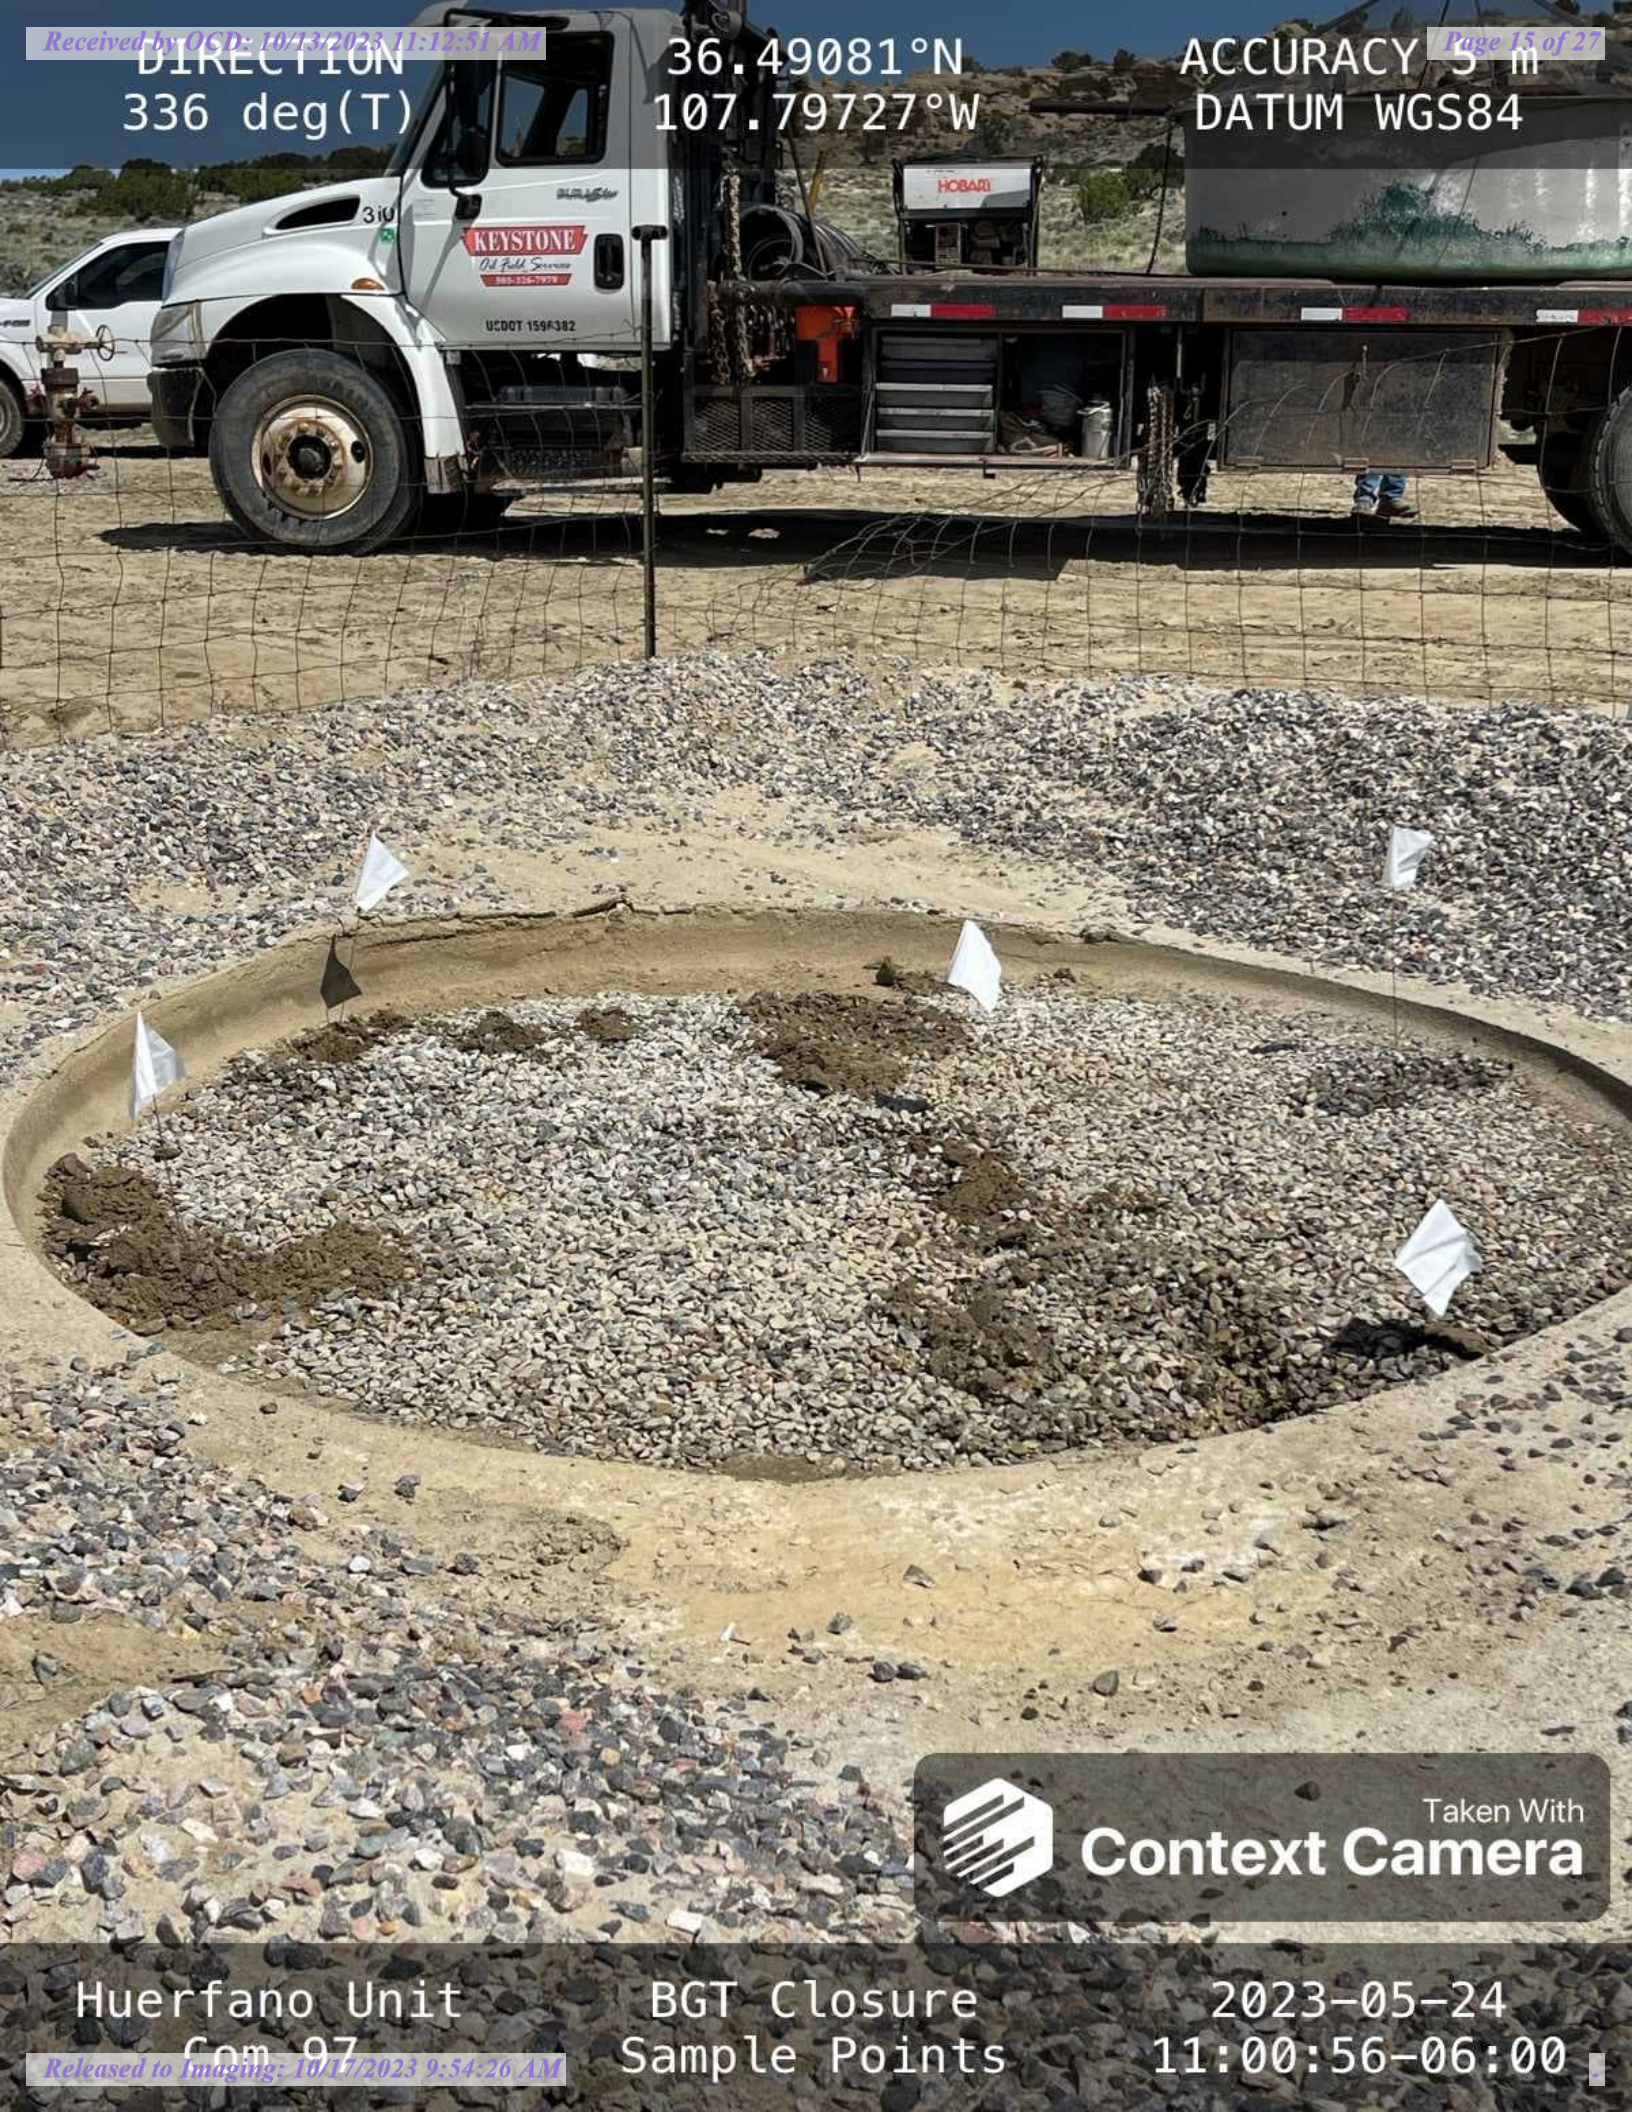
Huerfano Unit  
Com 07

36.49081°N  
107.79727°W
