Pit, Below-Grade Tank, or  
Proposed Alternative Method Permit or Closure Plan Application

1.  
Operator: Hilcorp Energy Company OGRID #: 372171  
Address: 382 Road 3100 Aztec, NM 87410  
Facility or well name: Omler #4  
API Number: 30-045-07080 OCD Permit Number: \_\_\_\_\_  
U/L or Qtr/Qtr B Section 36 Township 28N Range 10W County: San Juan  
Center of Proposed Design: Latitude 36.623107 Longitude -107.843764 NAD27  
Surface Owner: ☒ Federal ☐ State ☐ Private ☐ Tribal Trust or Indian Allotment

Hilcorp Energy Company  
San Juan Basin  
Below Grade Tank Closure Report

Lease Name: Omler 4  
API No.: 30-045-07080

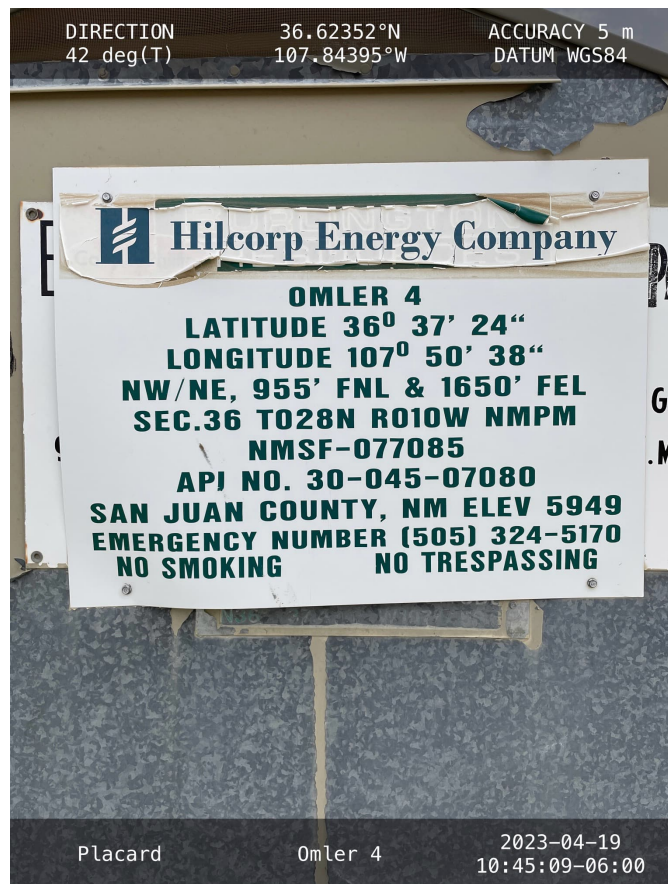
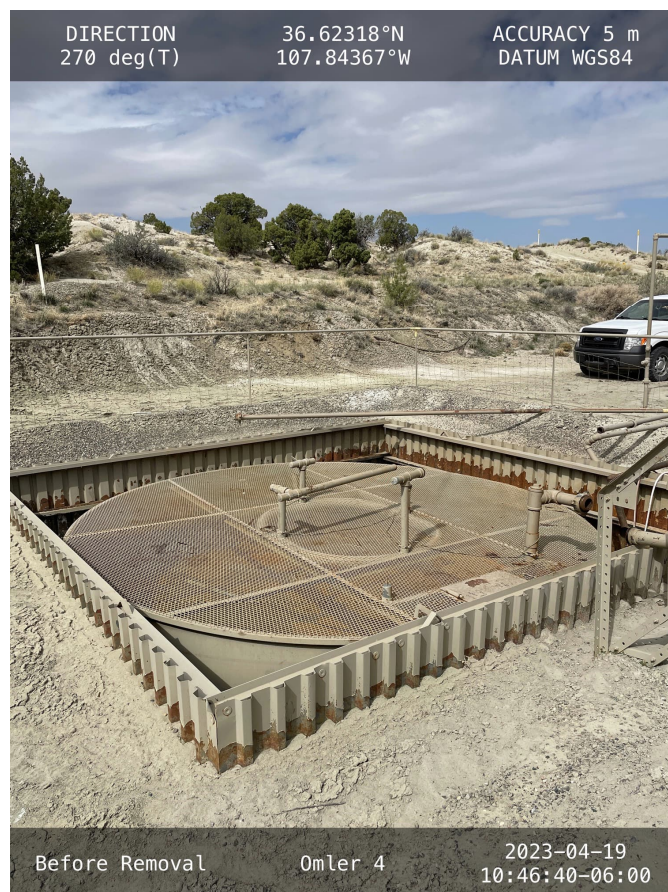
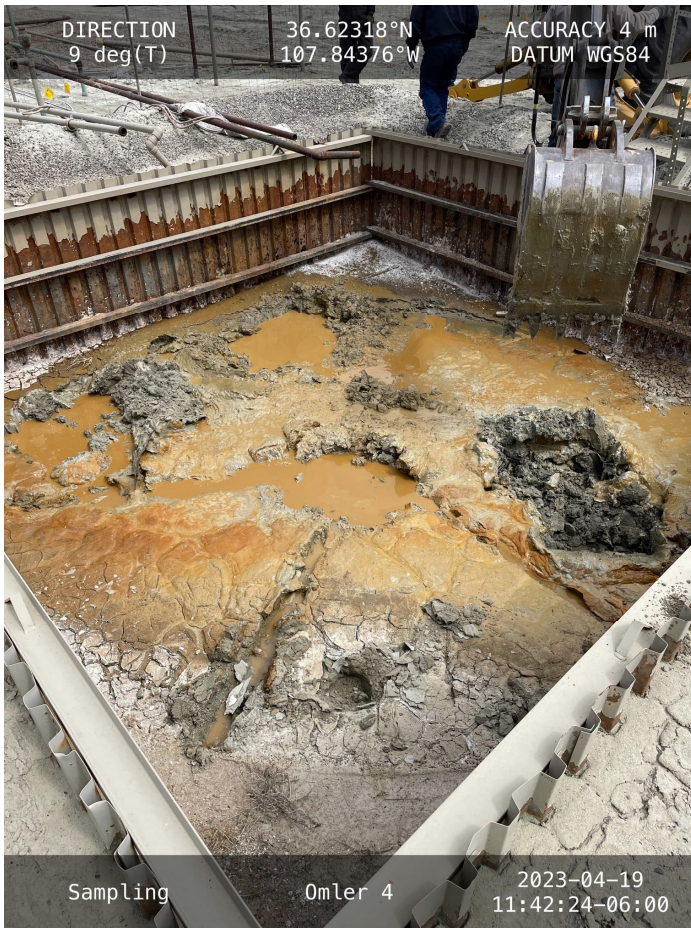
BGT Closure Photos

The below-grade tank area passed all requirements of Paragraph (4) of Subsection E of 19.15.17.13 NMAC and was backfilled with compacted, non-waste containing, earthen material.
