Pit, Below-Grade Tank, or
Proposed Alternative Method Permit or Closure Plan Application

**Hilcorp Energy Company
San Juan Basin
Below Grade Tank Closure Report**

Lease Name: Hanks 22R

API No.: 30-045-30497

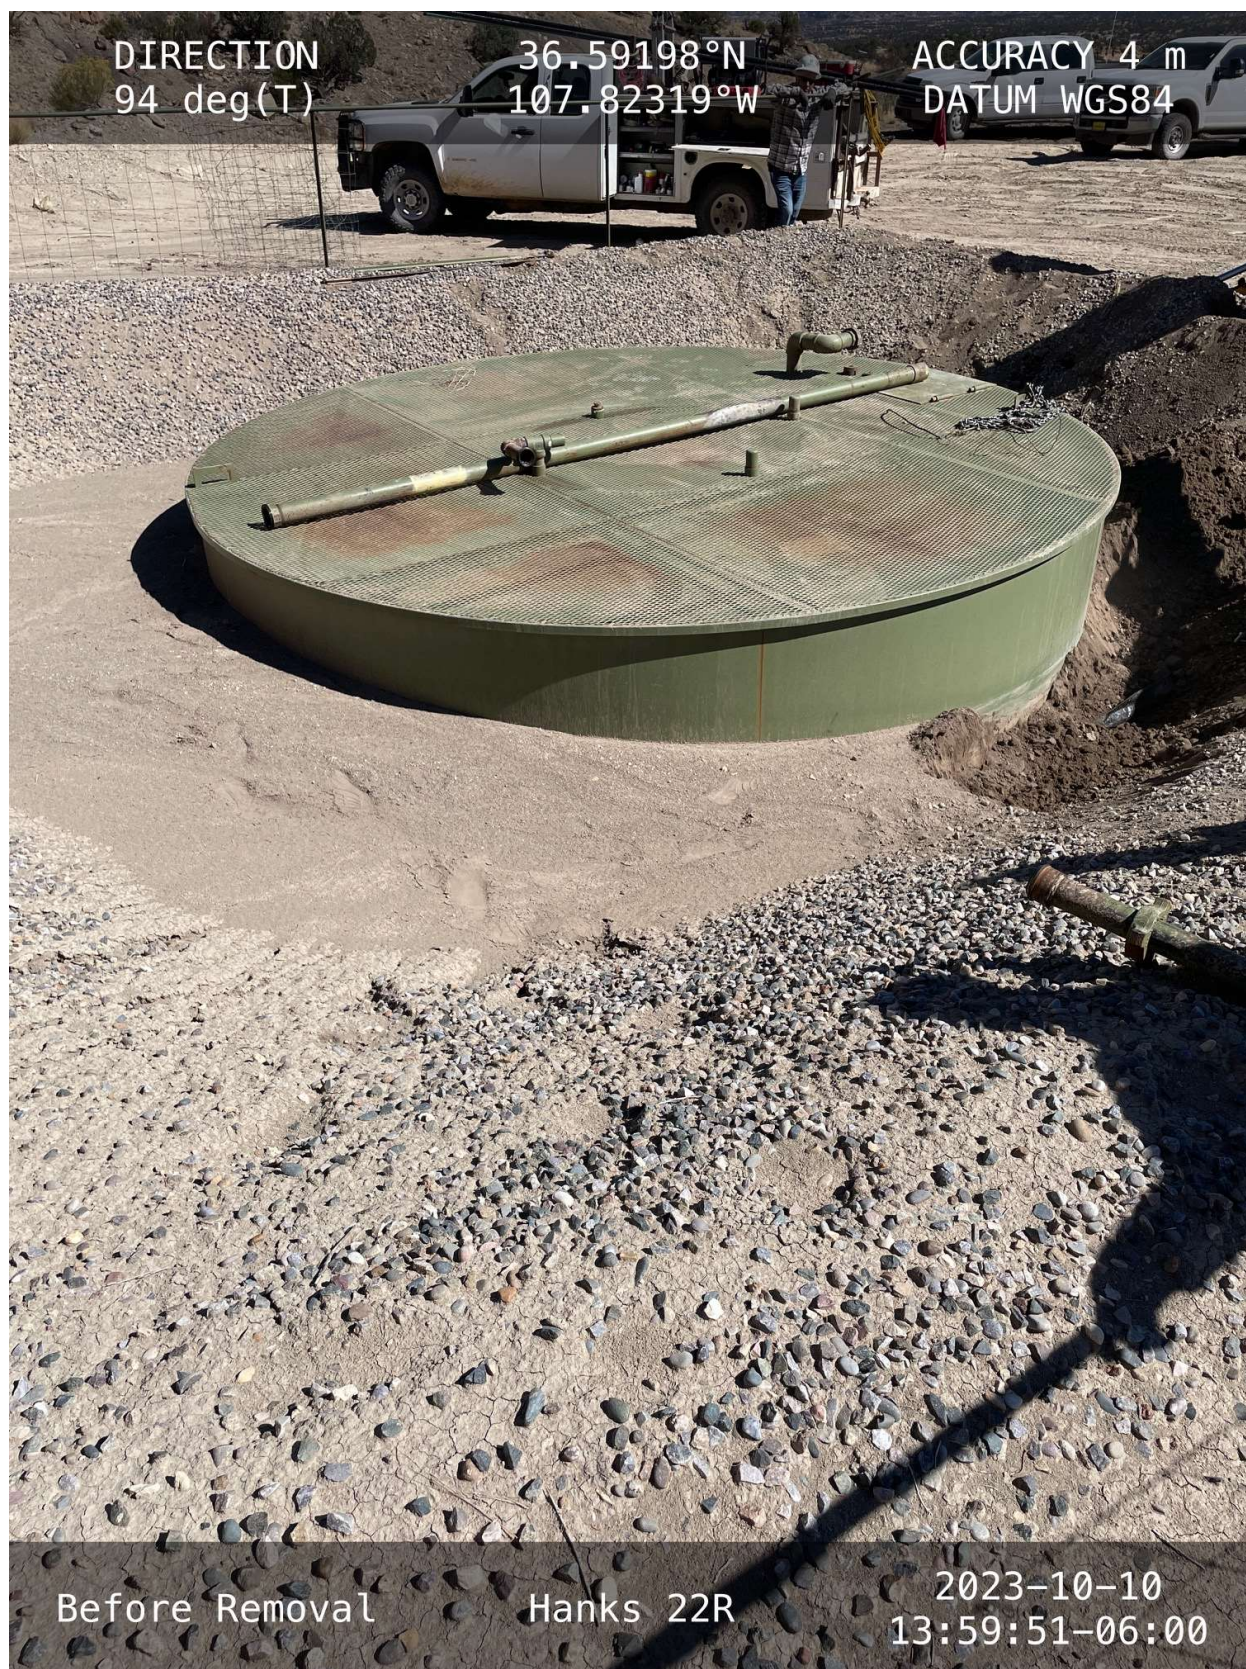
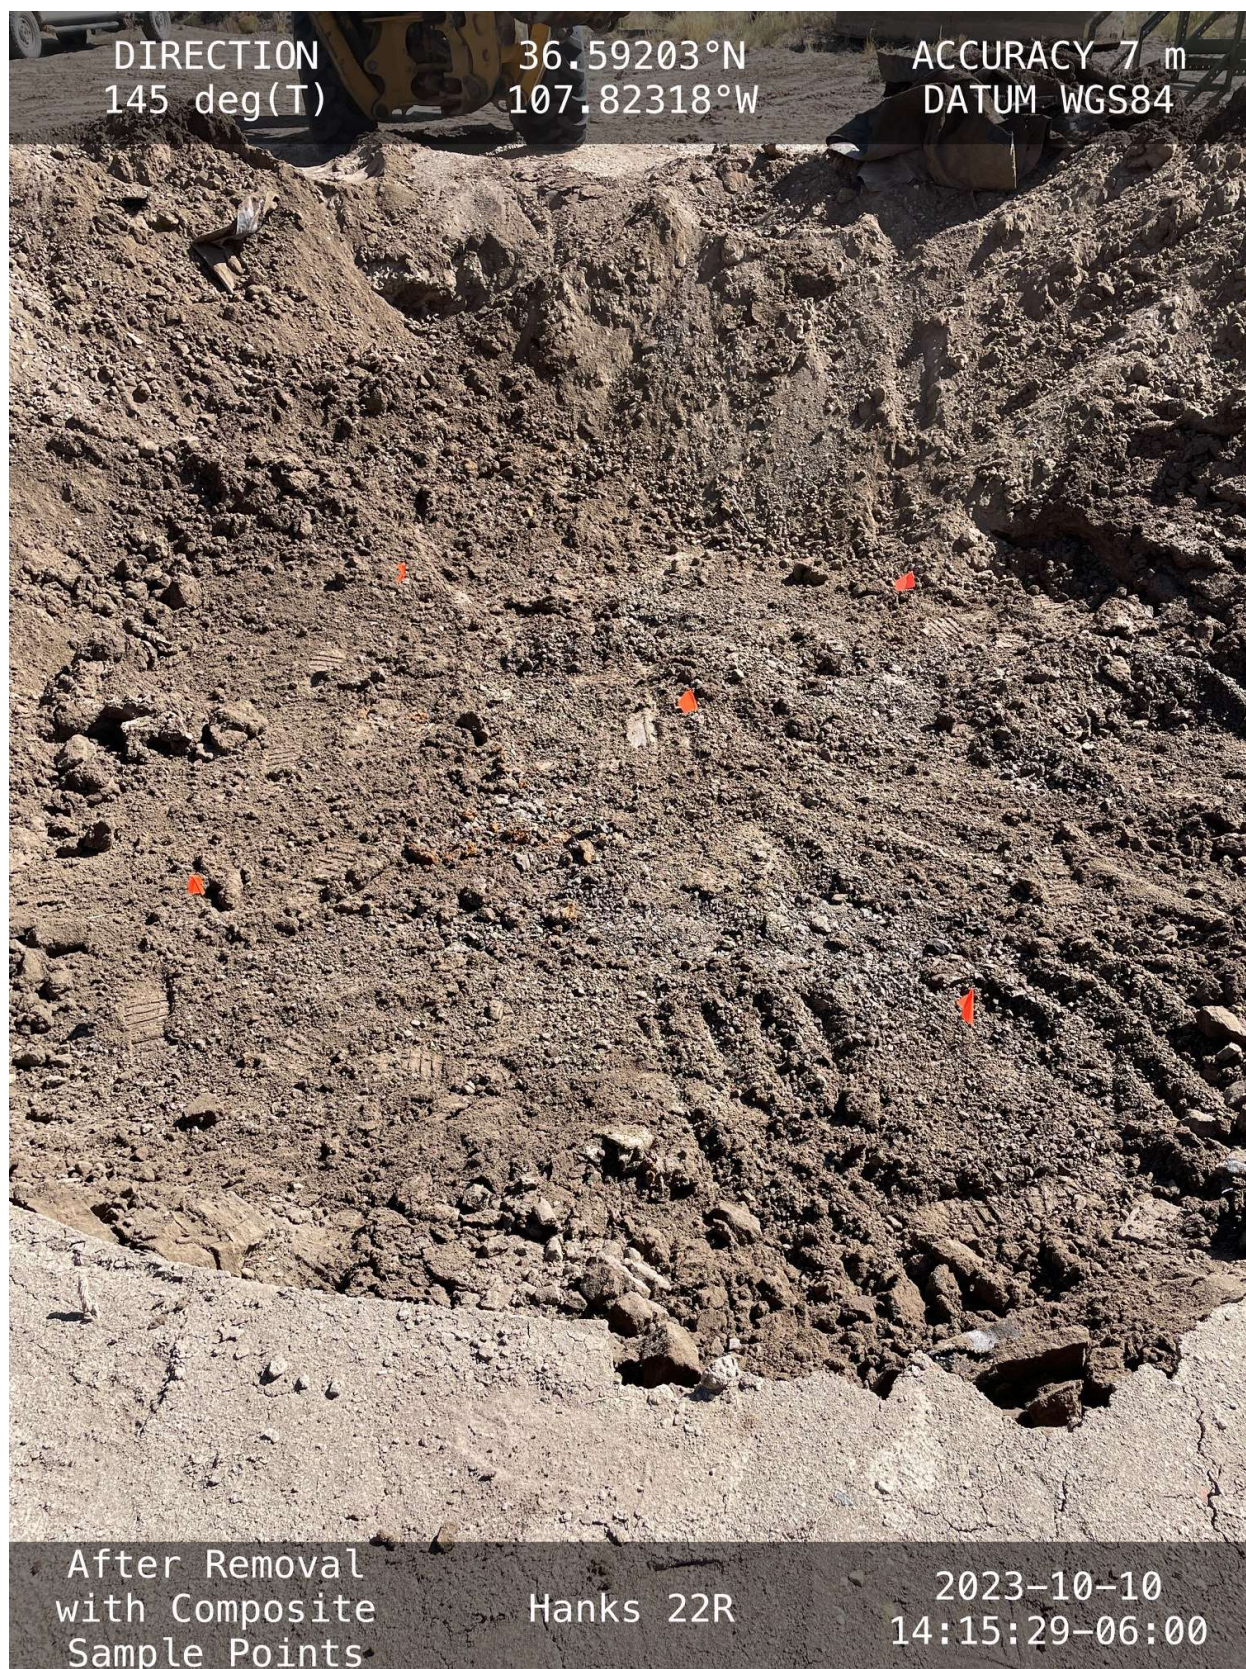
Hanks 22R

2023-10-10
13:47:40-06:00

The below-grade tank area passed all requirements of Paragraph (4) of Subsection E of 19.15.17.13 NMAC and was backfilled with compacted, non-waste containing, earthen material.
