Dugan Production Corp.

Dome Navajo 12-26-13 #90

BGT Closure Report

API# 30-045-29433

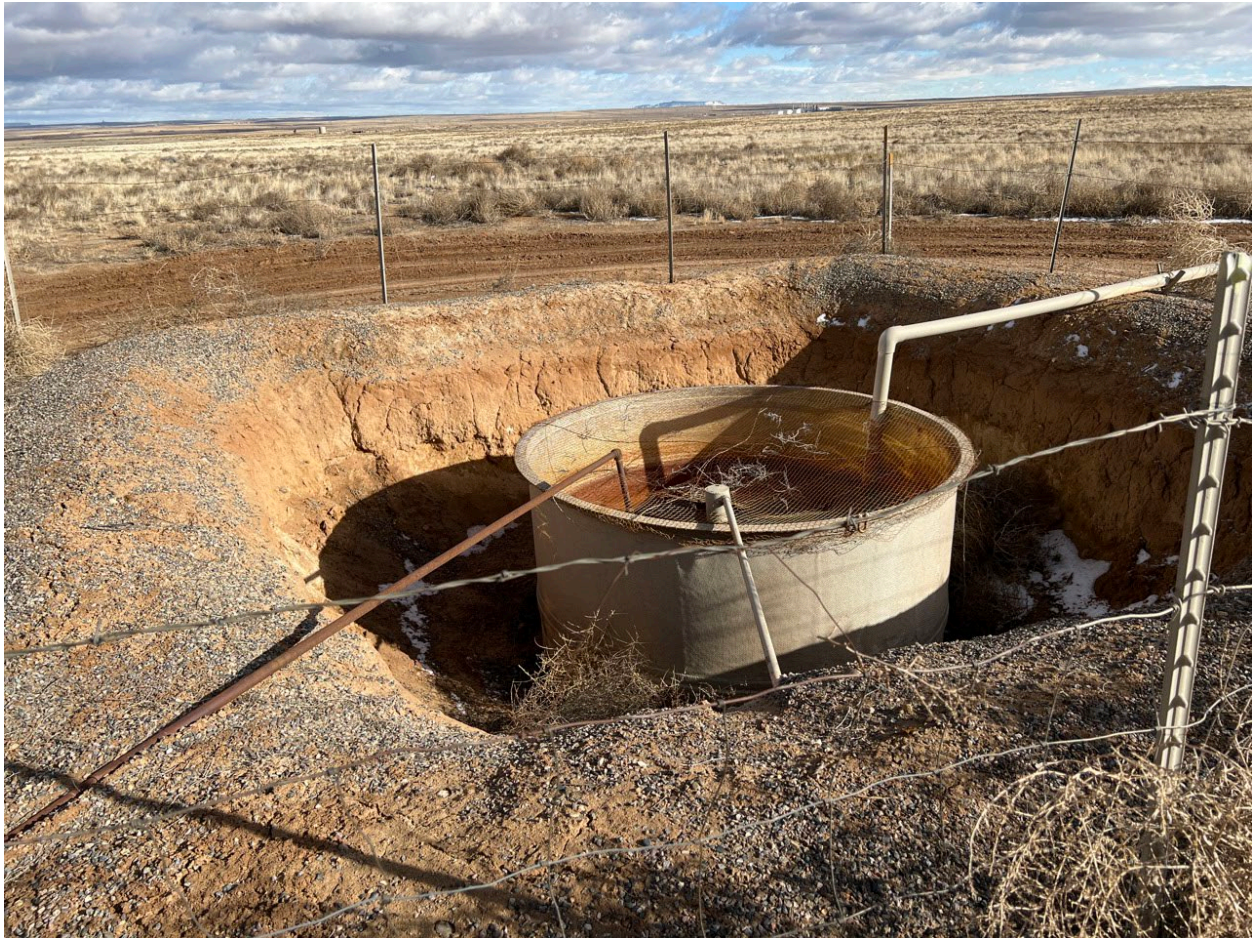
Photo 1: BGT Before Remediation

Dugan Production Corp. will be replacing the below-grade tank (BGT) located at the following well site on **Wednesday January 7th, 2026**. A Crack in the Pit was discovered 1/5/2026. The pit has been removed and remediation has taken place. Before replacement Soil Sampling will be conducted.

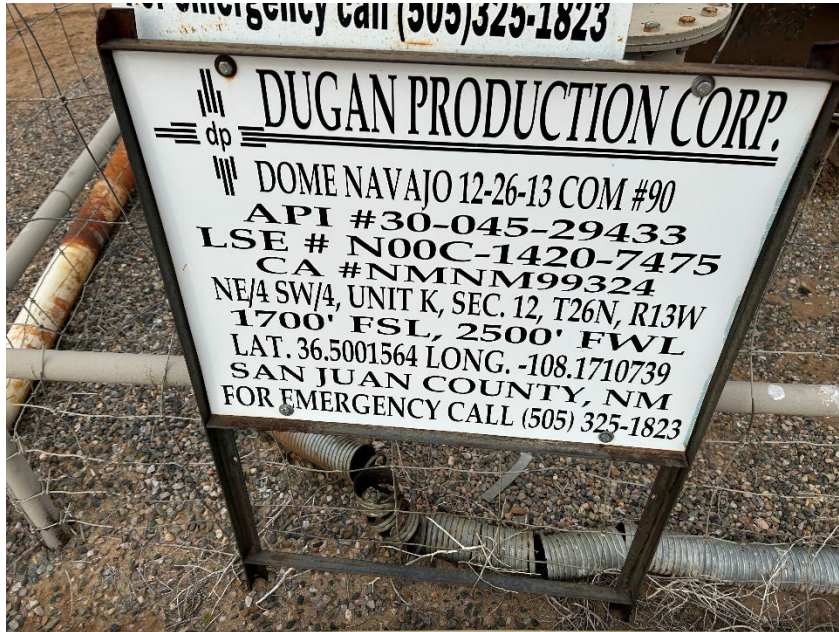
Photo 2: Location Signage/After Remediation

The below-grade tank vault area was cleared following the removal of the existing tank. Because a replacement below-grade pit will be installed at this location, no backfilling, recontouring, or re-vegetation activities were conducted at this time. The site has been left in a stable condition appropriate for the planned installation.

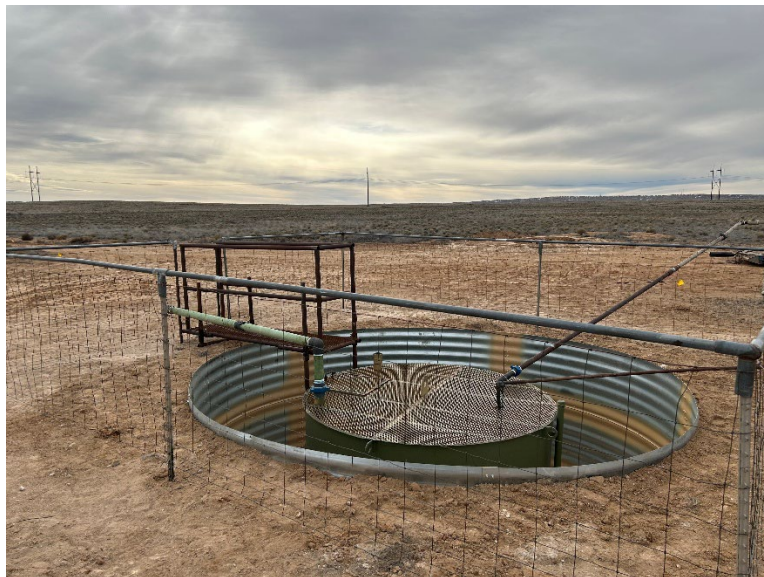
Photo 2-4: After installation of new BGT
