**Pit, Closed-Loop System, Below-Grade Tank, or  
Proposed Alternative Method Permit or Closure Plan Application**

1	
Operator: <b>Burlington Resources Oil &amp; Gas Company, LP</b>	OGRID#: <b>14538</b>
Address: <b>PO Box 4289, Farmington, NM 87499</b>	
Facility or well name: <b>SAN JUAN 27-4 UNIT 133A</b>	
API Number: <b>3003923711</b>	OCD Permit Number: _____
U/L or Qtr/Qtr: <b>E</b>	Section: <b>27</b> Township: <b>27N</b> Range: <b>4W</b> County: <b>Rio Arriba</b>
Center of Proposed Design: Latitude: <b>36.54699°N</b>	Longitude: <b>-107.24362°W</b> NAD: <input checked="" type="checkbox"/> 1927 <input type="checkbox"/> 1983
Surface Owner: <input checked="" type="checkbox"/> Federal <input type="checkbox"/> State <input type="checkbox"/> Private <input type="checkbox"/> Tribal Trust or Indian Allotment

## **SAN JUAN 27-4 UNIT 133A**

**Burlington Resources Oil & Gas Company, LP  
San Juan Basin  
Below Grade Tank Maintenance and Operating Plan**

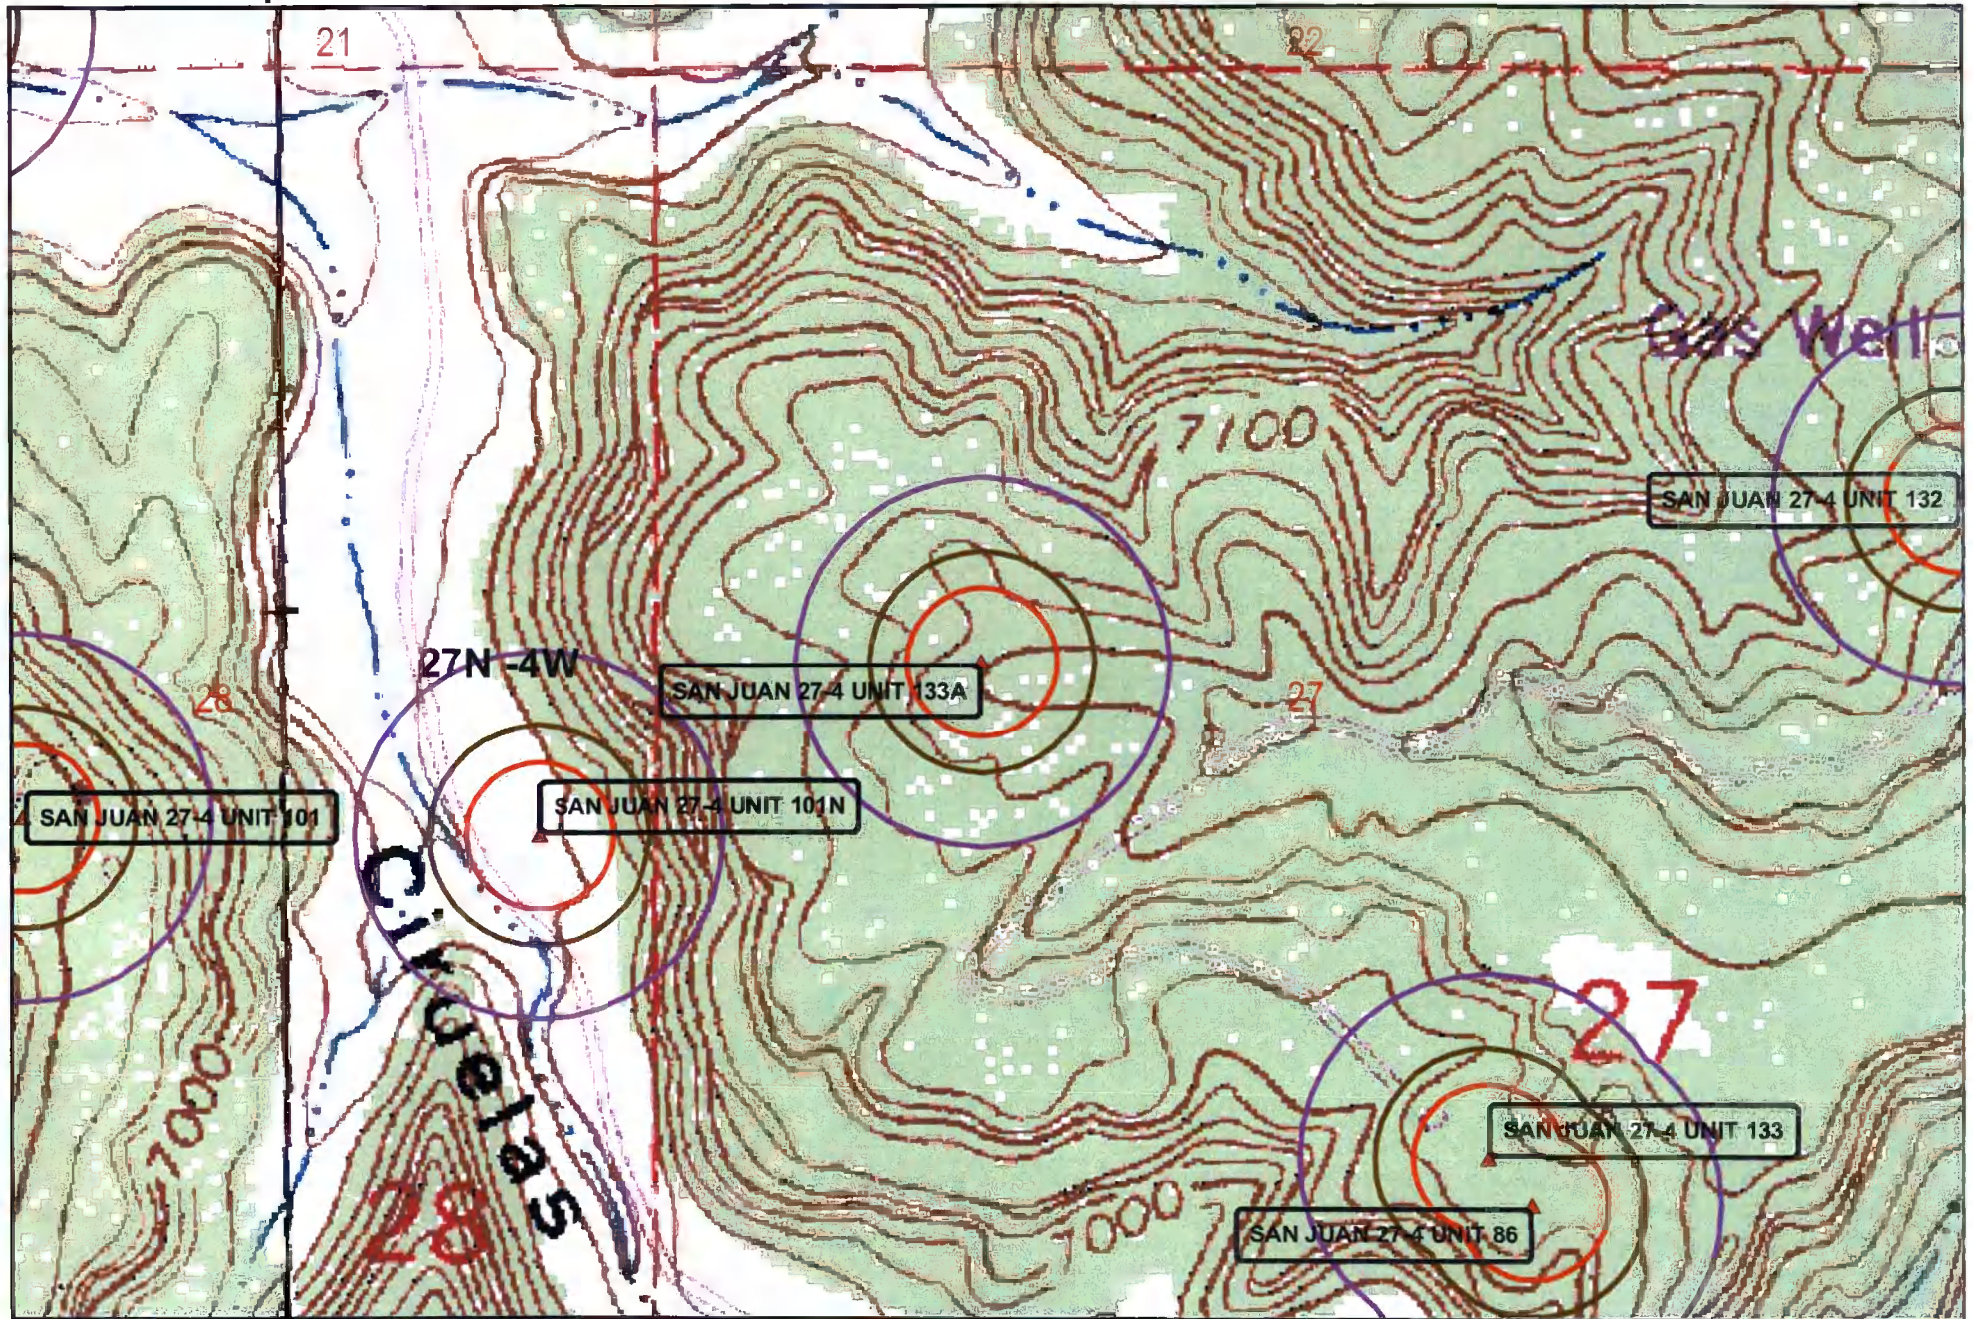
Wetlands data acquired from U.S. Fish and Wildlife  
<http://wetlandswms.er.usgs.gov>

**Ground Water**

- + iWaters
- + COP

**Buffers**

- 200ft
- 300ft
- 500ft
- Wetlands

The estimated depth to ground water at this point is 536 feet. This estimation is based on the data published on the New Mexico Engineer's iWaters Database website and water depth data from ConocoPhillips' Cathodic wells. Groundwater data available from the NM State Engineer's iWaters Database for wells near the proposed site are attached. The nearest stream is 1,141 feet to the northeast and is classified by the USGS as an intermittent stream. The nearest perennial stream is 6,592 feet to the west. The nearest water body is 6,547 feet to the west. It is classified by the USGS as an intermittent lake and is 0.1 acres in size. The nearest spring is 4,236 feet to the southeast. All stream, river, water body and spring information was determined as per the USGS Hydrographic Dataset (High Resolution), downloaded 3/2008. The nearest water well is 3,213 feet to the east. The nearest wetland is a 0.2 acre other located 6,533 feet to the west. The slope at this location is 5 degree, to the north as calculated from USGS 30M National Elevation Dataset. This information is also discerned from the aerial and topographic map included. The surface geology at this location is SAN JOSE FORMATION--Siltstone, shale, and sandstone with a Sandstone dominated formations of all ages substrate. There is no SSURGO soil data available for this location. The nearest underground mine is 20.4 miles to the north as indicated on the Mines, Mills and Quarries Map of New Mexico provided.

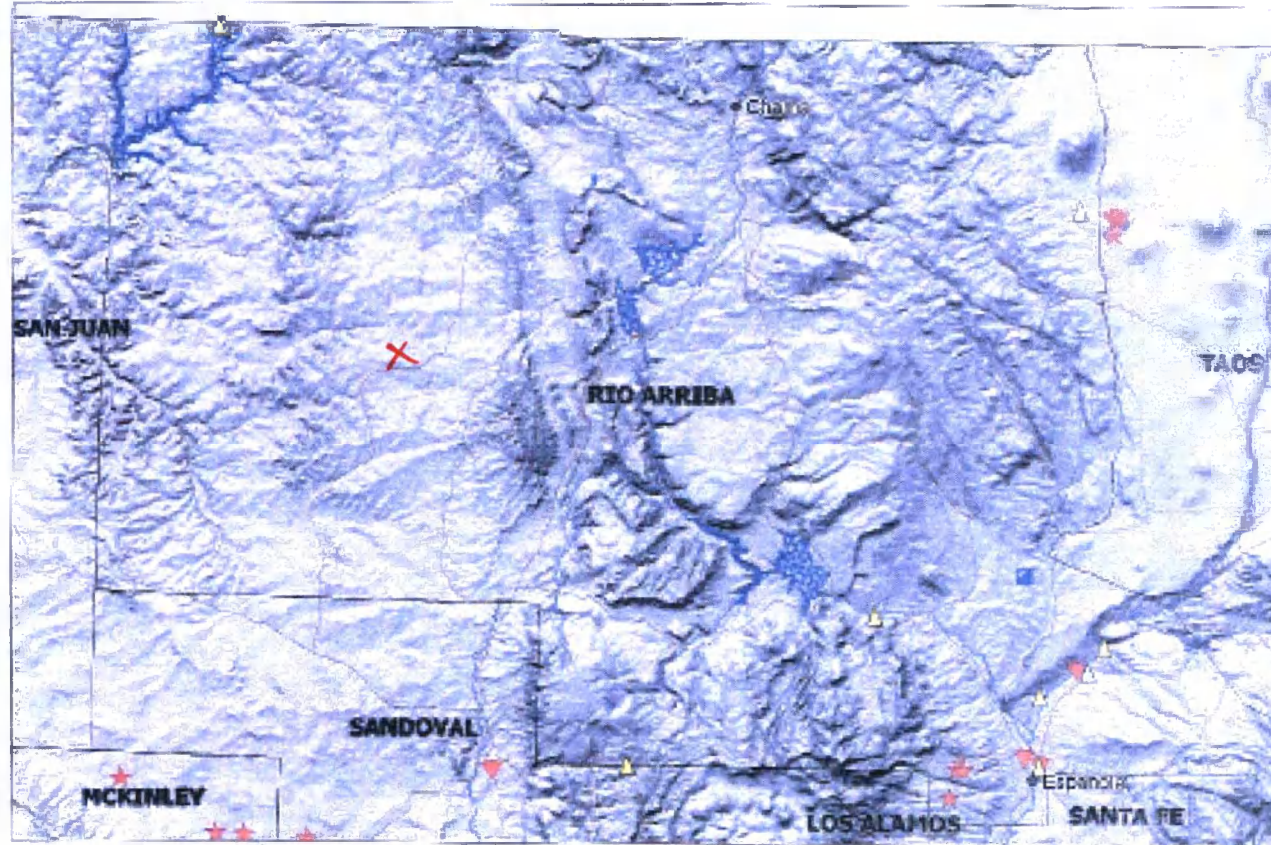
# Mines, Mills and Quarries Web Map

**SAN JUAN 27-4 UNIT 133A**

Unit Letter: E, Section: 27, Town: 027N, Range: 004W

## Mines, Mills & Quarries Commodity Groups

-   **Aggregate & Stone Mines**
-   **Coal Mines**
-   **Industrial Minerals Mines**
-   **Industrial Minerals Mills**
-   **Metal Mines and Mill Concentrate**
-   **Potash Mines & Refineries**
-   **Smelters & Refinery Ops.**
-   **Uranium Mines**
-   **Uranium Mills**
