Spill Closure Report

Dugan Production Corp.

Poles Paradise #90S

30-045-32450

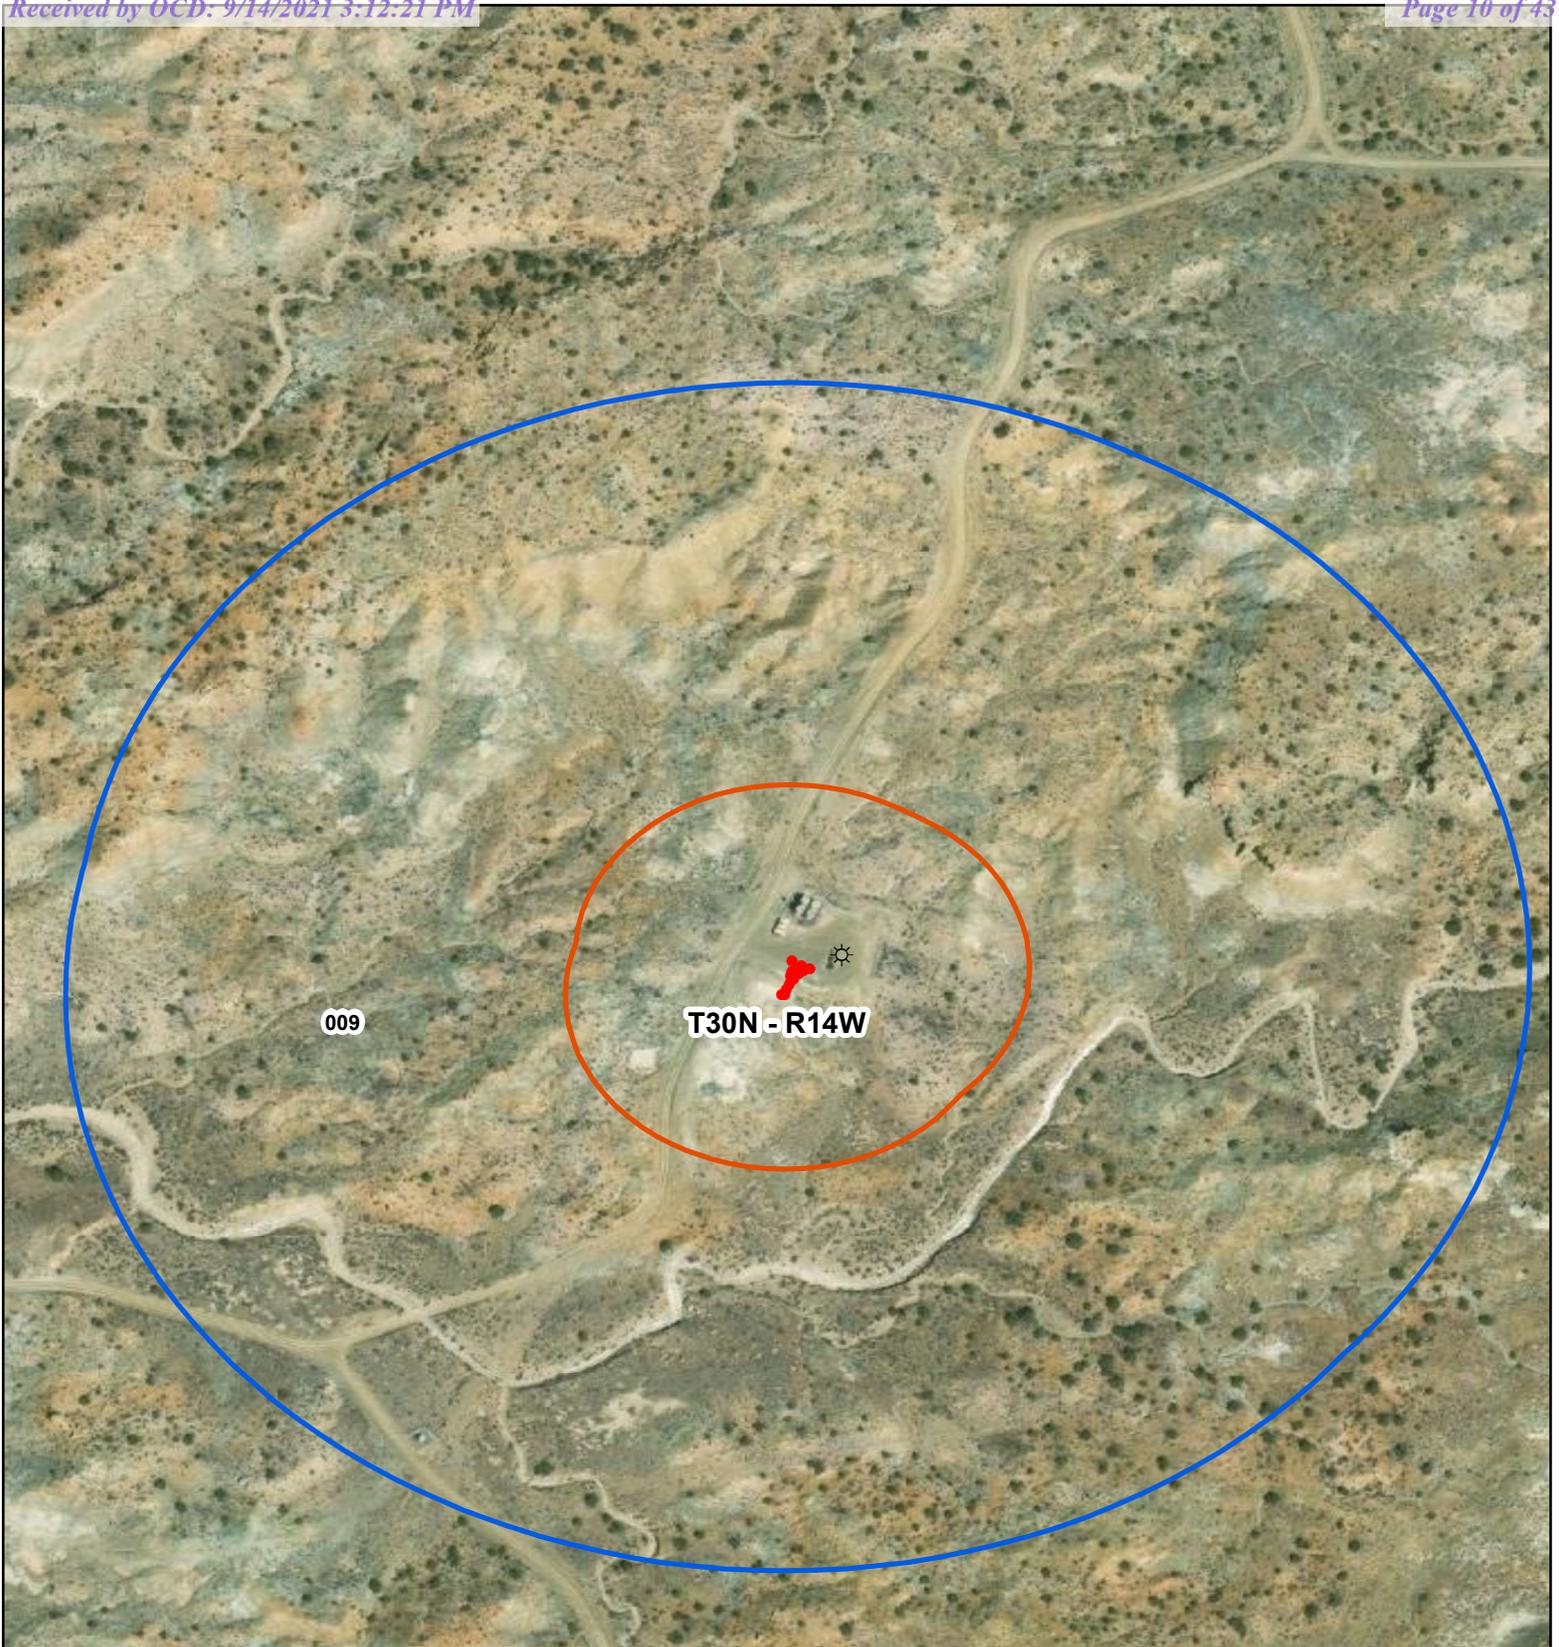
Soil Sampling Diagram

A produced water spill occurred at the Pole's Paradise #90S well. The spill was caused by corrosion of flowlines.

To remediate the spill Dugan personnel applied 200 lbs of gypsum to chemically treat the chlorides in the soil. As part of treatment Dugan also applied 80 bbl of fresh water to the affected soils.

Once soils appeared to be in good condition Dugan scheduled sampling activities with surface owners so they could witness sampling. Lab analytical results indicate the remediation was successful since minimal contamination was indicated in the lab results.
