Release Notification

**RE: Closure Request  
PLU Remuda Basin 4-24-30 Tank Battery  
Incident Number NAPP2120034052 & NAPP2120846562  
Eddy County, New Mexico**

WSP USA Inc. (WSP), on behalf of XTO Energy, Inc. (XTO), presents the following Closure Request detailing site assessment and soil sampling activities at the Poker Lake Unit (PLU) Remuda Basin 4-24-30 Tank Battery (Site) in Unit B, Section 4, Township 24 South, Range 30 East, in Eddy County, New Mexico (Figure 1). The purpose of the site assessment and soil sampling activities was to assess for the presence or absence of impacts to soil following two releases of produced water at the Site. Based on field observations, field screening activities, and soil sample laboratory analytical results, XTO is submitting this Closure Request and requesting no further action (NFA) for Incident Numbers NAPP2120034052 and NAPP2120846562.

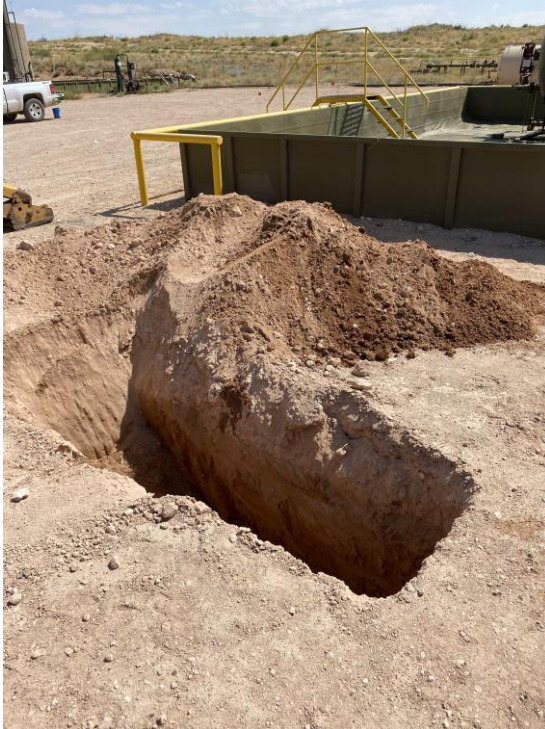
| Photo No. | Date | |
|---|---|---|
| View southeast of pothole for liner delineation to the north of containment. | | A photograph showing a large, deep, irregular pothole in a dry, sandy, light-brown soil. The pothole is roughly rectangular with jagged edges. In the background, there is a yellow metal structure, possibly a tank or containment wall, and a white pickup truck parked on a dirt area. The sky is clear and blue. |

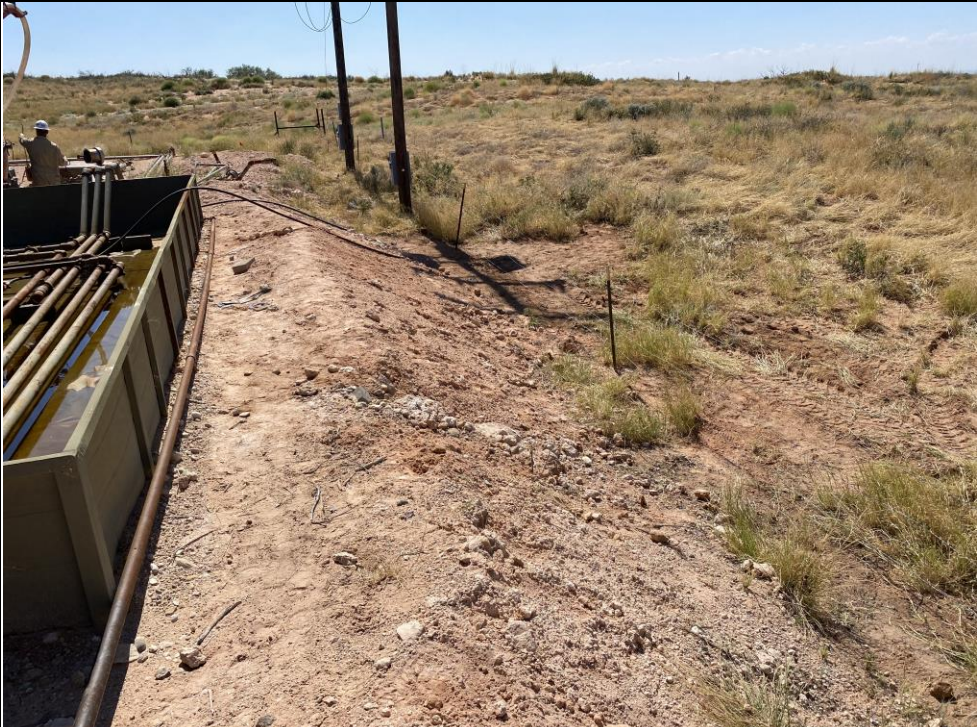
| Photo No. | Date | |
|---|---|---|
| View south of BH02 and BH03 location. | | A photograph showing a dirt road or path leading through a dry, grassy field. On the left side of the path, there is a long, narrow, dark-colored metal container or tank. In the background, there are utility poles and a clear blue sky. The terrain is arid with sparse vegetation. |
