**Re: Closure Request
Asio Otus Federal #003H
API #: 30-015-42395
RP#: 2RP-4484
Unit Letter K Section 12, Township 26S, Range 26E
Eddy County, NM**

COG Operating, LLC (COG) is pleased to submit the following closure report for the Asio Otus Federal #003H. This release occurred on November 8, 2017. Following the release an assessment of impacted soils was conducted. A remediation work plan was submitted to and subsequently approved by the New Mexico Oil Conservation Division (NMOCD).

ASIO Otus Federal #3H

API #: 30-015-42395
RP#: 2RP-4484
Unit Letter K Section 12, Township 26S, Range 26E
Eddy County, NM

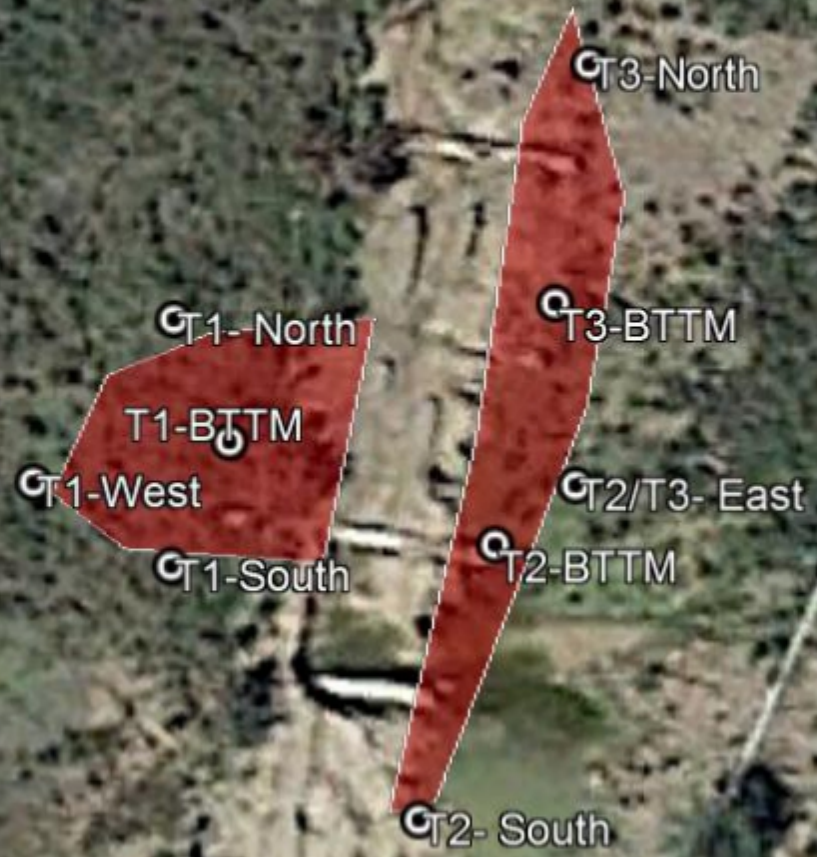
APPENDIX I

AOI

Sample Points

- The impacted area in the vicinity of sample location T-1 was excavated to a depth of three (3) feet BGS.
- The impacted area in the vicinity of sample location T-2 and T-3 was excavated to a depth of two (2) feet BGS.
- Confirmation samples were taken for each area of the excavation. (Appendix II).
- The excavation was backfilled with clean “like” material, and contoured to match the surrounding terrain.
