| From: | Price, Henryetta |
|---|---|
| Subject: | [External] Re: (Closure Request) Road Runner Federal #001H Tank Battery (Flare Fire) 6-30-17 (30-015-43133) |

Re: Closure Request Letter Road Runner Federal #001H API #: 30-015-43133 Unit Letter P, Section 25, Township 25S, Range 26E Lea County, NM

COG Operating LLC (COG) is pleased to submit for your consideration the following Closure Request for the Road Runner Federal #001H Flare Fire. The flare fire occurred on June 30, 2017 and impacted an area of pasture adjacent to the flare. This closure letter is in response to a request from the New Mexico Oil Conservation Division (NMOCD) that a soil sample be collected from the burned pasture.

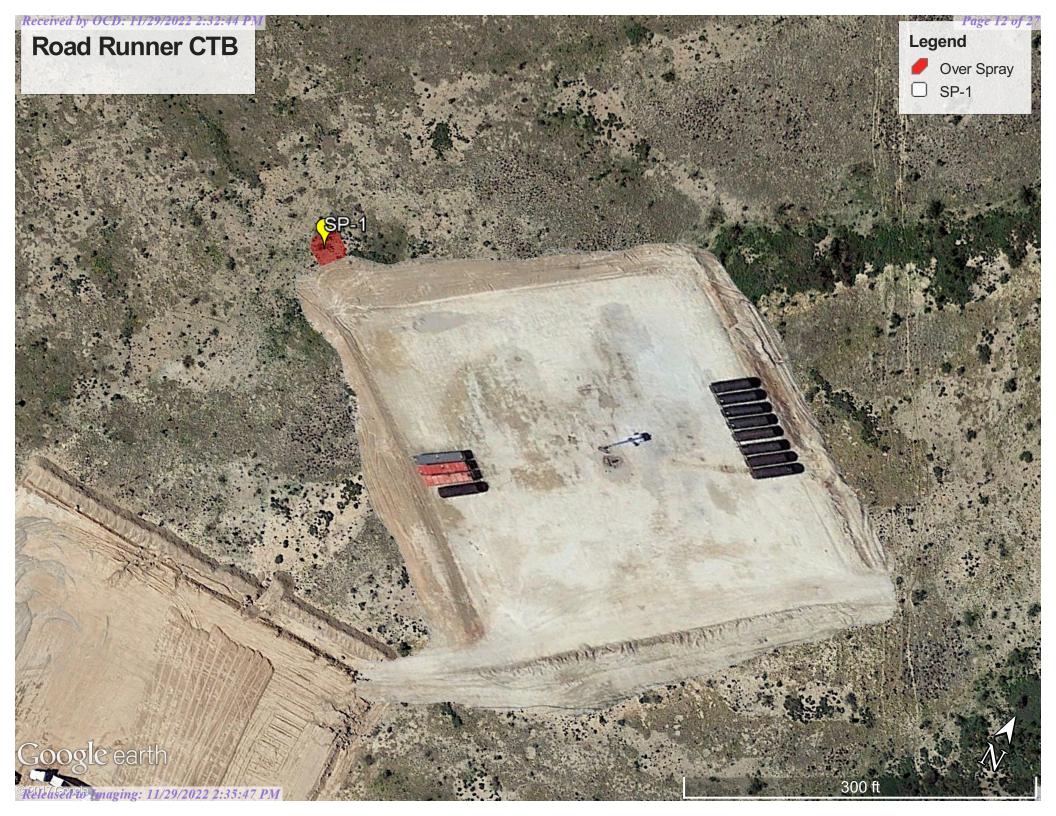
On July 18, 2017, a COG representative collected a soil sample from the impacted area. Analytical results indicate no significant impact to the pasture and are provided below.
