Release Notification and Corrective Action

SOIL REMEDIATION FINAL CLOSURE FOR INCIDENT 2RP-3836

ENTERPRISE FIELD SERVICES LLC
PIPELINE ROW, CHINABERRY

UL A, SECTION 29, T23S R26E, NMPM
EDDY COUNTY, NM
MARCH 7, 2017

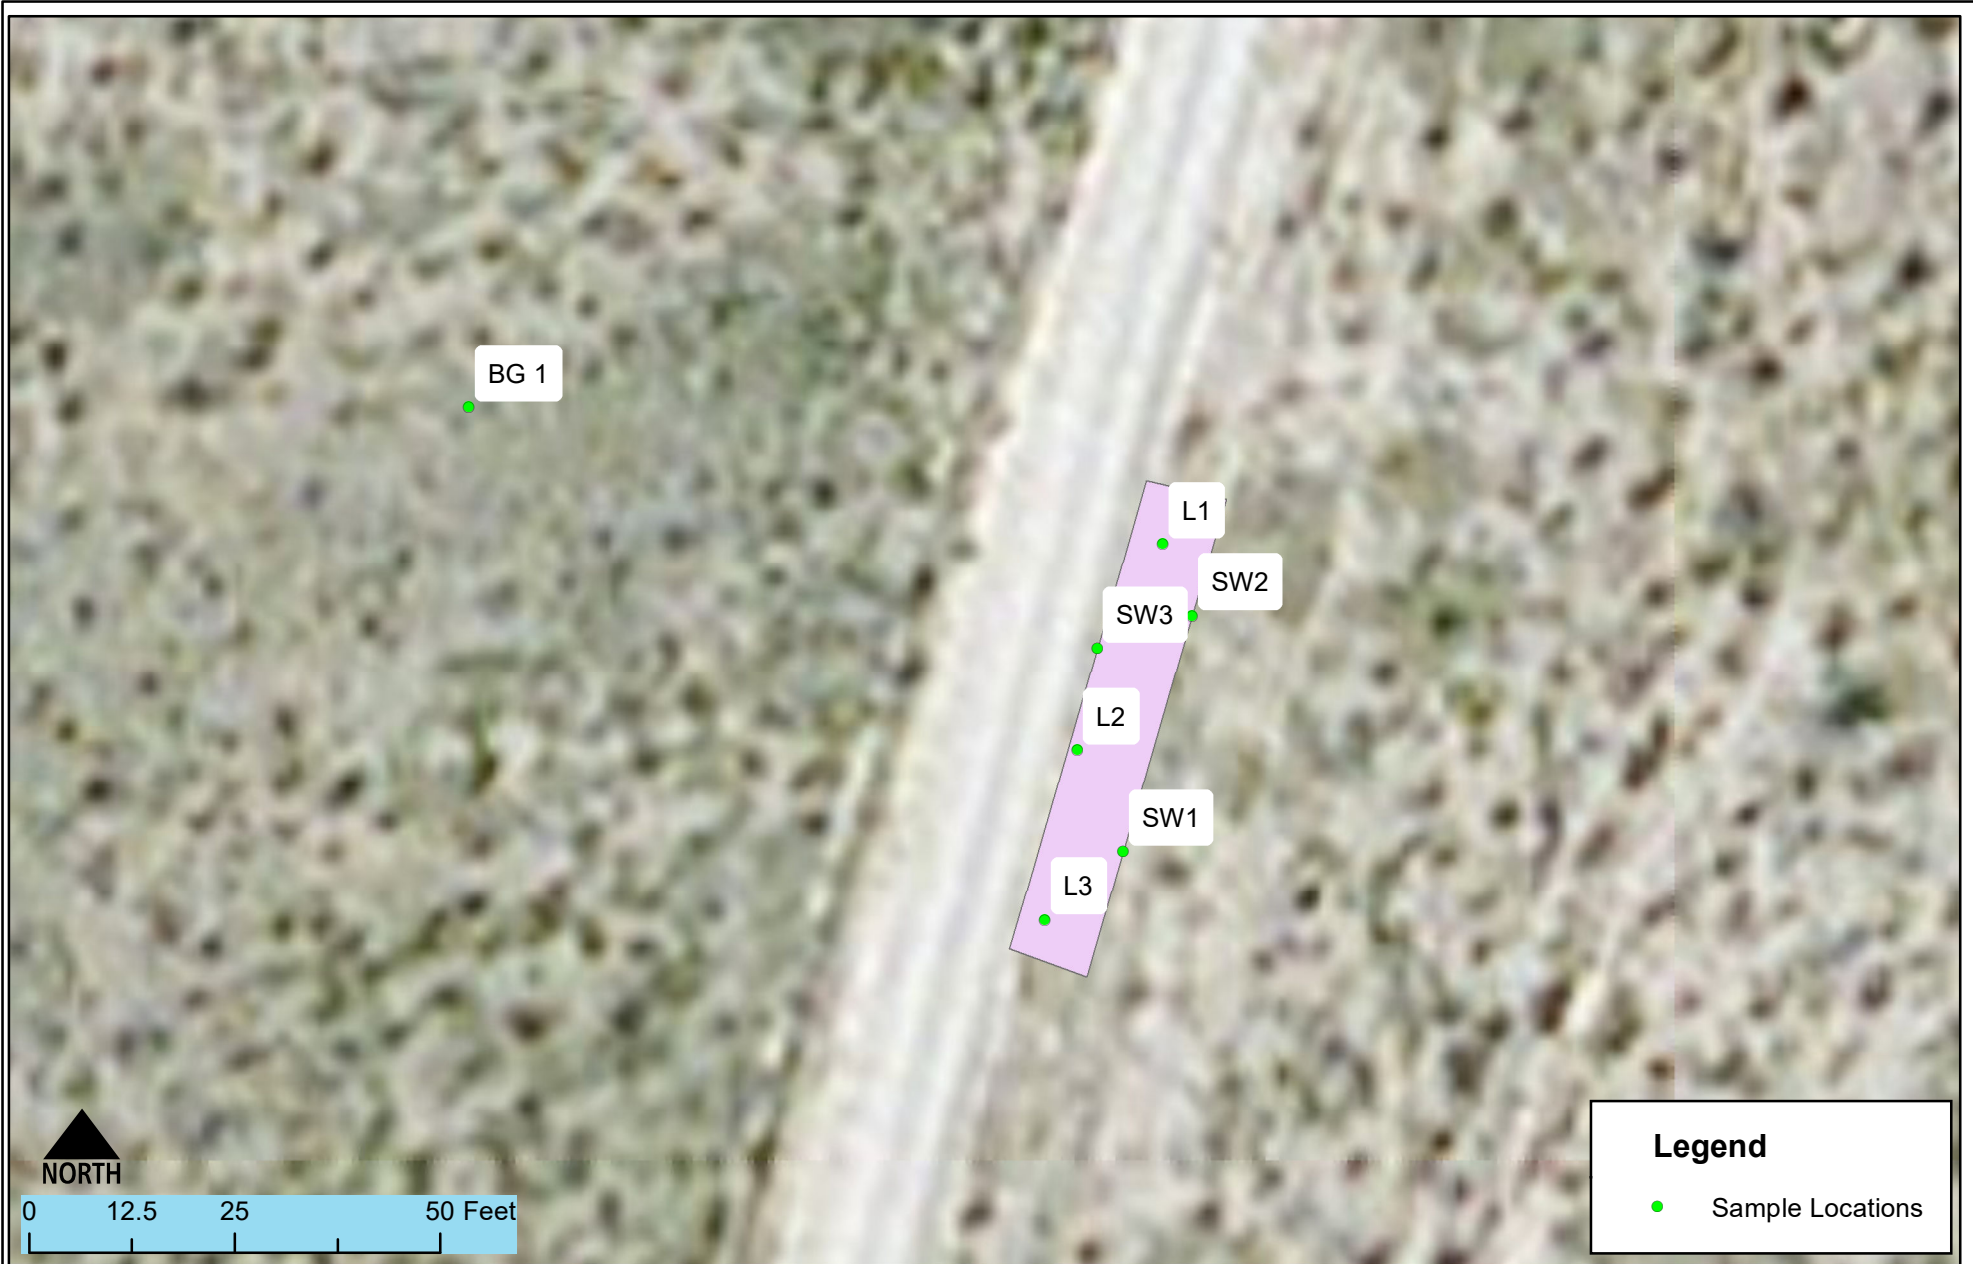
FIGURE 2

DETAILED SITE AND SAMPLE MAP

Detailed Sample Map
 ROW Chinaberry - Enterprise
 Carlsbad, New Mexico

Excavation of affected soils began on 09/21/16, with approval from area utilities owners via 811 and NMOCD. SMA continuously guided the excavation activities by collecting composite soil samples for field screening with a mobile chlorides titration unit (EPA 4500) and a calibrated PID. Delineation was performed to a depth of 6 feet bgs to define the plume limits by NMOCD standards. Excavation was to a depth sufficient to remove the contaminated soil approximately five feet bgs. The excavated contaminated soil was loaded into a dump truck and hauled to Lea Land, near Carlsbad, NM. Discrete final closure samples were collected within the excavation. Approximately 114 cubic yards of chloride contaminated soil was removed and replaced with 114

Laboratory analytical results for all final closure samples collected were below NMOCD closure standards for Benzene, BTEX, and TPH as well as below laboratory detection limits for the methods used. No further remedial activities are recommended. Soil contaminant concentrations are illustrated in Figure 2. A summary of laboratory analytical results is included in Table 3. Laboratory reports are included in Appendix C.
