Closure Report

**Williams B Federal #3
Eddy County, New Mexico
Unit F Sec 29 T17S R28E
32.80586°, -104.19833°**

Incident ID: nAPP2319952763

Incident ID: nAPP2322332538

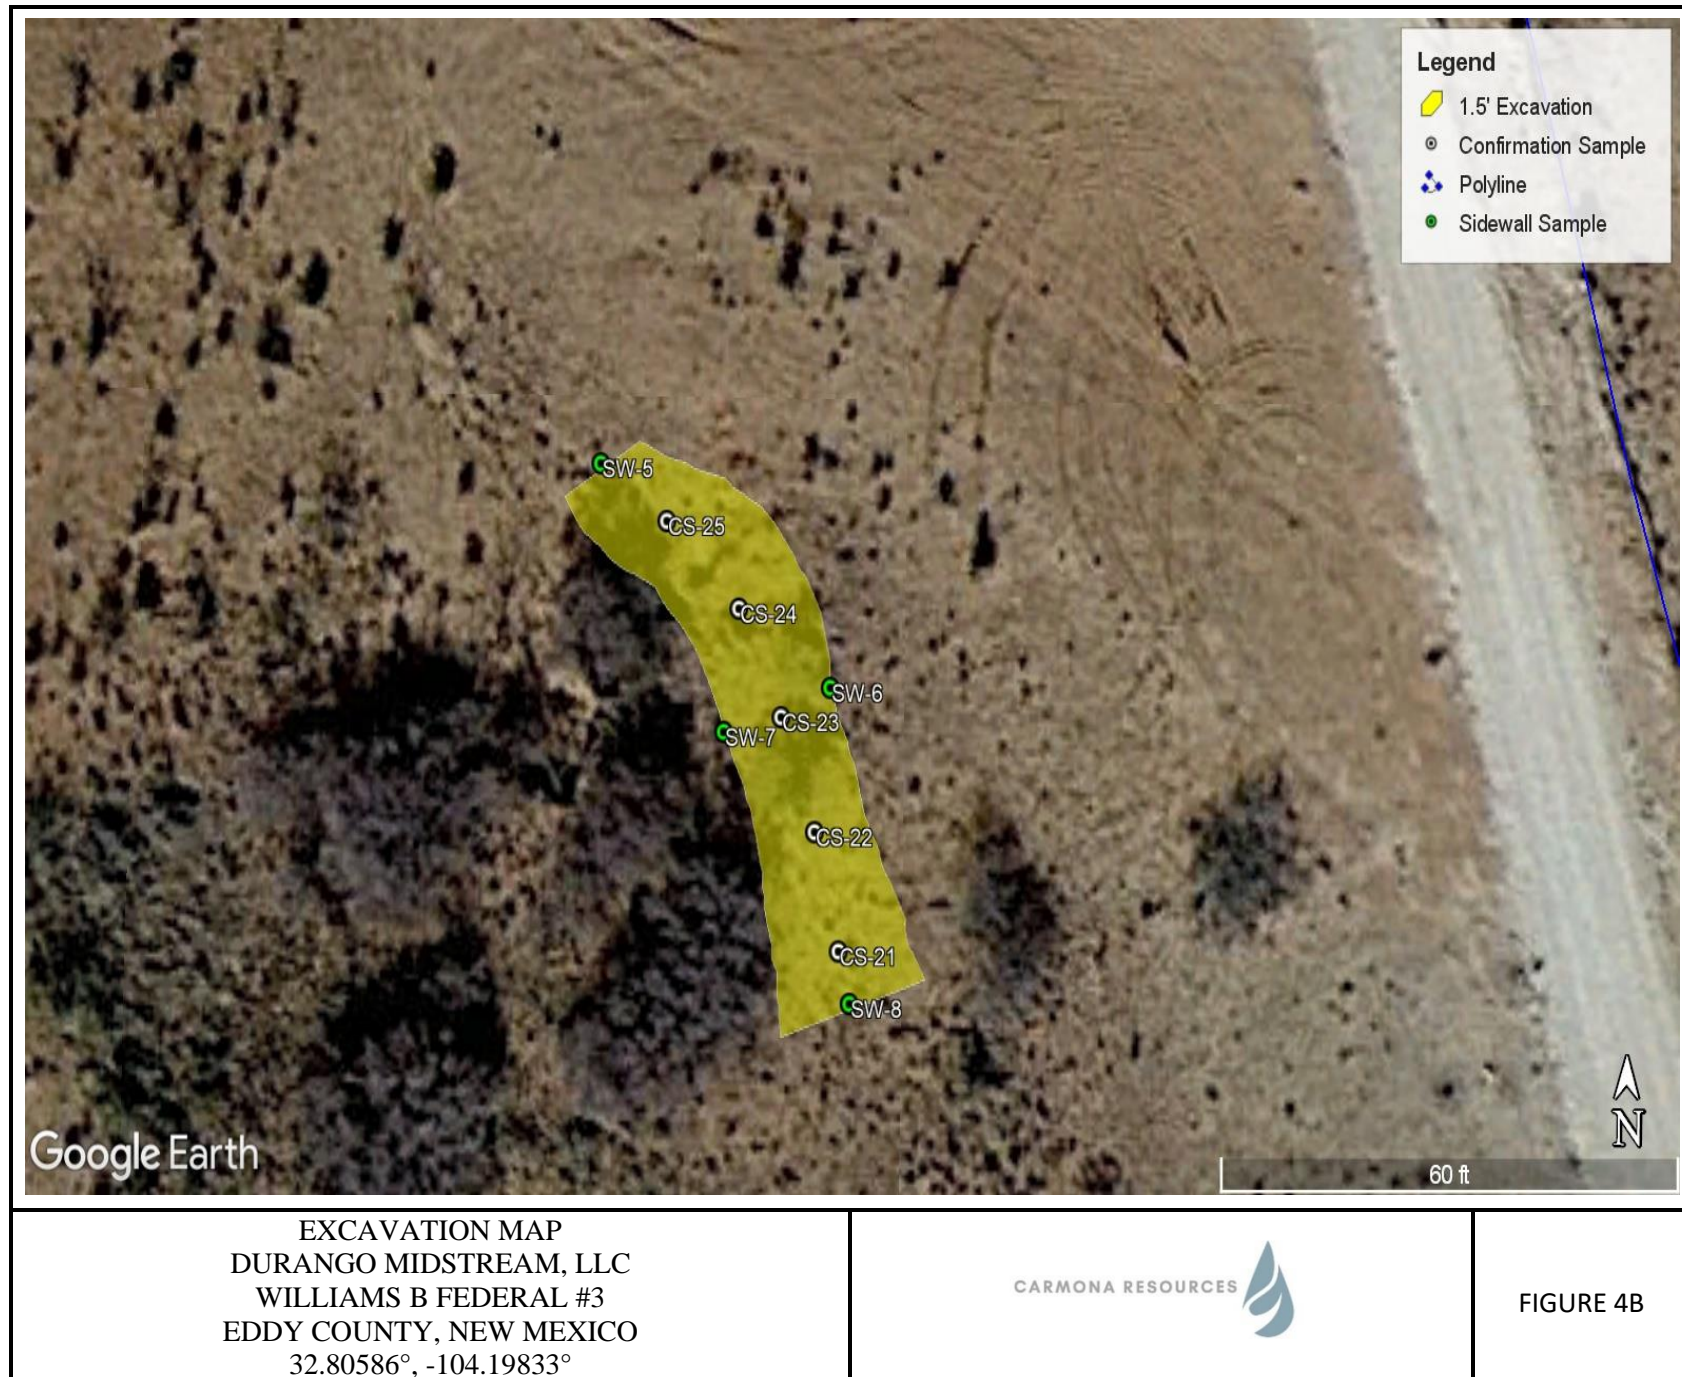
FIGURE 4

EXCAVATION OVERVIEW MAP
DURANGO MIDSTREAM, LLC
WILLIAMS B FEDERAL #3
EDDY COUNTY, NEW MEXICO
32.80586°, -104.19833°

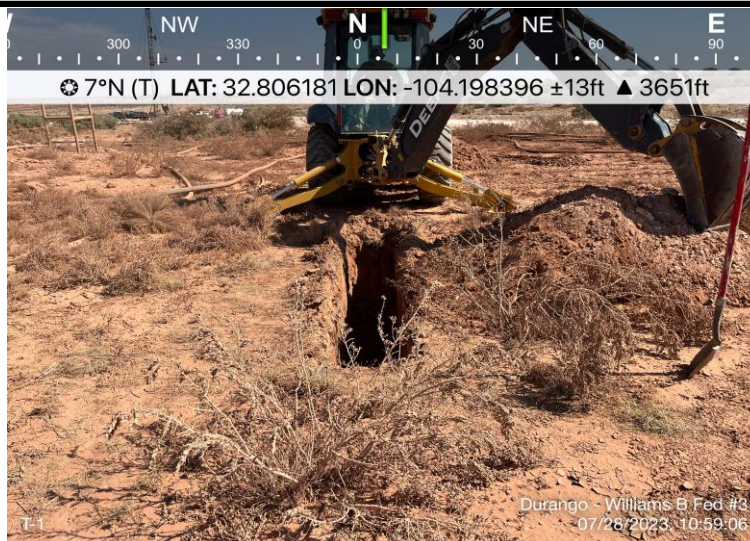
View North, area of T-1.

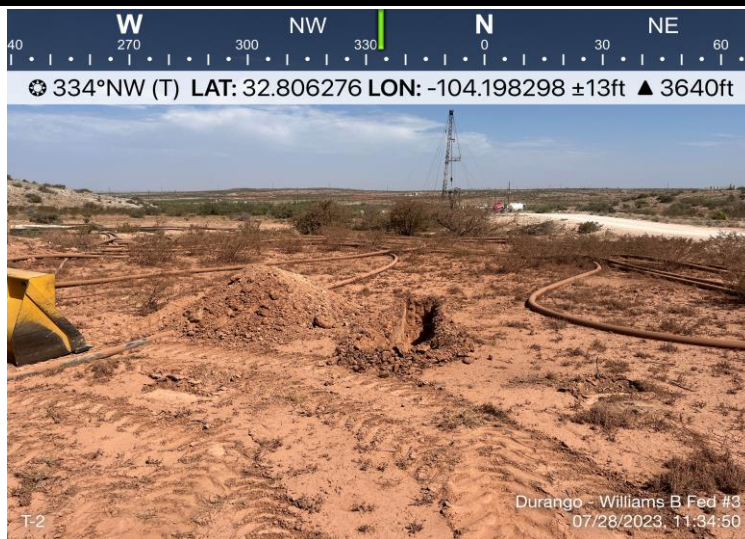
Photograph No. 2

View Northwest, area of T-2.

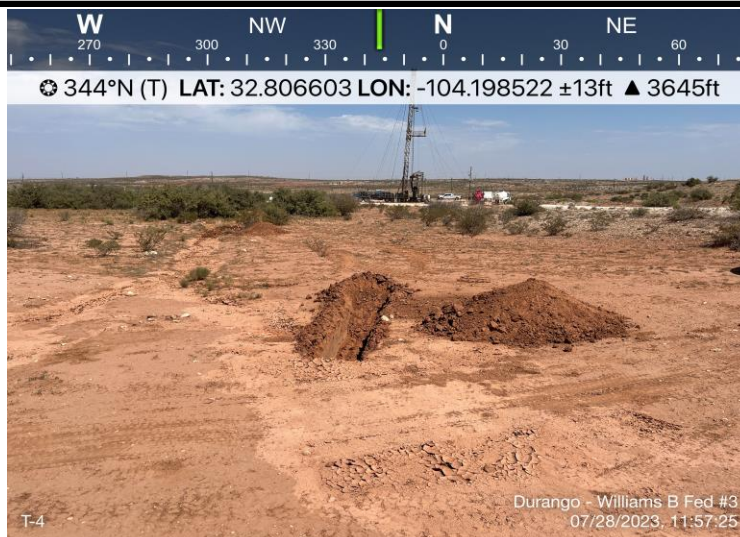
View North, area of T-4.

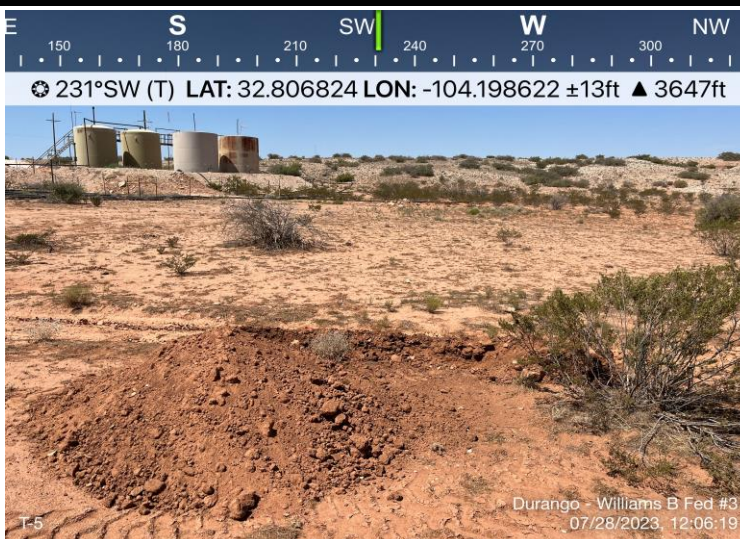
Photograph No. 5

View Southwest, area of T-5.

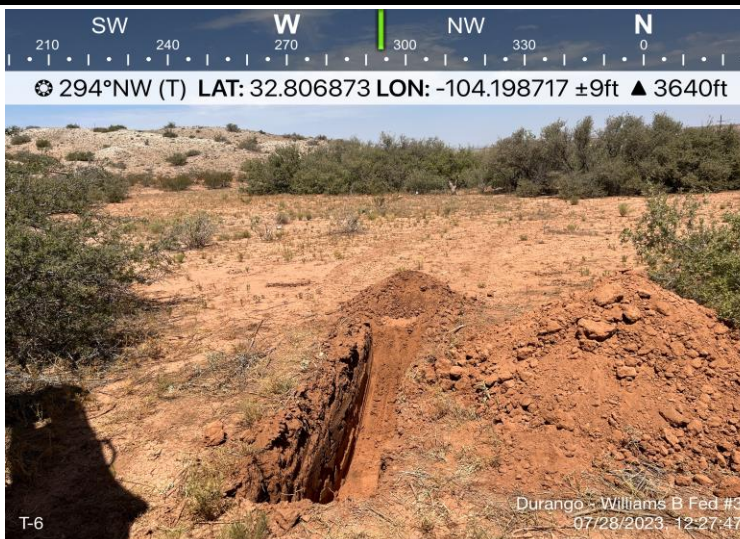
Photograph No. 6

View Northwest, area of T-6.

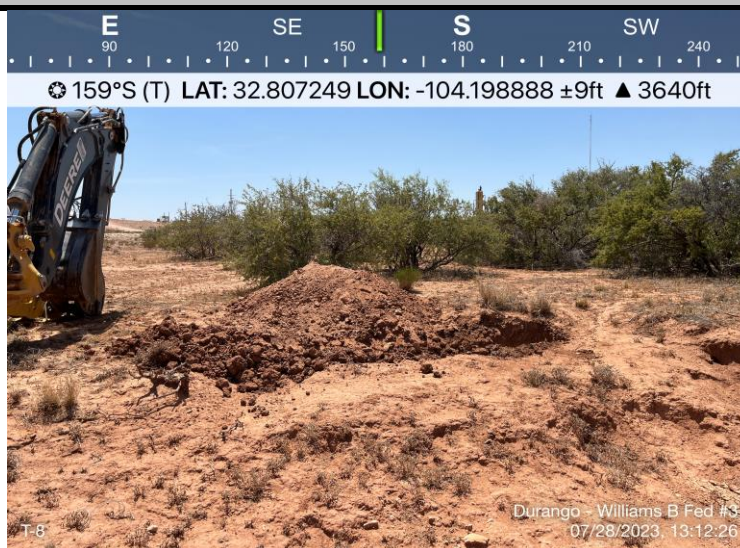
Photograph No. 8

View South, area of T-8.

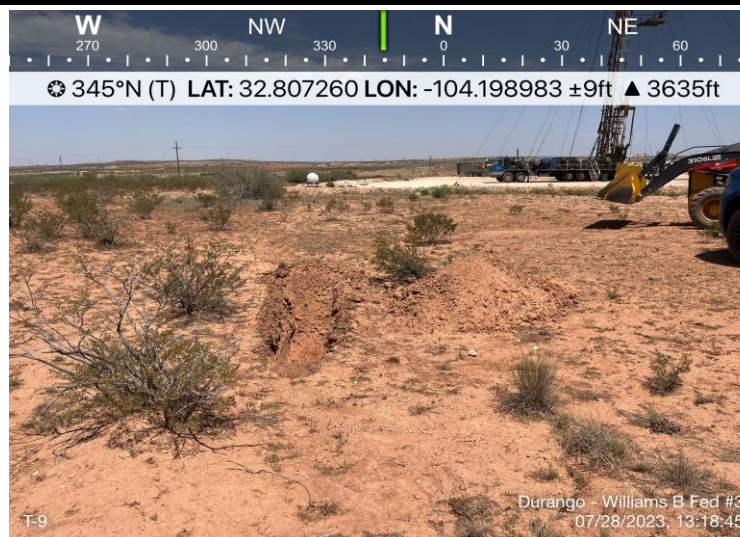
Photograph No. 9

View North, area of T-9.

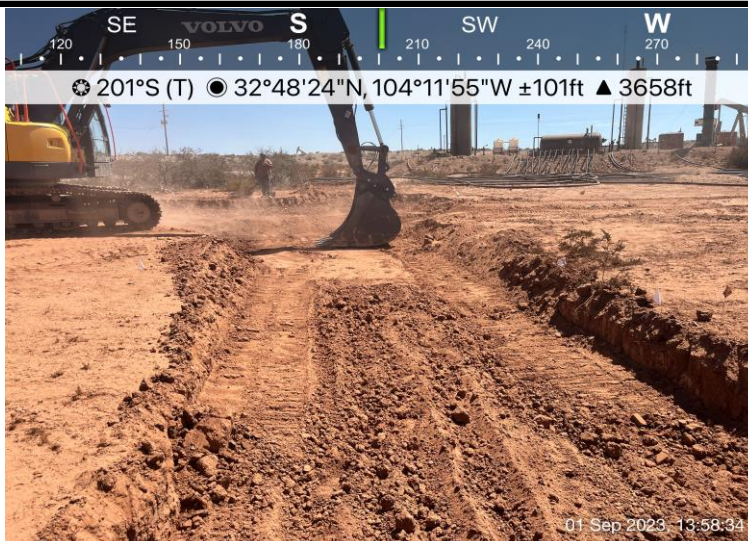
View South, area of confirmation samples (1-20).

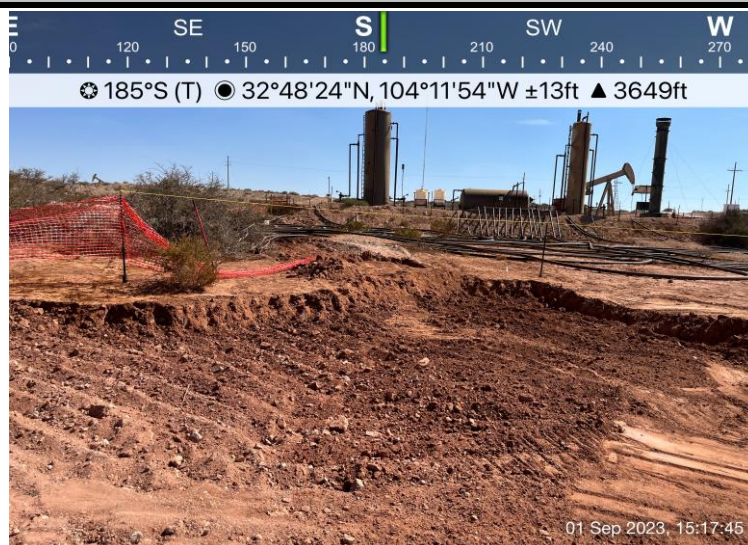
Photograph No. 11

View South, area of confirmation samples (1-20).

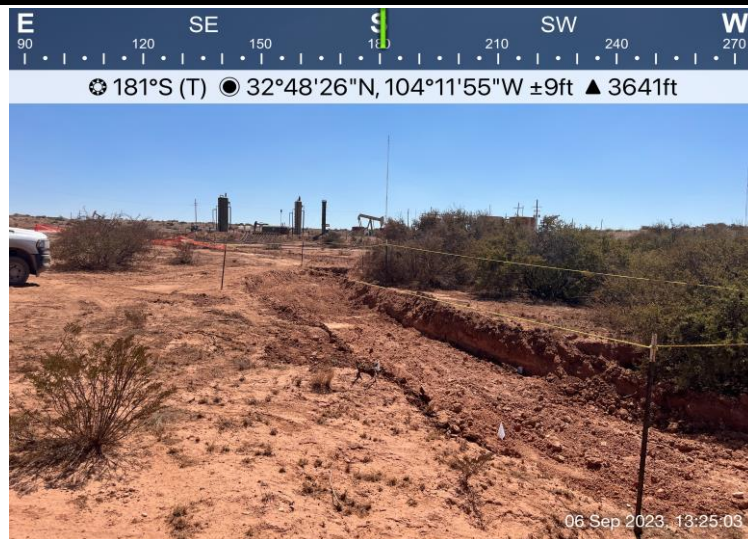
Photograph No. 12

View South, area of confirmation samples (21-25).
