**Re: 2023 Annual Groundwater Report**

Davis #1A  
San Juan County, New Mexico  
Harvest Four Corners, LLC  
NMOCD Incident# nAUTOfAB000119  
Remediation Permit Number 3RP-311-0

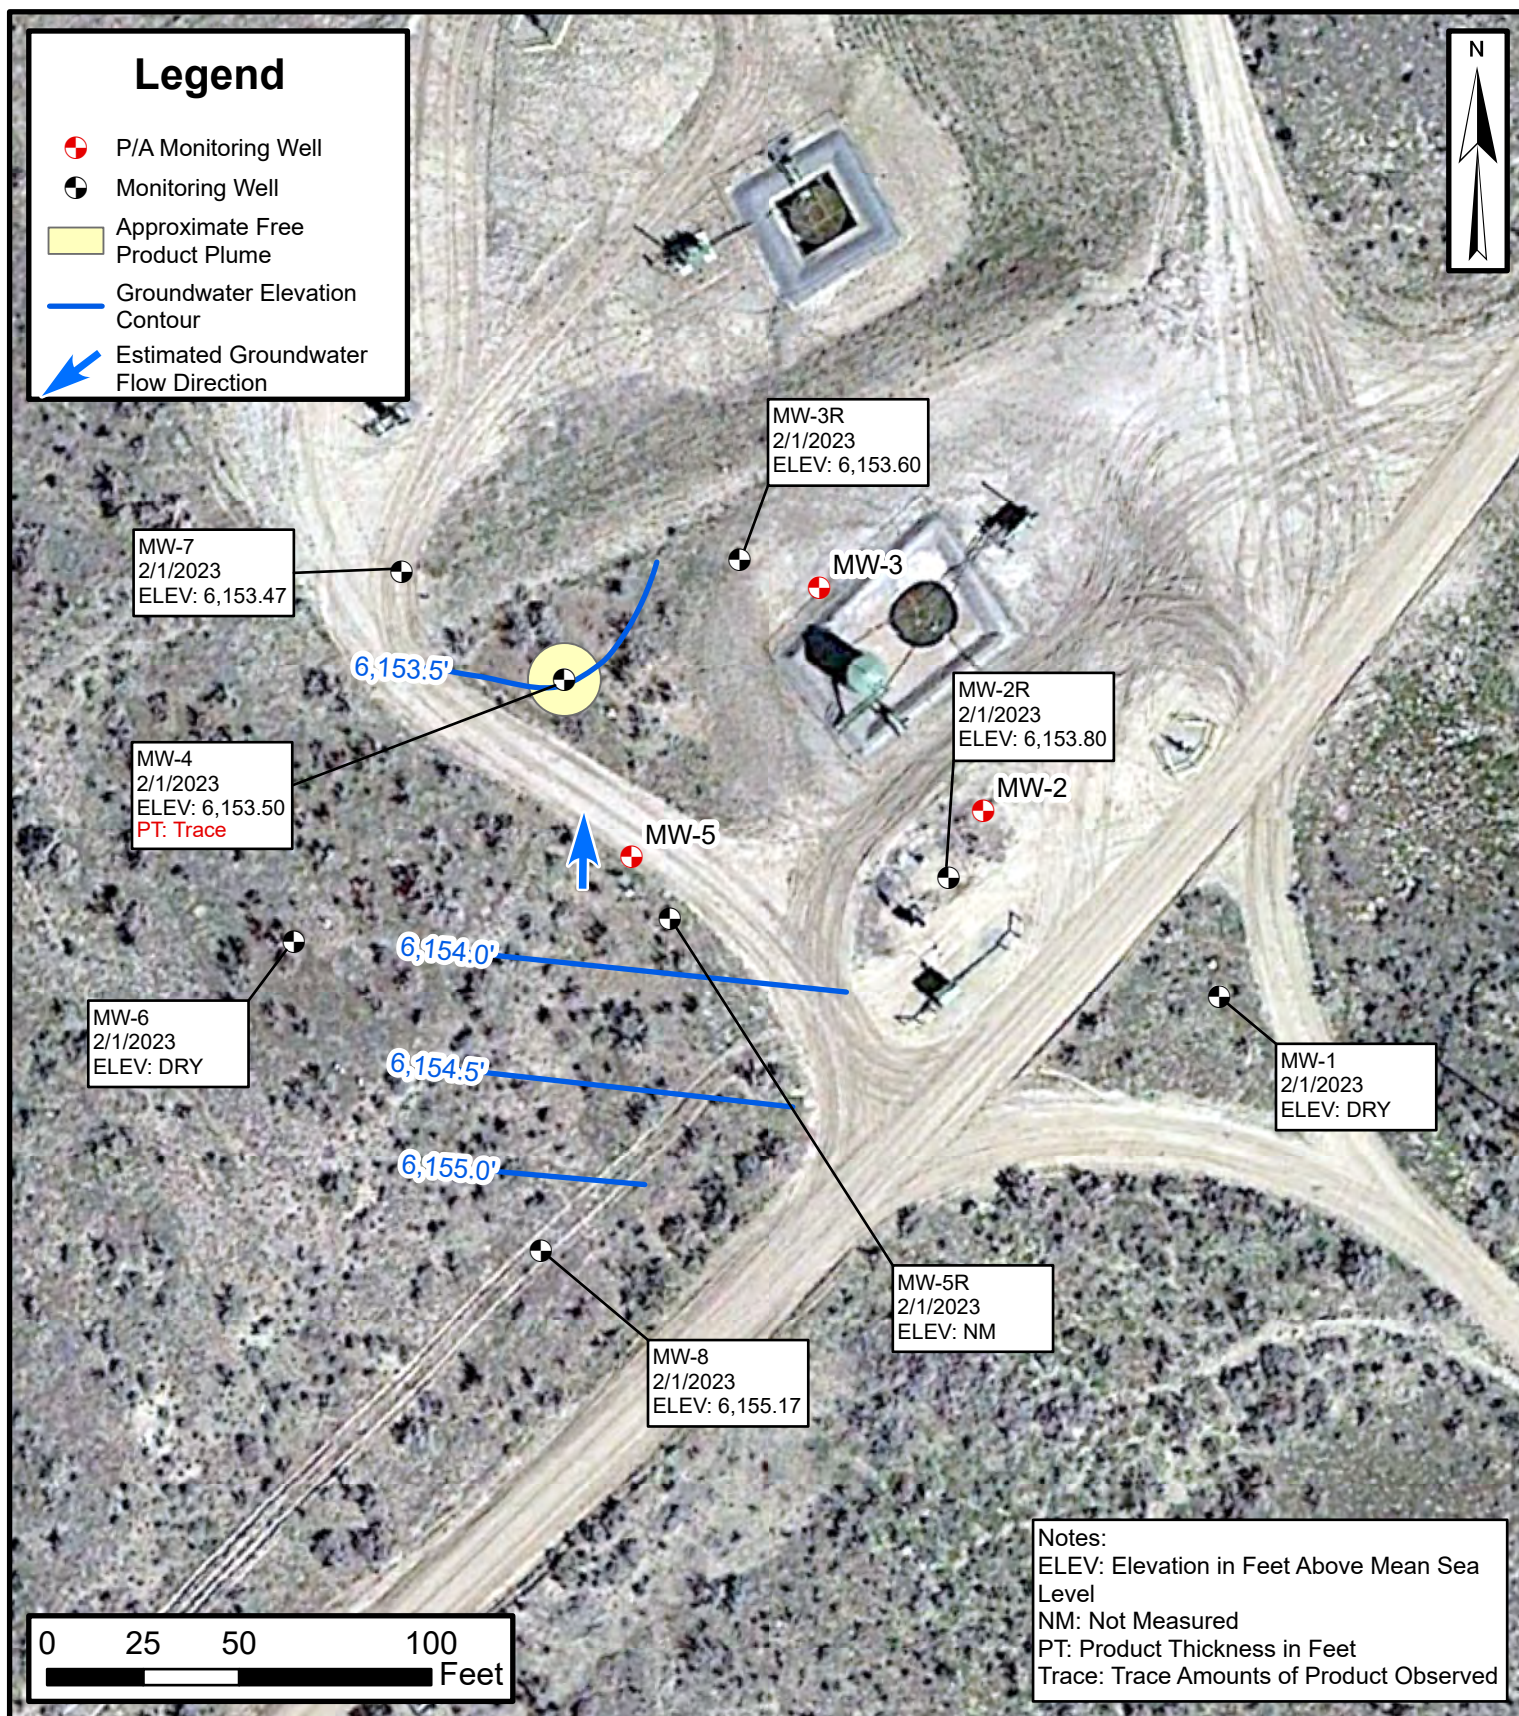
FIGURE  
**2**

Groundwater elevation monitoring included recording depth to groundwater measurements in all existing wells with an oil/water interface probe. The interface probe was decontaminated with Alconox® soap and rinsed with distilled water prior to each measurement. Ensolum used existing top-of-casing well elevations to draft groundwater contours and determine groundwater flow direction. Contours were inferred based on groundwater elevations and physical characteristics at the Site (topography, proximity to irrigation ditches, etc.). This data is summarized in Table 1 and depicted on Figures 2 through 5.

Depth to groundwater data collected during the February, June, August, and December 2023 monitoring events is summarized in Table 1. Groundwater flow direction was generally to the north (Figure 2 through Figure 5). Monitoring wells MW-1 and MW-6 were dry during all groundwater monitoring events.

## Groundwater Elevation Contour Map (February 2023)

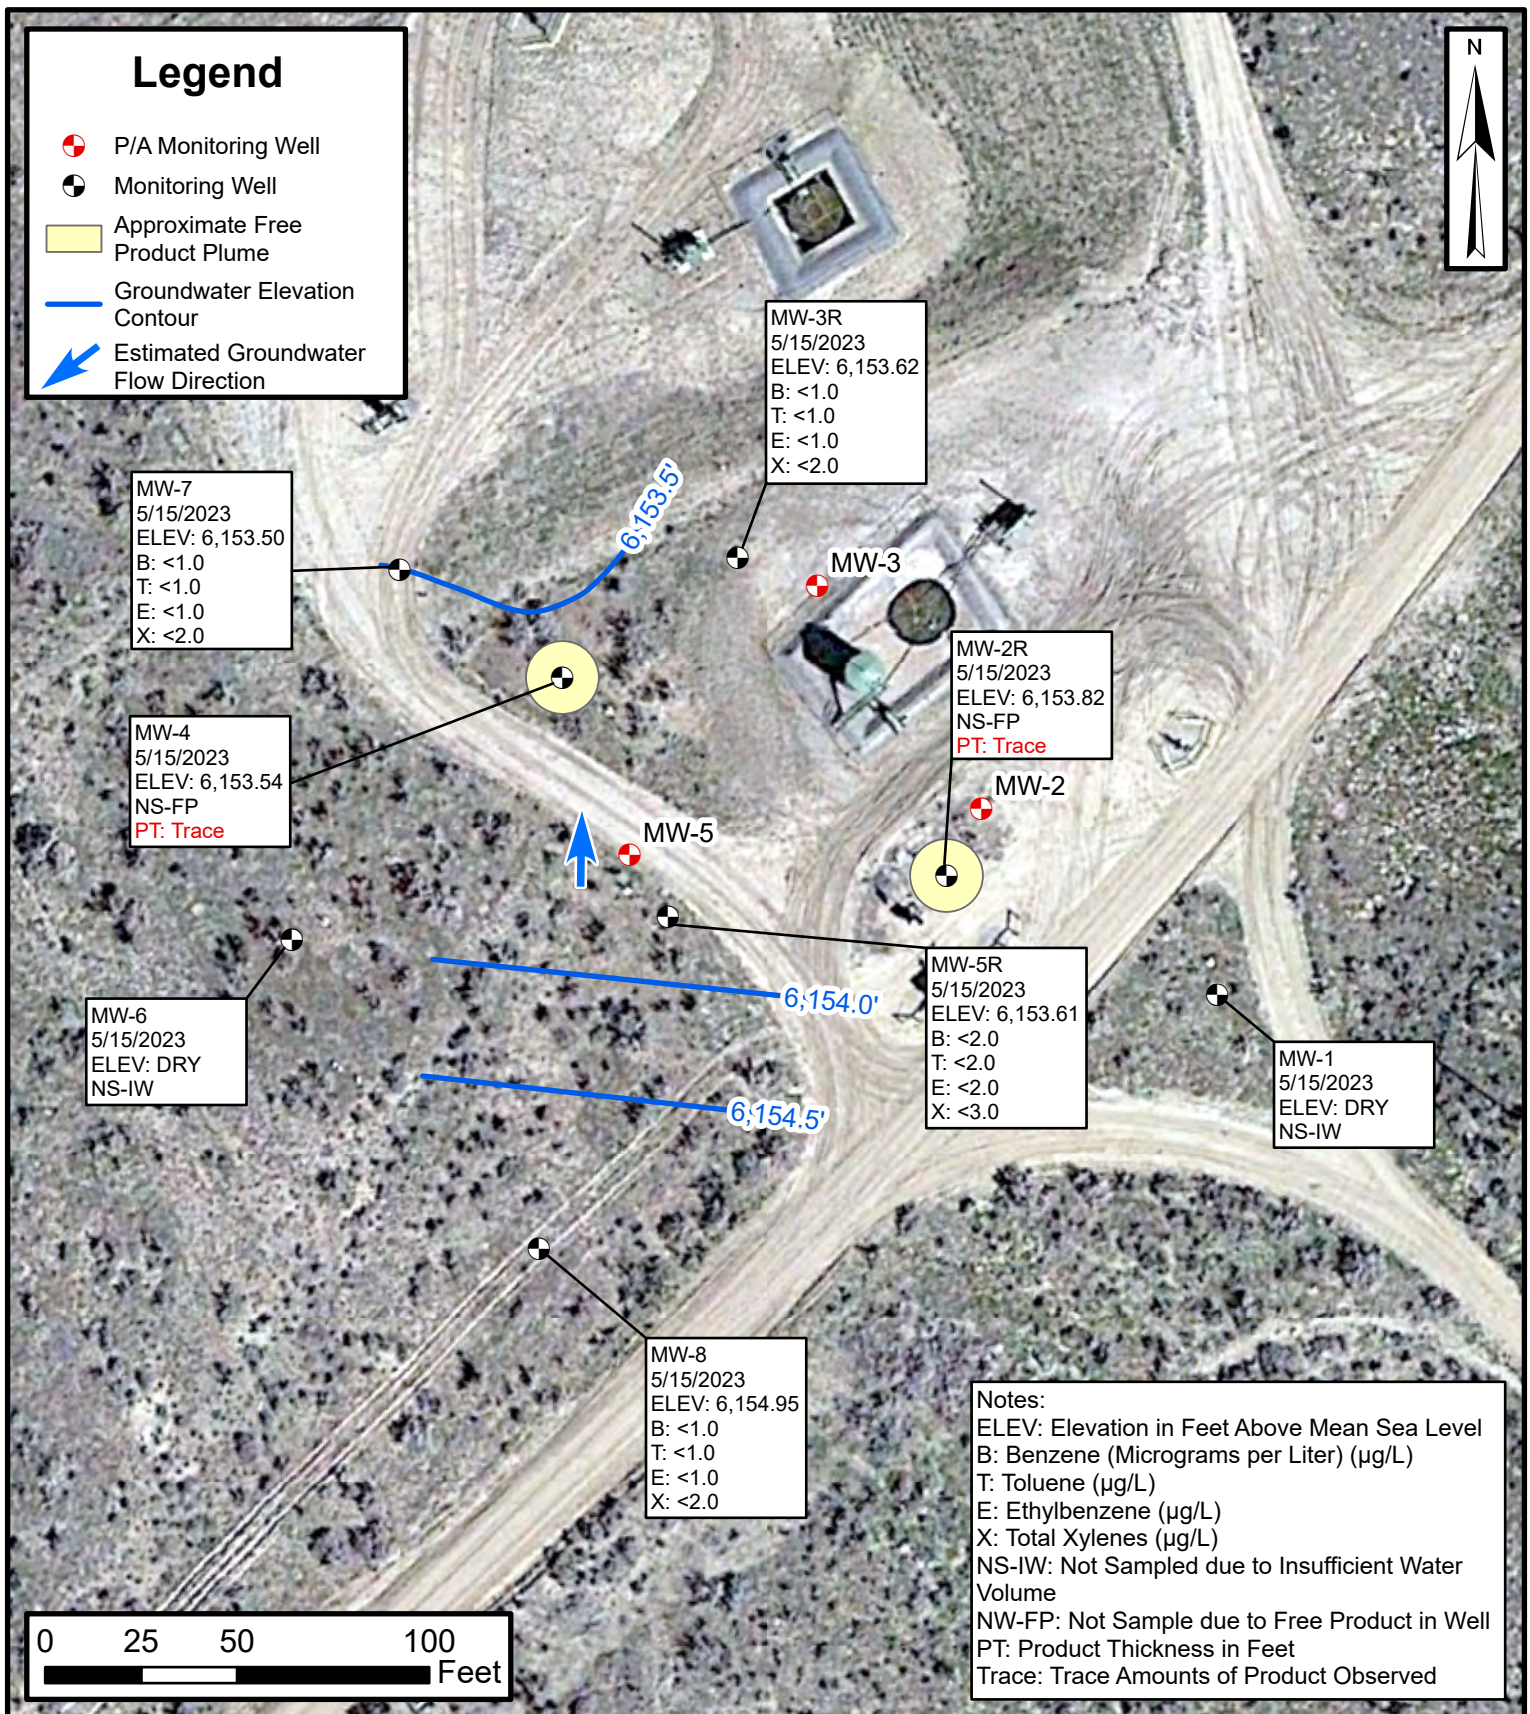
Trace PSH was observed in monitoring wells MW-2R and MW-4 during the June 2023 groundwater sampling event while purging the wells for ground water sampling. No PSH thickness was measured with the oil/water interface probe during 2023. Laboratory analytical results for groundwater samples collected from monitoring wells MW-3R, MW-5R, MW-7, and MW-8 indicated concentrations of BTEX were below laboratory analytical reporting limits or in compliance with applicable New Mexico Water Quality Control Commission (NMWQCC) standards. Table 2 summarizes groundwater analytical results, and the complete laboratory analytical report is included in Appendix B.
