Remediation Report and Closure Request
Laguna Seca CDP
Section: 19 Township: 31N Range: 5W
Lat: 36.880605 Long: -107.402704
Rio Arriba County, New Mexico

Photo Page
Laguna Seca
Lat: 36.880605 Long: -107.402704

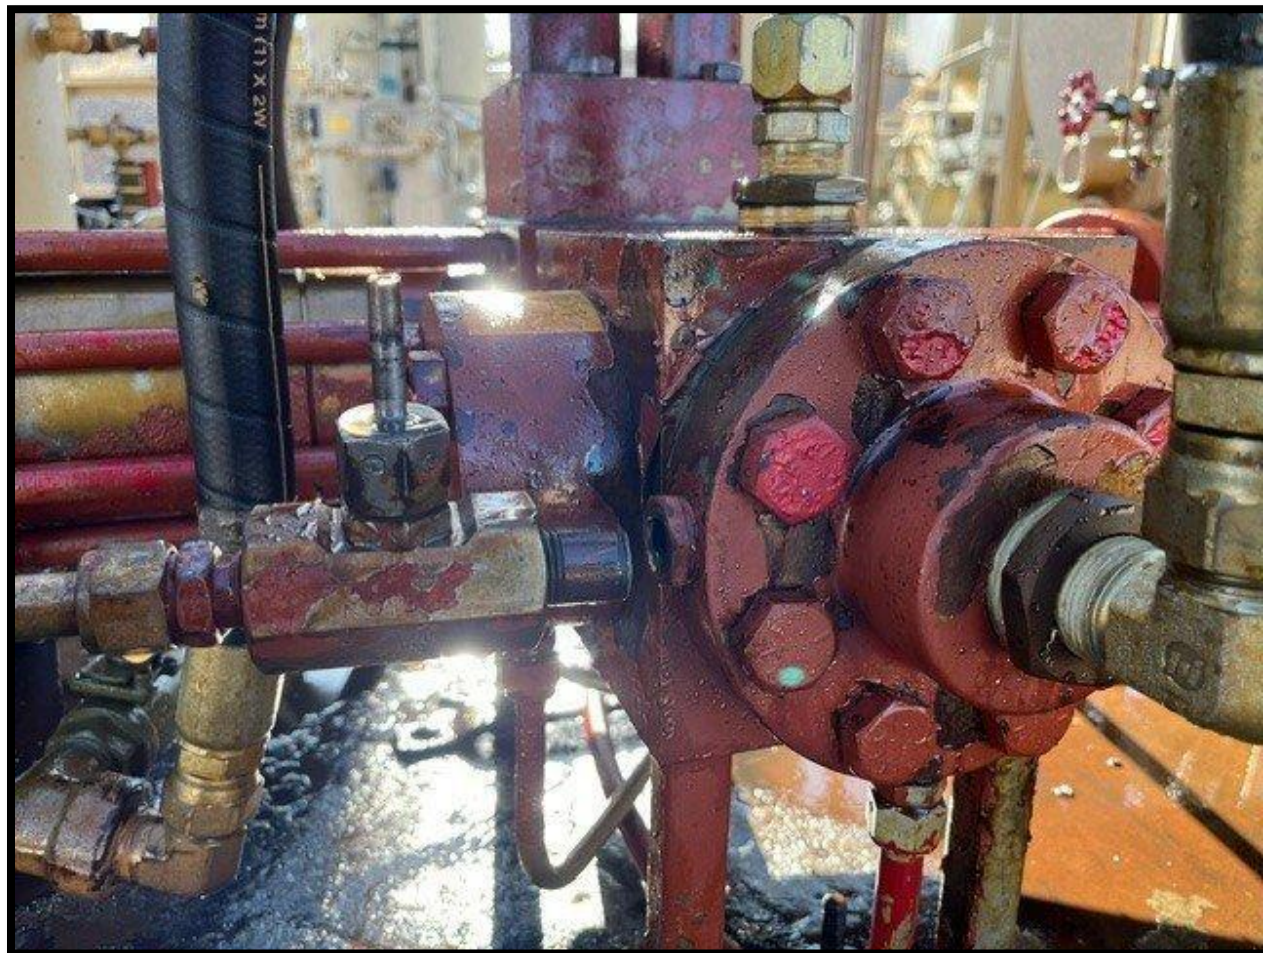
Photo 1: Release Point

Harvest personnel discovered a release at Laguna Seca. The operator discovered a ½" fitting on the glycol pump broke draining 109 gallons (2.6 bbls) of glycol from the storage tank with 25 gallons of it making off the skid onto the ground, the remaining 84 gallons stayed on the dehy skid. Once glycol storage tank was emptied, it was calculated that 805 mcf released from the ½" fitting for 7 hours. Upon discovery the operator shut in the dehy to stop the release. All free-standing liquids were sucked up. NOR was submitted on 4/12/2024 and incident number nAPP2410349074 was assigned for this release. Emmanuel Adeloye with the BLM was contacted via phone call at approximately 2:00pm with a follow up email to him and Nolan Craun (BLM) notifying them of the release.

A crew was onsite to pressure wash dehy skid and to scrap up contaminated soil. Approximately 3 yards of soil was scraped up and removed from effected area.

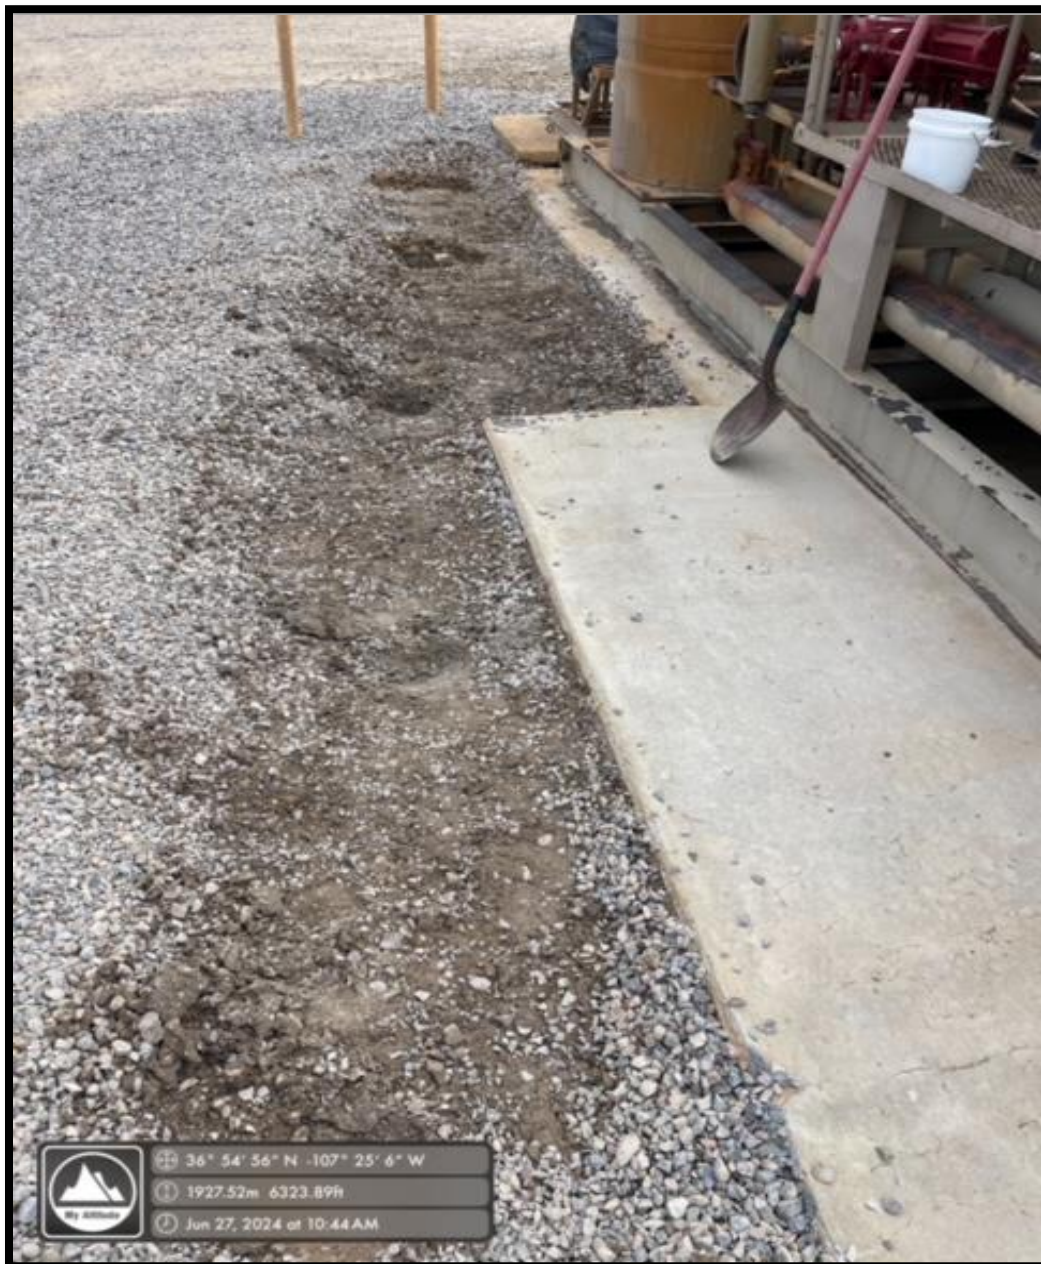
Photo 3: Sample Event 6/27/2024

Harvest was onsite to perform sampling activities. There were no witnesses from the NMOCD nor the BLM during sampling event. One five-point composite sample was collected and sent in for analysis of GRO/DRO/ORO, BTEX, and Chlorides. Area sampled measured 26 ft long by 4 foot wide. See attached "Sample Map" for reference.
